WASTE MANAGEMENT OF CANADA CORPORATION

TWIN CREEKS ENVIRONMENTAL CENTRE: 2020 FOURTH QUARTER & ANNUAL MONITORING REPORT VOLUME 2C OF 5 – COMPLIANCE MONITORING APPENDICES J TO S

RWDI #2001313-1000 February 25, 2021

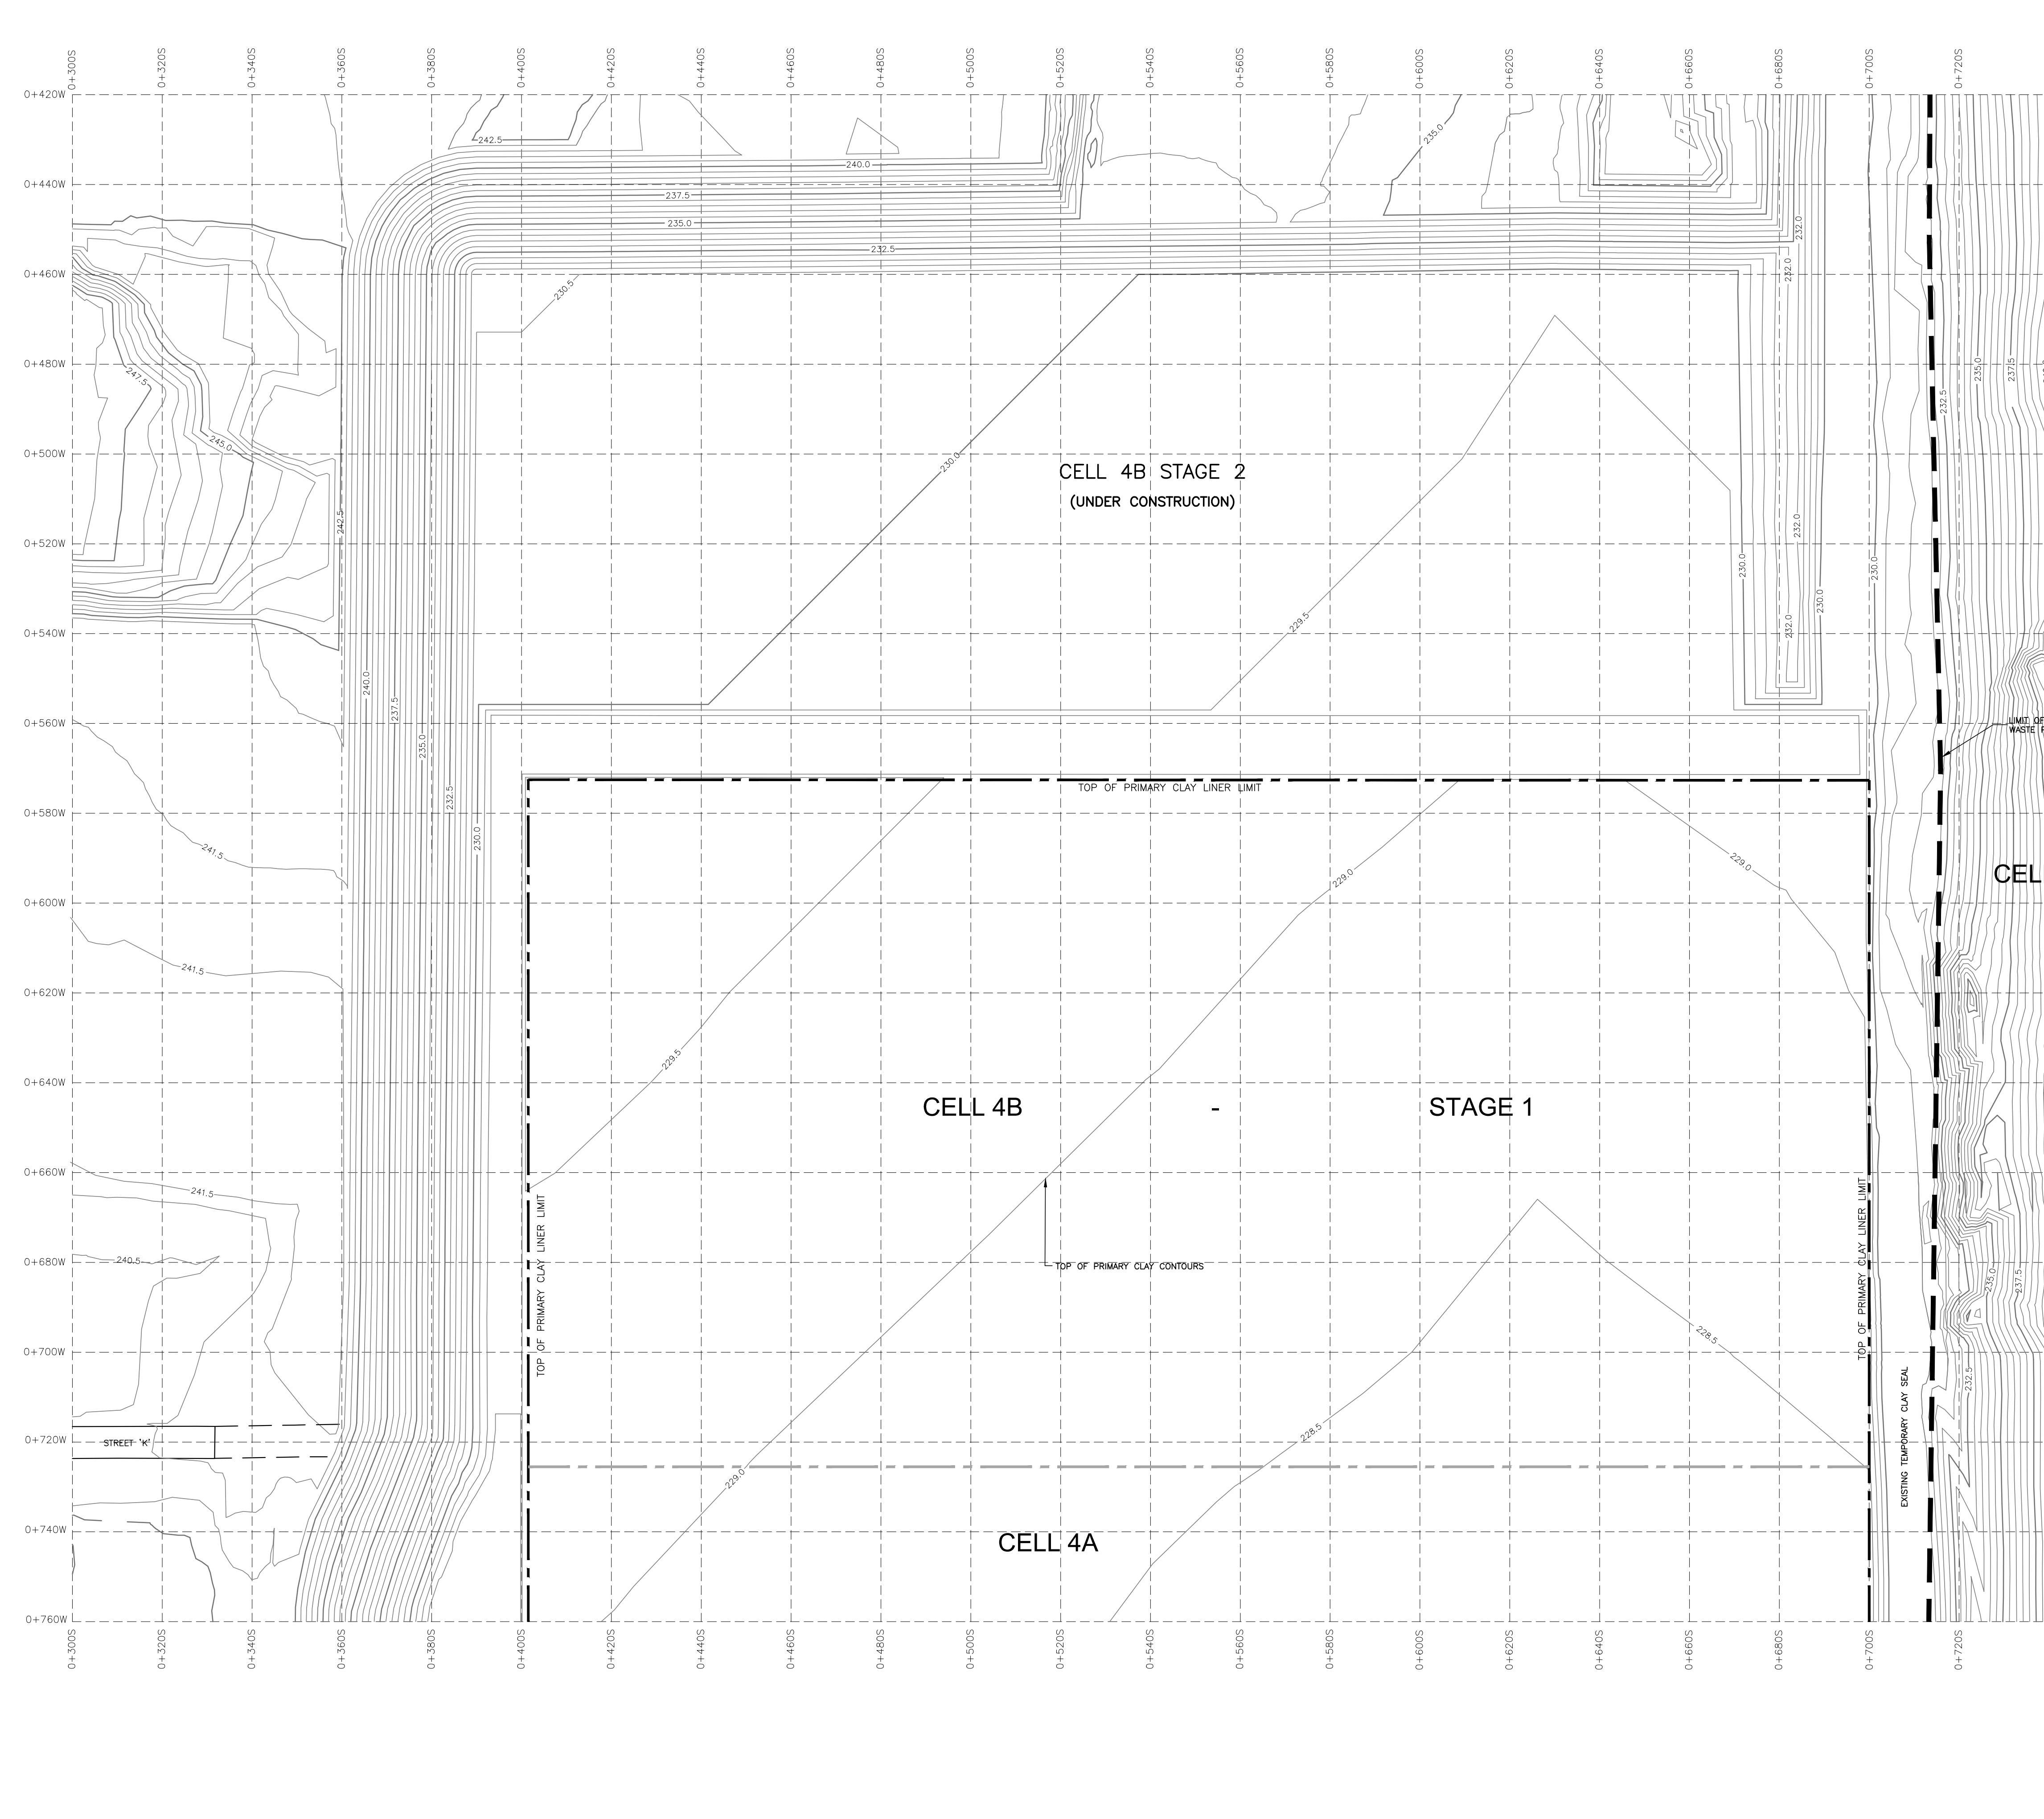
In summary, the above field testing indicated that the liner soil was constructed at the acceptable compaction and moisture content for optimum placement. As-built PL surface grades are detailed on Sheet AC-904.

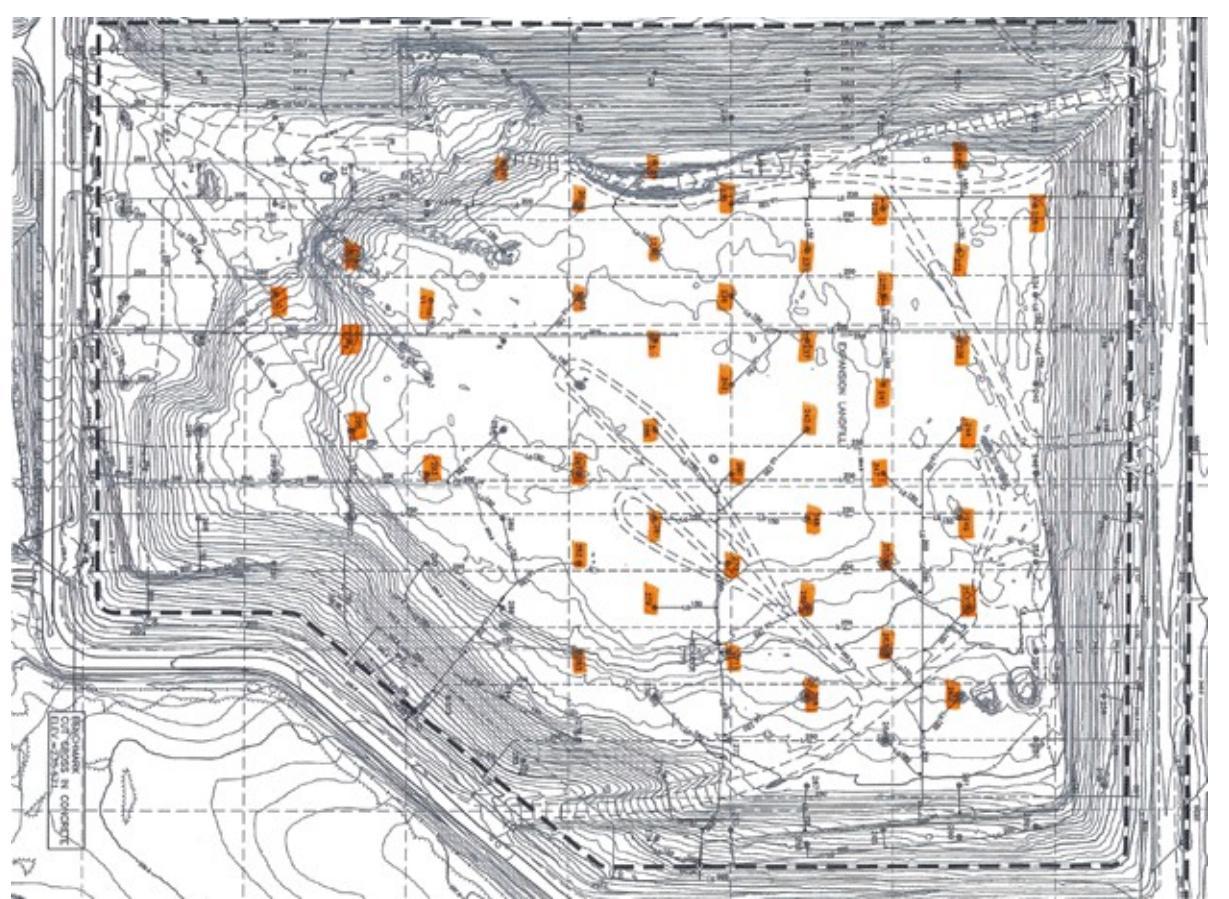
Fourty-four (44) landfill gas (LFG) collection system pipes continue to be disconnected (see Figure 1 below) for repairs and replacement. Refer to the September 2019 inspection report for more details. During this review period, WM staff were periodically observed adding intermediate clay cover on portions of Cell 2 and 3 of the landfill. However the Company reported that wet weather conditions has delayed the process for completing repairs to the LFG collection system and re-connecting the wells/pipes. As a result, the Ministry has requested from the Company an action plan with timelines to re-connect the LFG collection system and address any off-site impacts such as landfill gas odours.

Figure 1. A map of the disconnected landfill gas collection system wells on Cell 2 and 3 of the landfill as of February 12, 2020.

** See Section 5.0 of this inspection report for Action required by the Company. **
