**HAWTHORN PARK LANDFILL
APPENDIX III-4G
MCBRIDE-RATCLIFF ASSOCIATES, INC. – GEOLOGIC FAULT
ASSESSMENT**

APPENDIX D
GEOLOGIC FAULT ASSESSMENT
HAWTHORN PARK RECLAMATION PROJECT
AND RECYCLING CENTER
HARRIS COUNTY, TEXAS

SANIFILL OF TEXAS, INC.
HOUSTON, TEXAS

McBRIDE-RATCLIFF AND ASSOCIATES, INC.
HOUSTON, TEXAS
JANUARY 1993

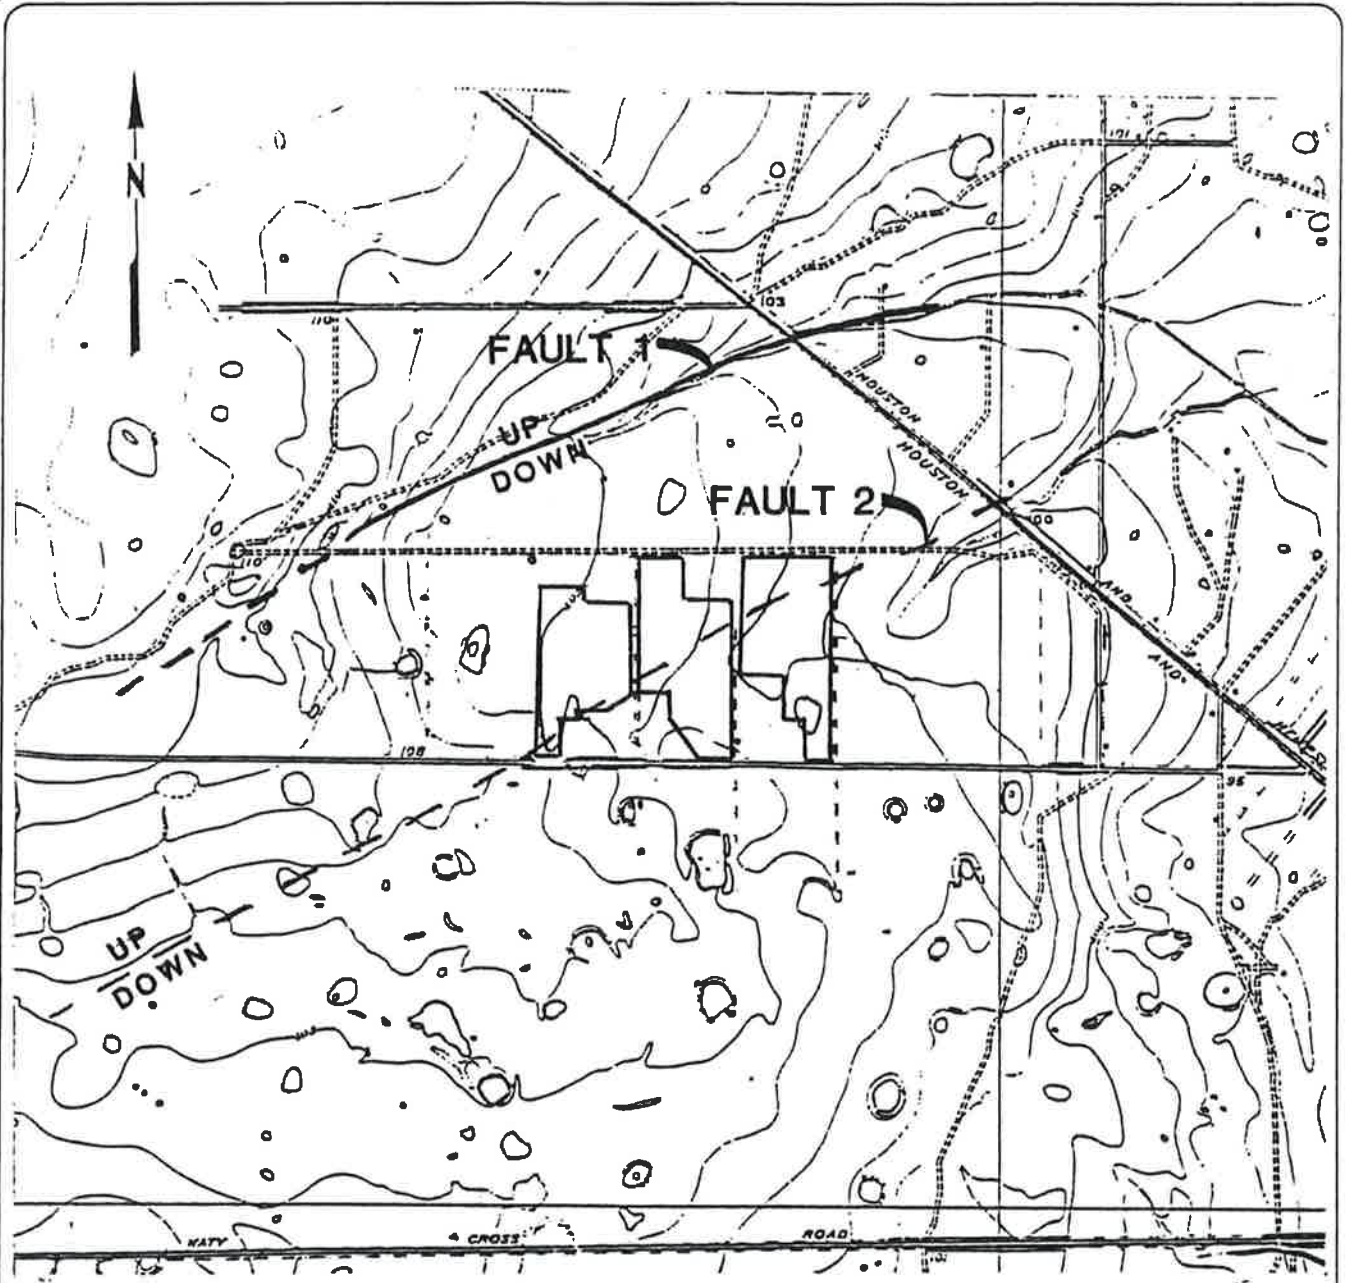
PROJECT NO 190-0638
FIGURE D-1

In a report published by Turner Collie and Braden, Inc. of Houston in 1966, Dewitt C. Van Sienen presented a map which represented his interpretation of the surface location of faults in the general vicinity of the study area. Figure D-1 illustrates the Van Sienen fault map. Van Sienen has interpreted the surface location of 2 faults in the area of the HPRPRC site. Fault 1 represents Van Sienen's interpretation of the surface location of the Brittmoore Fault. Fault 2 is Van Sienen's representation of the surface location of an interpreted "possible" fault (projection of the White Oak Fault). As illustrated on Figure D-1 Fault 2 traverses the middle of the HPRPRC site.

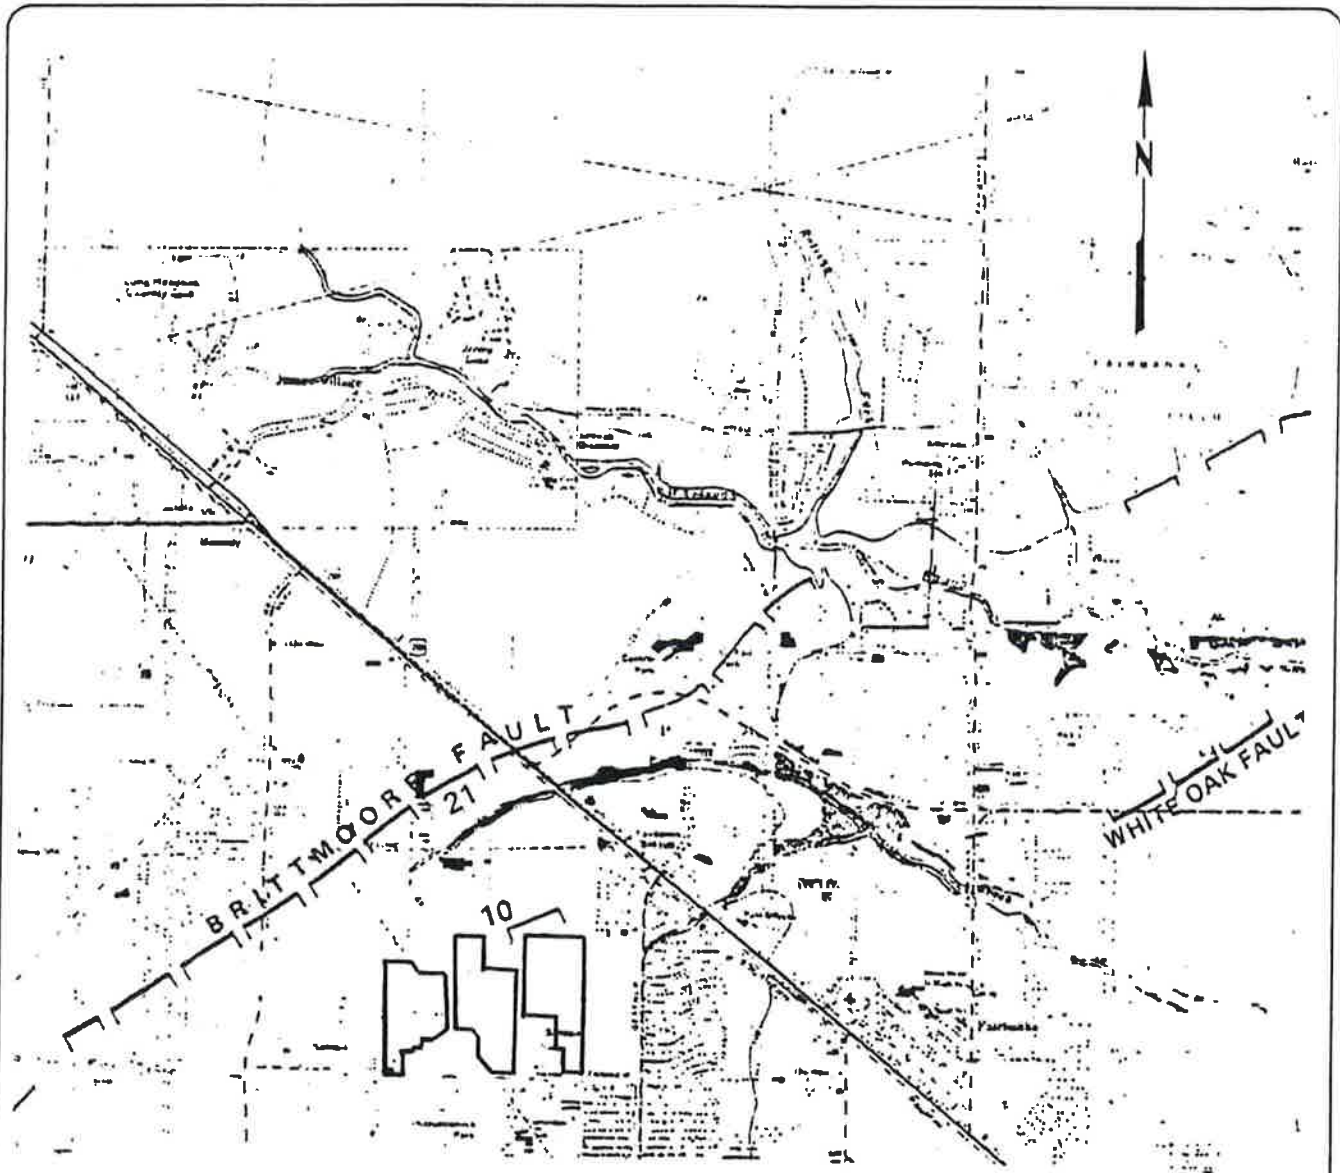
PROJECT NO: 90-0638
FIGURE D-2

As a partial fulfillment of the Master Degree in geology at the University of Houston, Wolfgang C. Heuer presented his 1979 thesis entitled *Active Faults In The Northwestern Houston Area*. The HPRPRC site is situated in Heuer's mapping area. Figure D-2 illustrates the interpreted location of faults and "possible" fault related features interpreted by Heuer in the area of the HPRPRC site. As shown on Figure D-2, the fault features designated as 10, 10A, and 10B are located in the HPRPRC site.

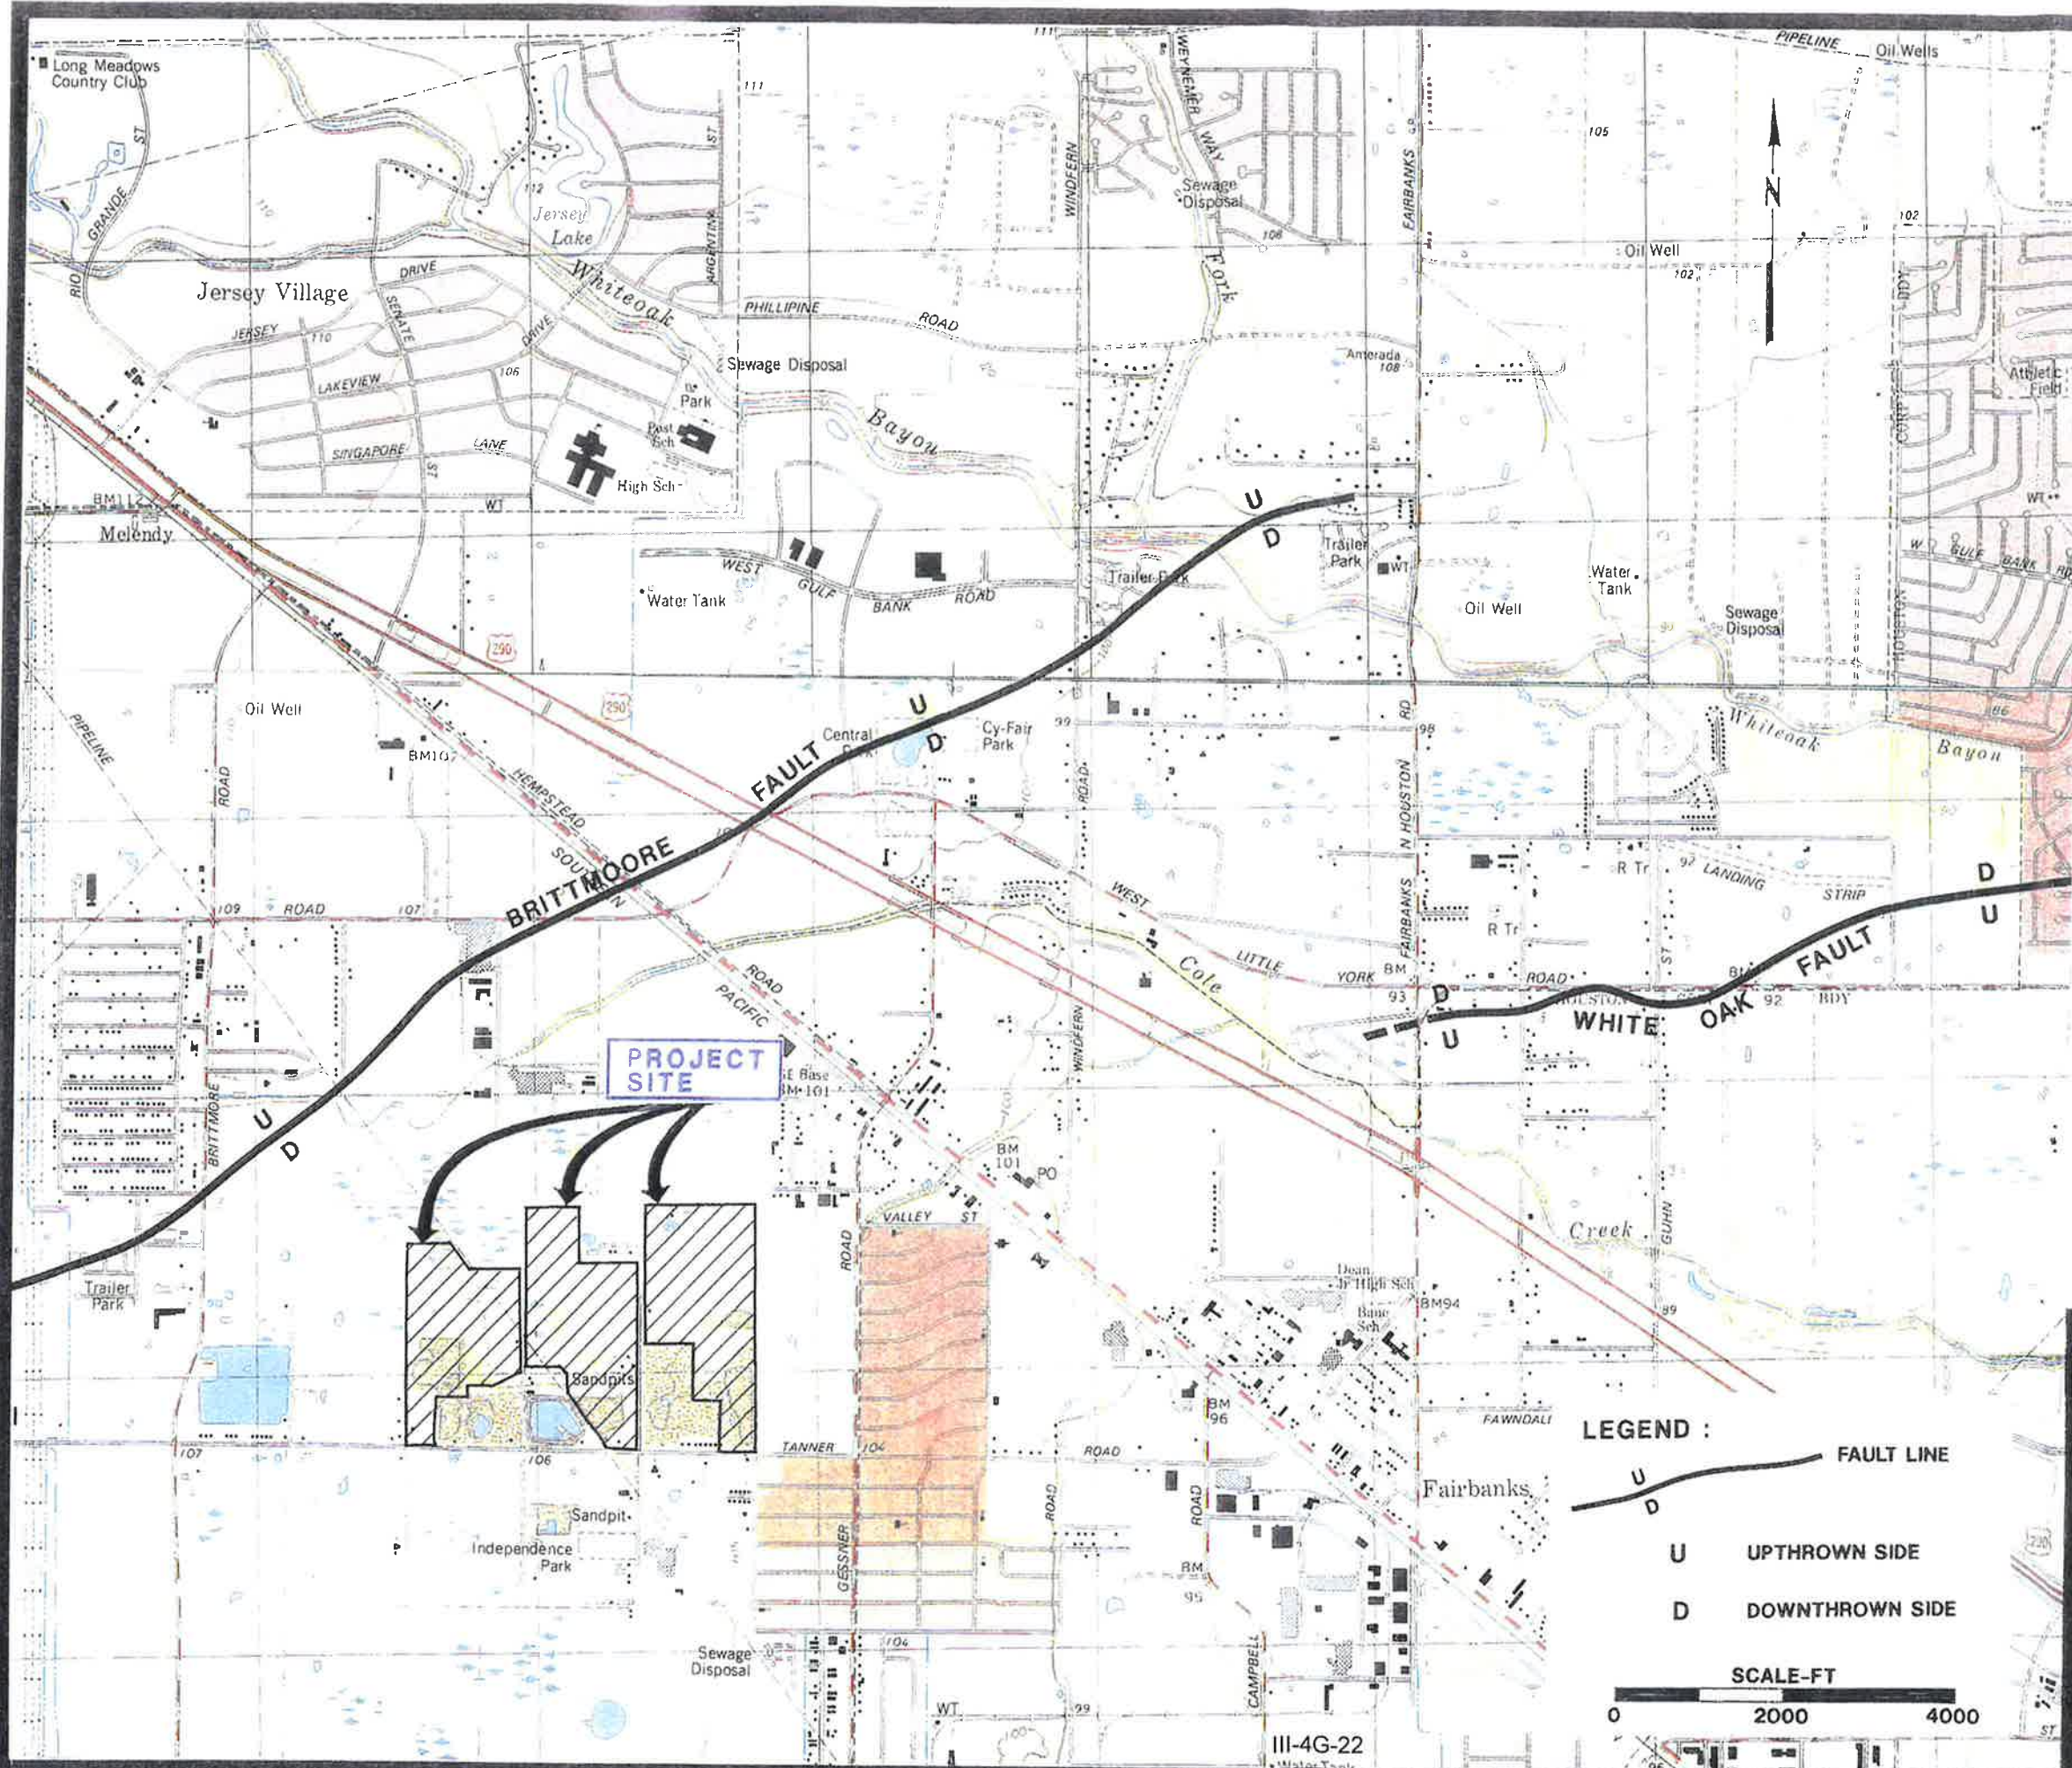
SCALE NOTED	MADE CHECK	LLD/SMH LAL	DATE 10-11-93	FILE NO. 90-0638
			DATE 10-11-93	FIGURE D-6

Areas of off-site concern which were reviewed during our reconnaissance included the location of the Brittmoore Fault and the White Oak Fault. Figure D-6 illustrates the relationship of the location of the Brittmoore Fault and the White Oak Fault to the HPRPRC site. The surface location of these faults were mapped on January 16, 1992. As shown, the HPRPRC site is not traversed by either fault. Surface evidence of the White Oak faults terminates northwest of the site about 2 miles. Surface evidence of the White Oak Fault was noted on a northeast trend away

from the HPRPRC site. A well defined scarp identifies the surface location of the Brittmoore Fault throughout the vicinity. Structural distress in roads and building structures situated above both faults indicate that these faults are active.

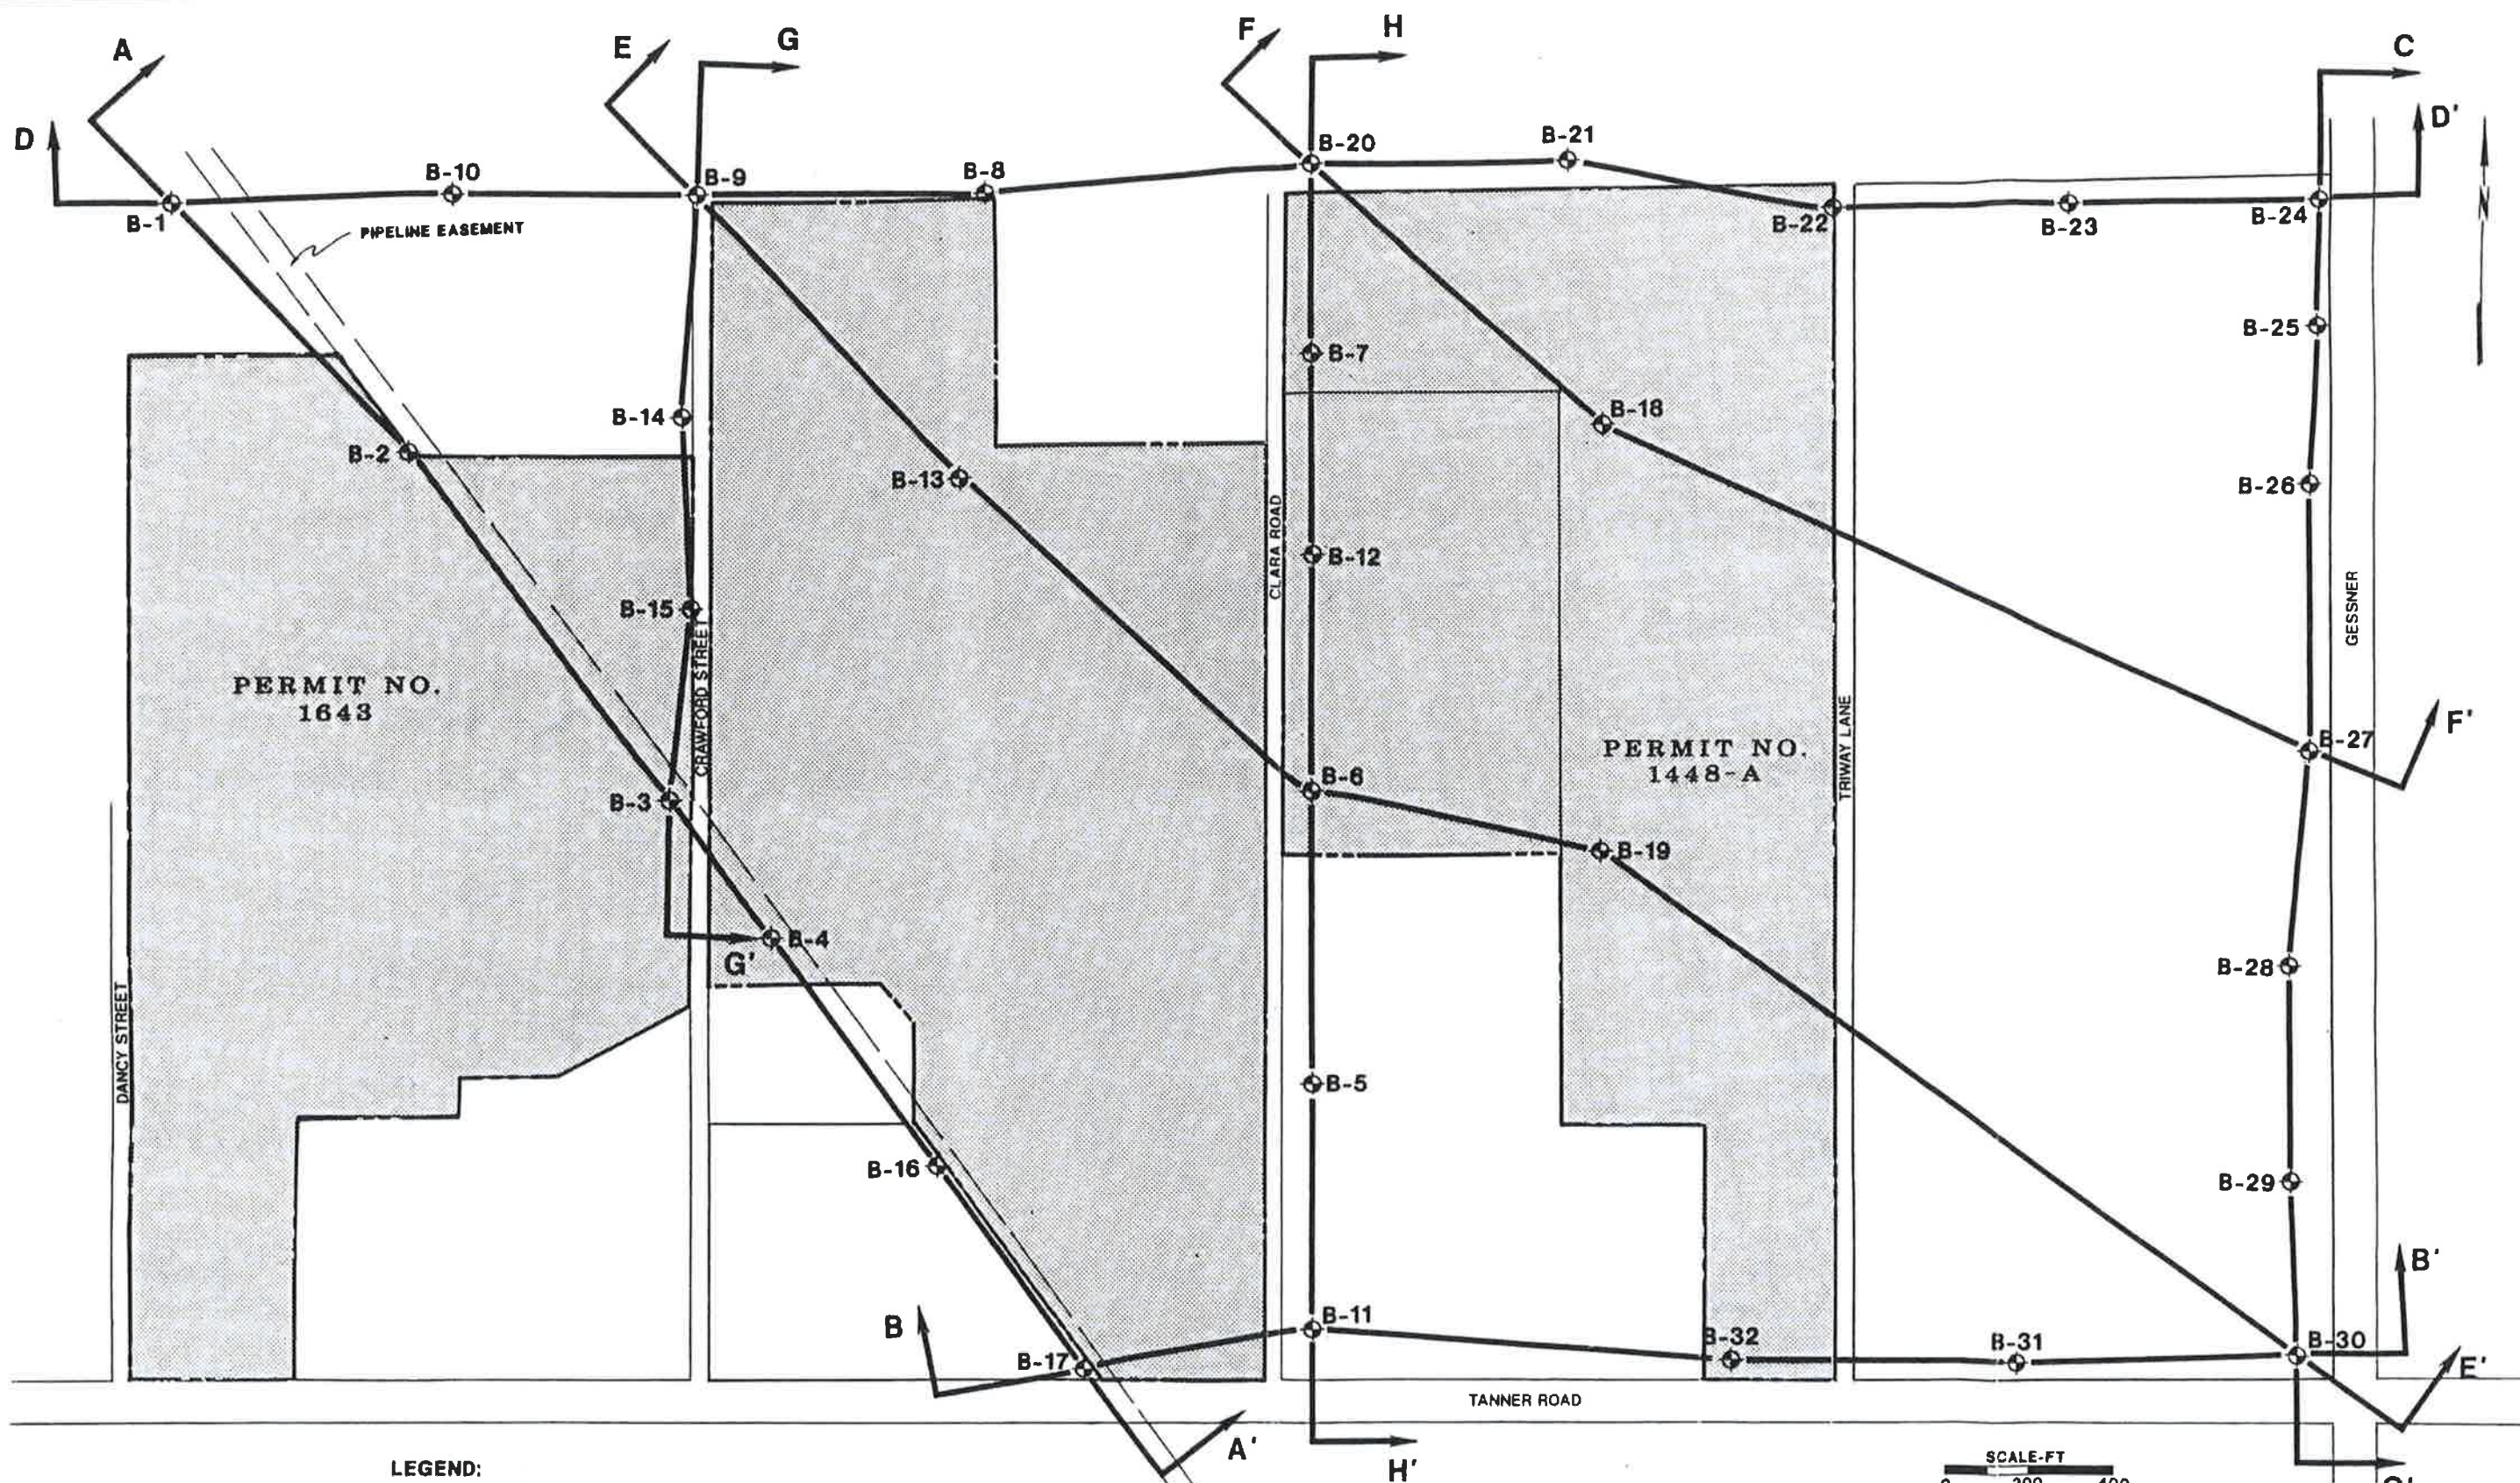
SCALE NOTED	MADE CHECK	LLD/SMH LAL	DATE 10-11-93	FILE NO. 90-0838
TESTHOLE LOCATIONS				FIGURE D-7

Thirty-two test holes located as shown on Figure D-7, were drilled, geophysically logged, and grouted for the subsurface evaluation of the HPRPRC site. A testhole depth of 300 ft below the ground surface was selected to penetrate stratigraphic units which could be readily correlated over the site. Geophysical logs were obtained immediately upon completion of the drilling. Three geophysical curves were obtained from each log, natural gamma ray, spontaneous potential, and single-point resistance. The three curves are interpreted to identify distinct stratigraphic units, referred on the cross-sections as Marker Beds. The logs are placed in a cross-sectional form and are analyzed to identify subsurface anomalies which are characteristic of faults.
