RICHMOND SANITARY LANDFILL SITE, MONITORING REPORT NO. 36

PART OF LOTS 1, 2 AND 3, CONCESSION IV,
TOWN OF GREATER NAPANEE, COUNTY OF
LENNOX AND ADDINGTON

PROJECT NO.: 081-12459-04 (8570)
DATE: MARCH 27, 2023

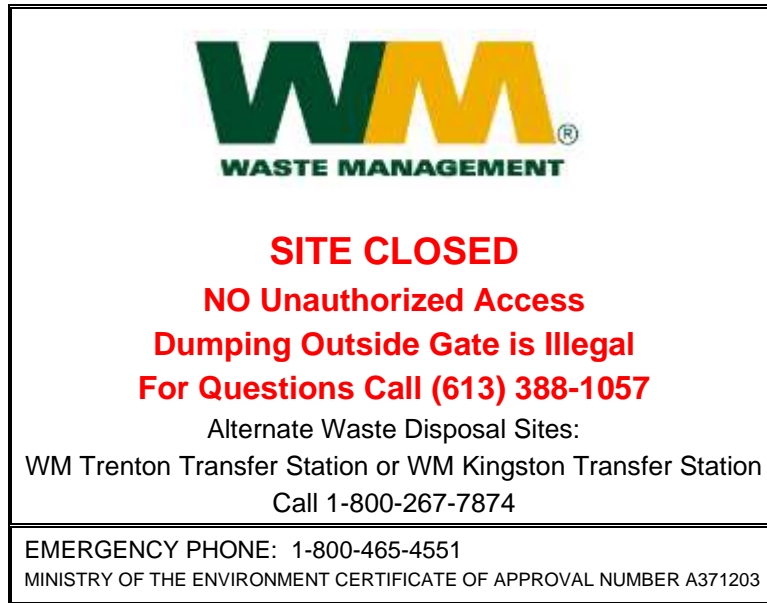
Signs are erected along the access road near Beechwood Road identify the landfill site. The main sign supplies the following information:

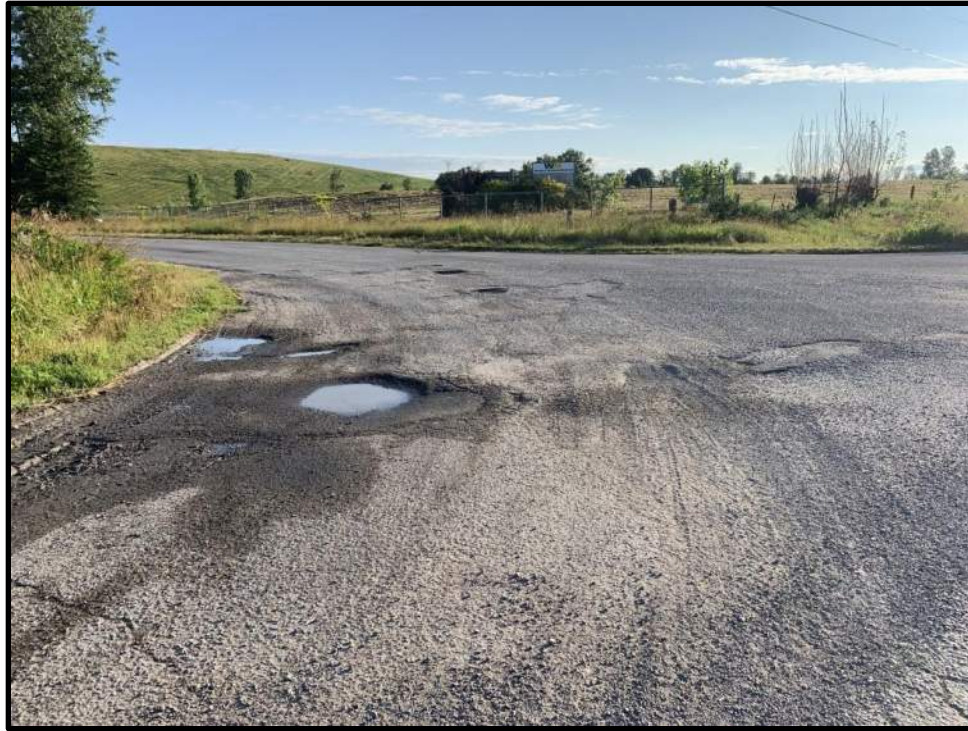
Photo 1: View facing north of the pavement at the site entrance off Beechwood Road. Potholes are emerging on the southwest portion of the road.

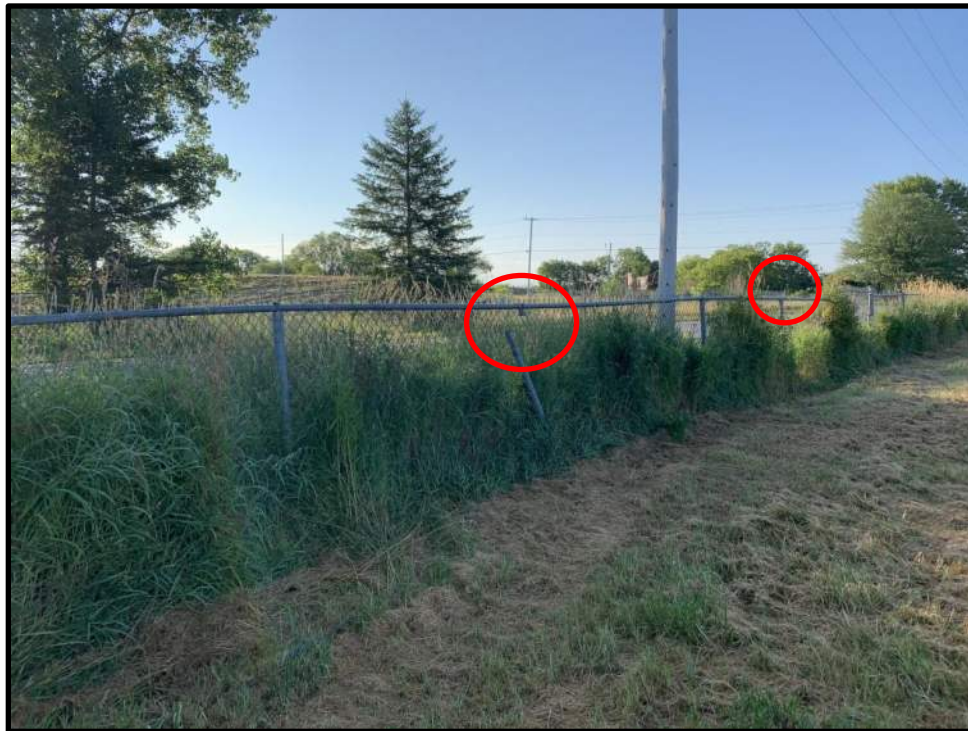
Photo 2: View facing southeast of the chain link fence along the east side of the landfill entrance. Some posts have separated from the top rail.

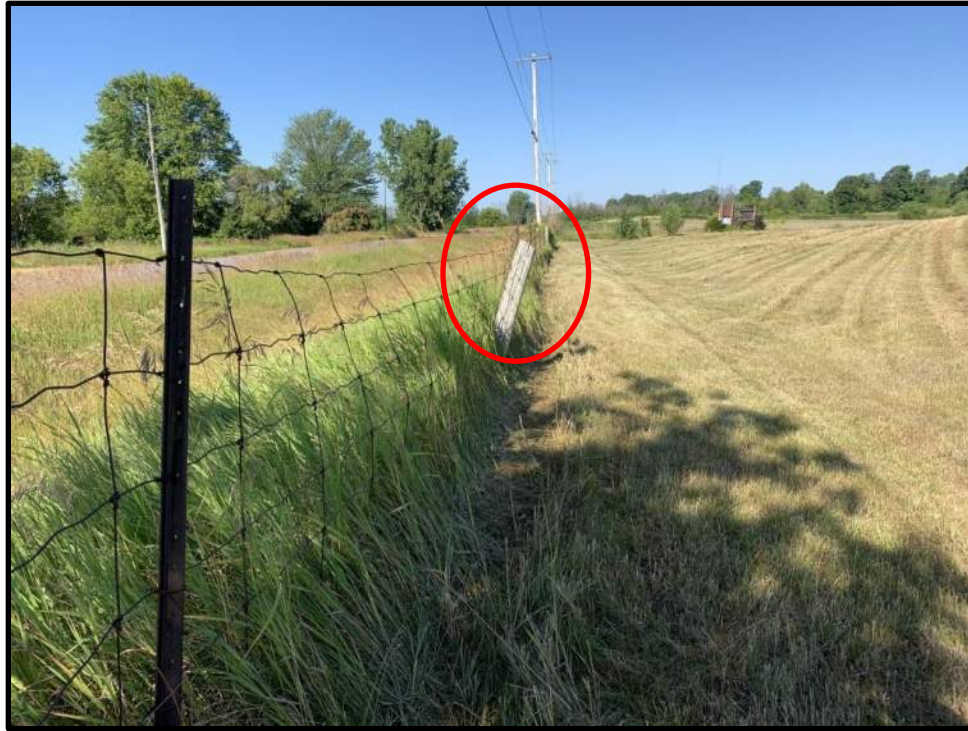
Photo 3: View facing west of a leaning fence post along the south perimeter of the site, east of the entrance. The paige wire has also dislodged from the post.

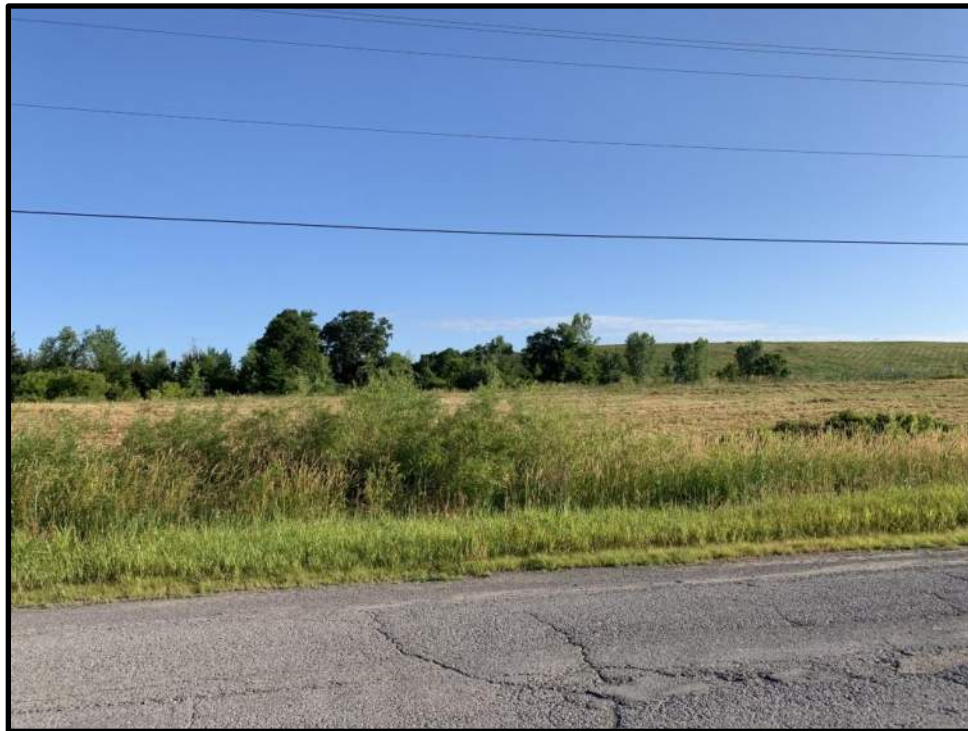
Photo 4: View facing north of the paige wire fence along the south perimeter of the site, west of the site entrance. The fence and "No Trespassing" signs are obscured by thick vegetation.

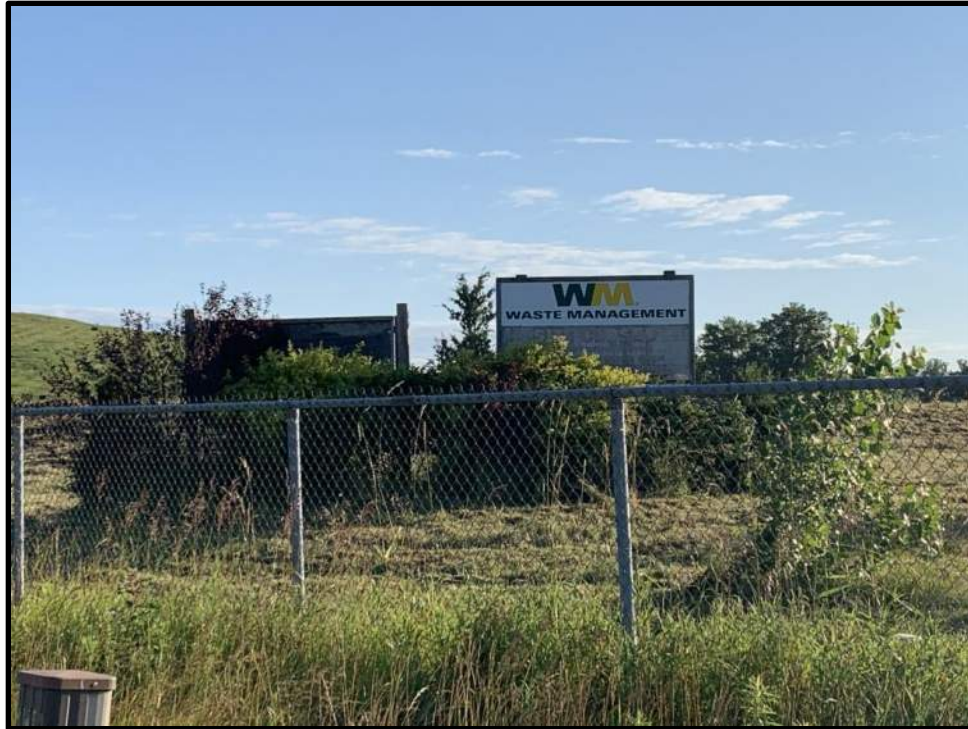
Photo 5: View facing northeast of the signage east of the landfill entrance. The sign is becoming obscured by vegetation, and contact information has faded to a point that it is indiscernible.

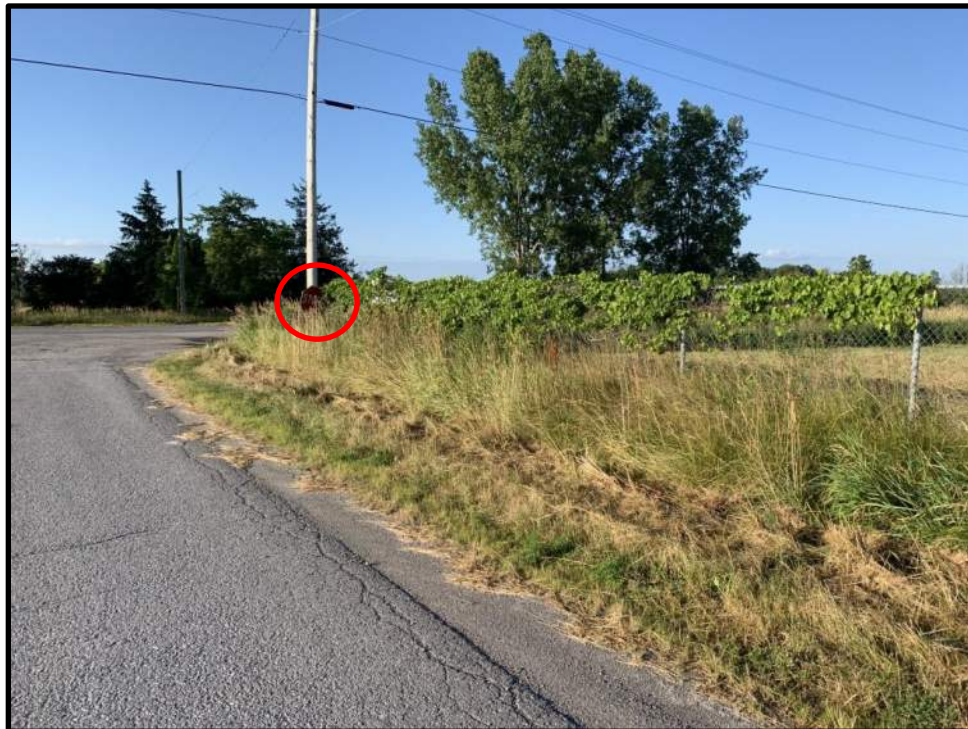
Photo 6: View facing southwest of the Stop sign at the landfill entrance. The Stop sign is leaning away from the traffic sight line and thick vegetation is obscuring the emergency evacuation signage on the fence.

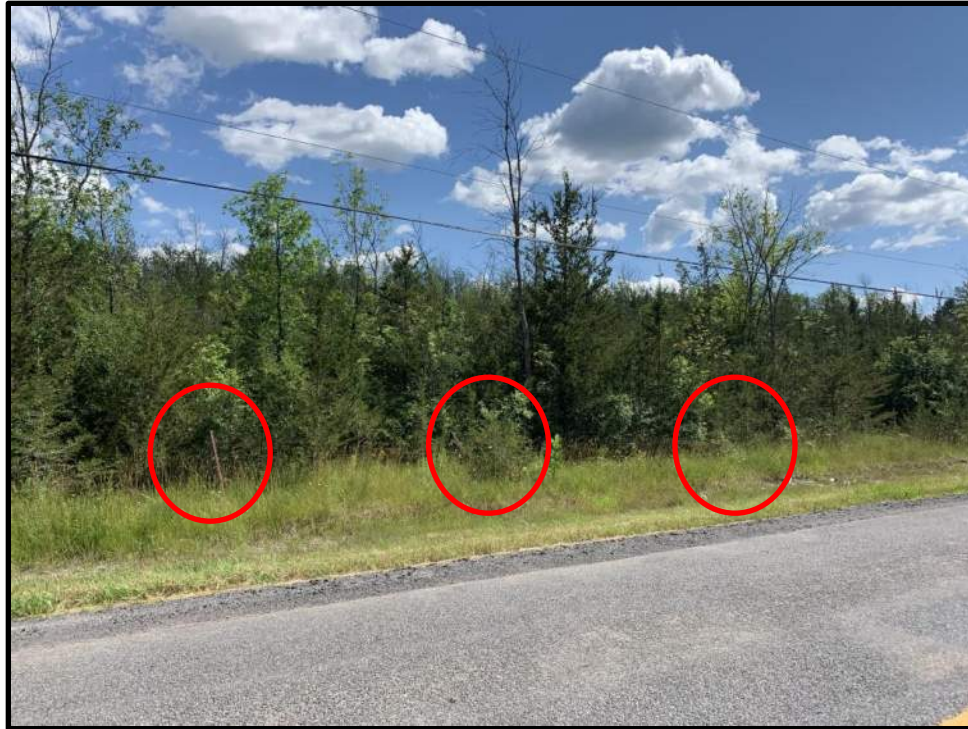
Photo 7: View facing southwest of a section of the north perimeter fence along Selby Road, east of the former Wildlife Habitat house. Fence posts in the area are leaning or are missing; the paige wire fence is down; and the “No Trespassing” signs are not present in this location

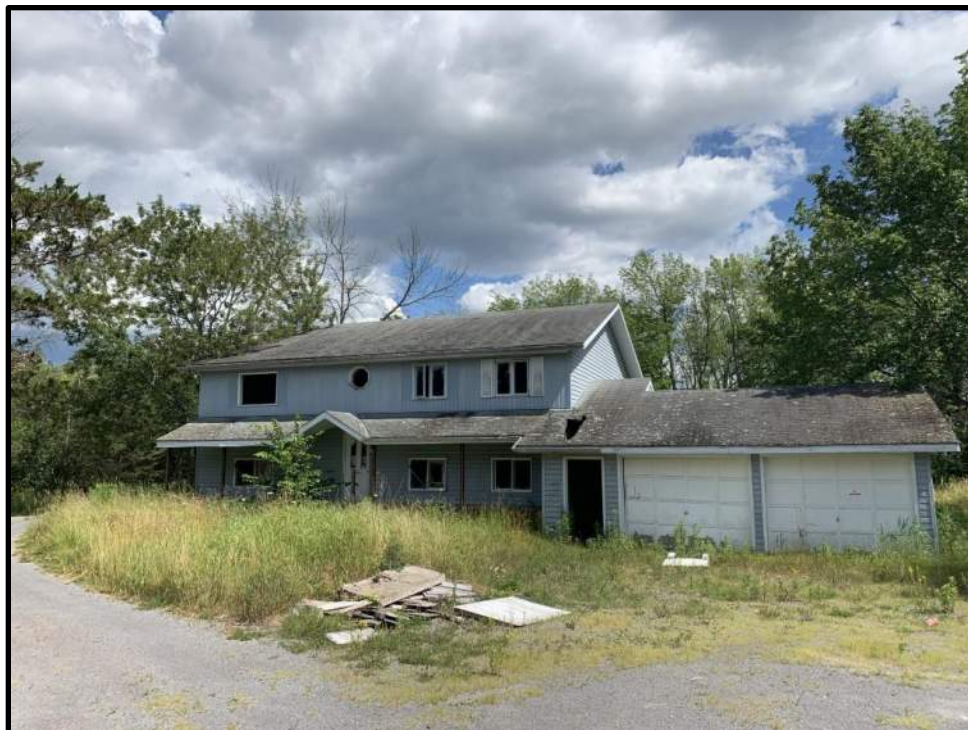
Photo 8: View facing southeast of the Wildlife Habitat house at 3792 Selby Road. All windows in the house have been smashed; a hole is present in the garage roof; and piles of debris are present.

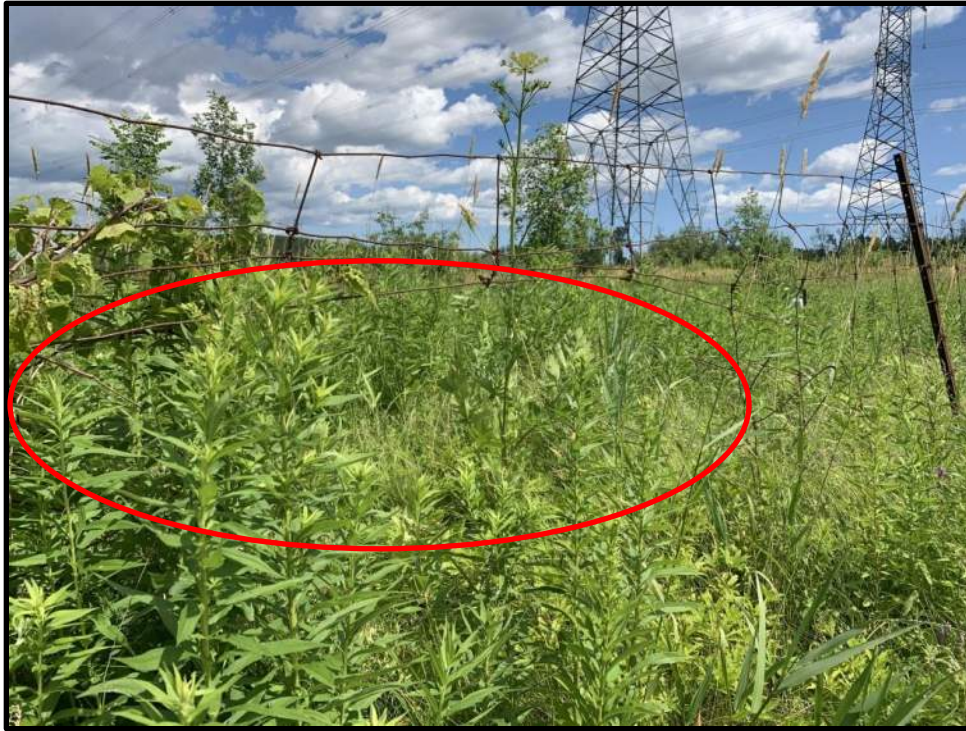
Photo 9: View facing east of a hole in the paige wire fence along County Road 10, east of hydro tower ID X527B and west of monitoring wells 82-1 and 82-2. Vegetation is beginning to obscure the opening.

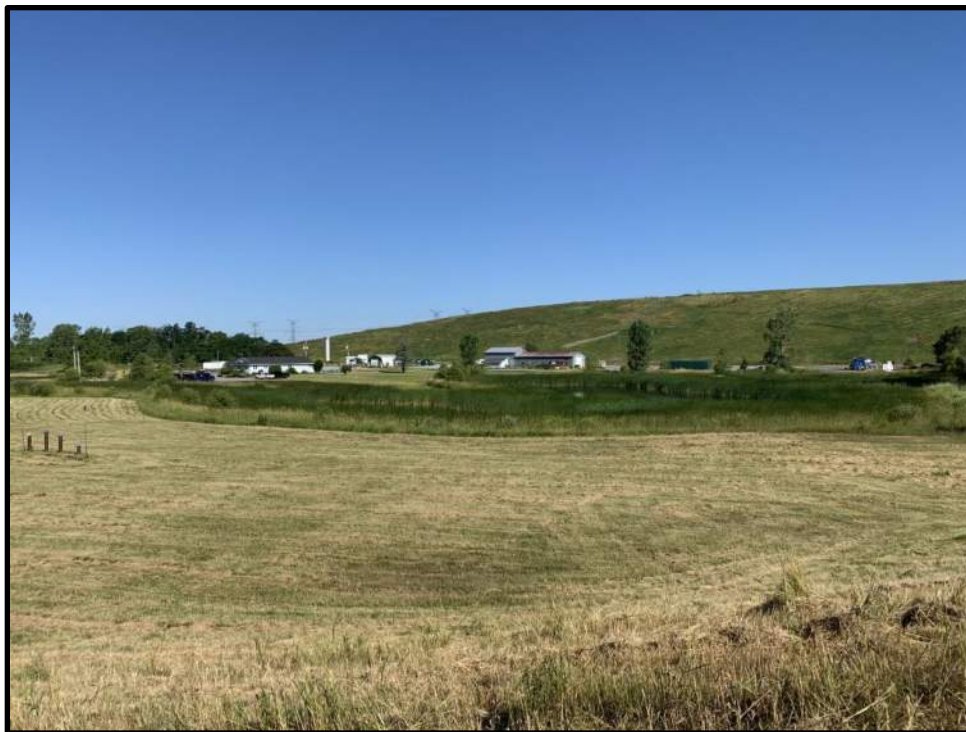
Photo 10: View facing northwest of the east side of Stormwater Pond 3. The pond banks are obscured with thick vegetation, preventing observations.

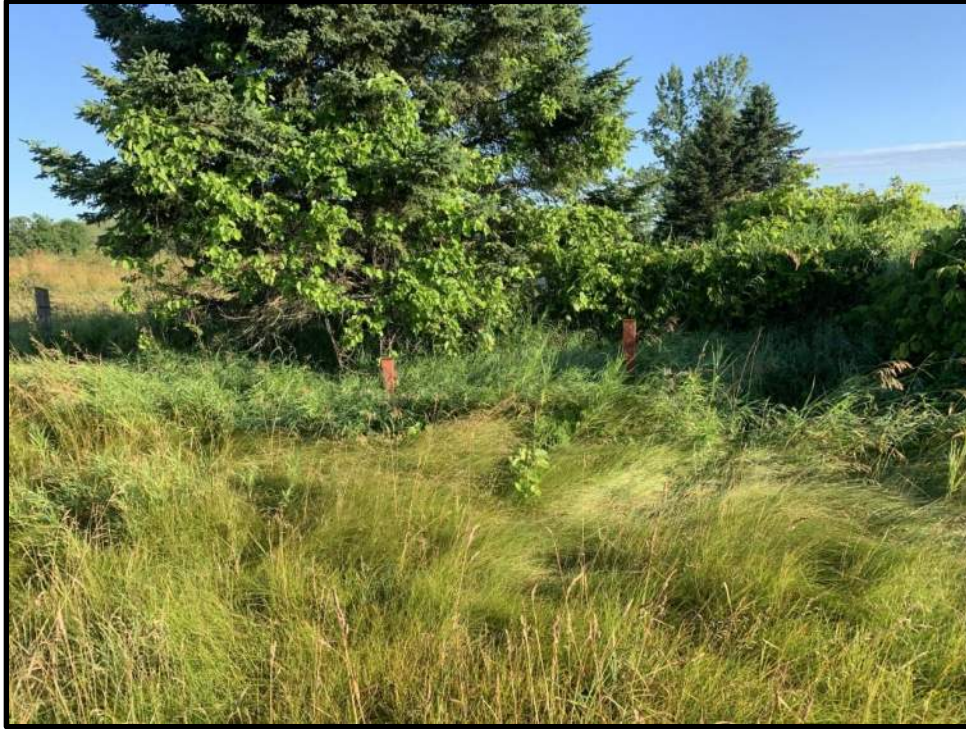
Photo 11: View facing north of the southeast perimeter of the site along Beechwood Road. A blue barrel located to the right of the red well casings observed in previous inspections has been removed.

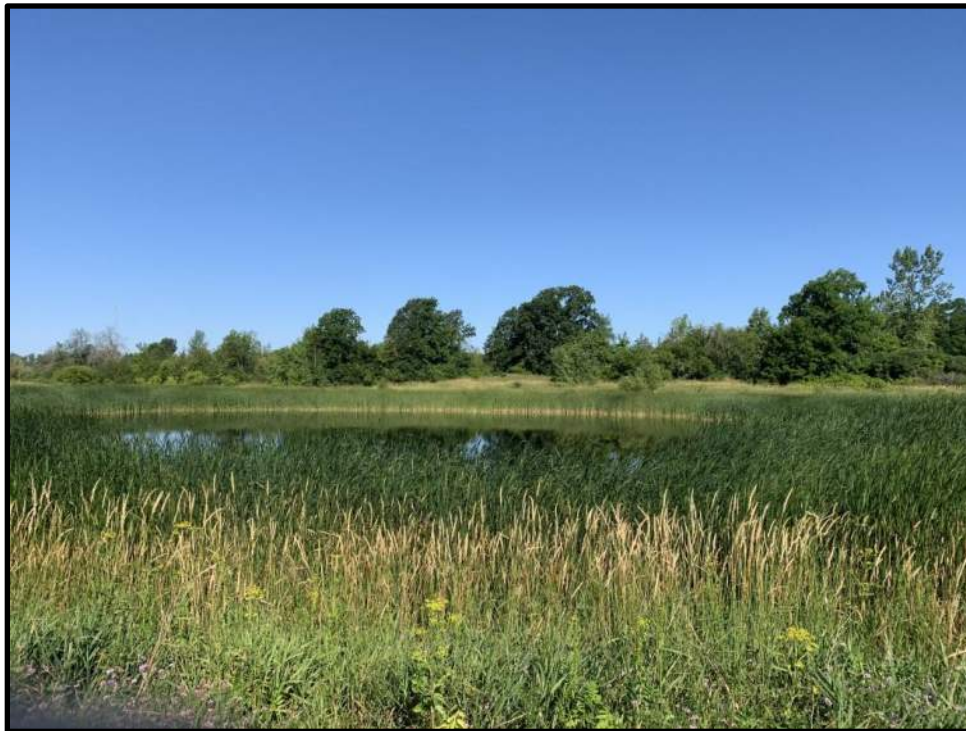
Photo 12: View facing north of the west side of Stormwater Pond 3. The pond banks are obscured with thick vegetation, preventing observations. No stains, sheens, floating foam or scum was observed.

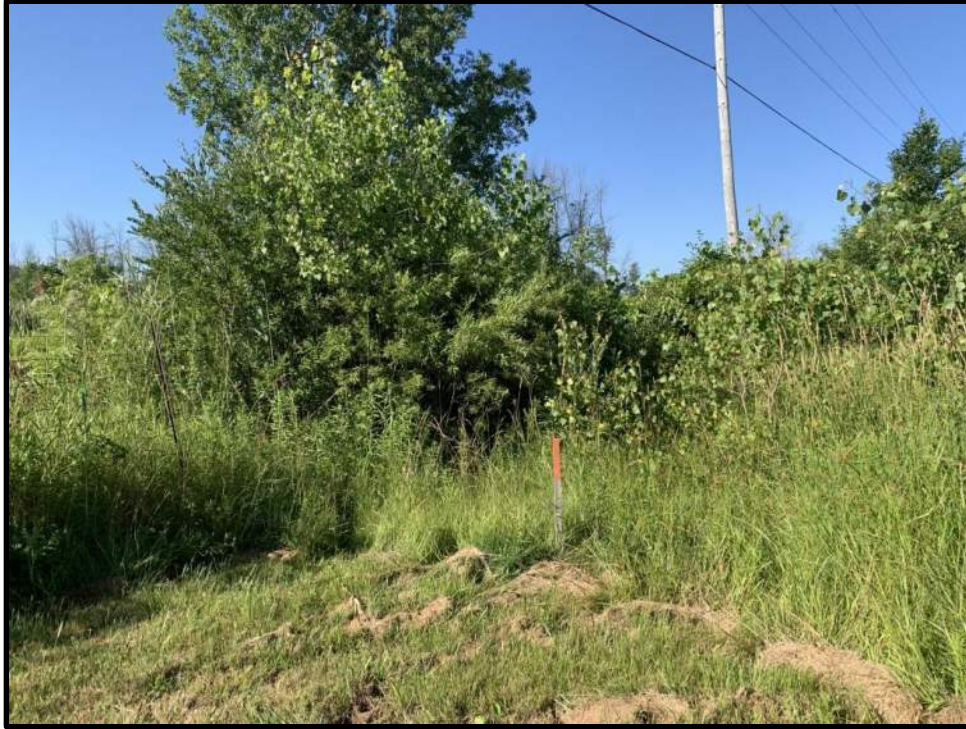
Photo 13: View facing southwest of the emergency spillway channel outlet from Stormwater Pond 3 to the ditch along Beechwood Road. Thick Vegetation has obscured the outlet, preventing visual observations.

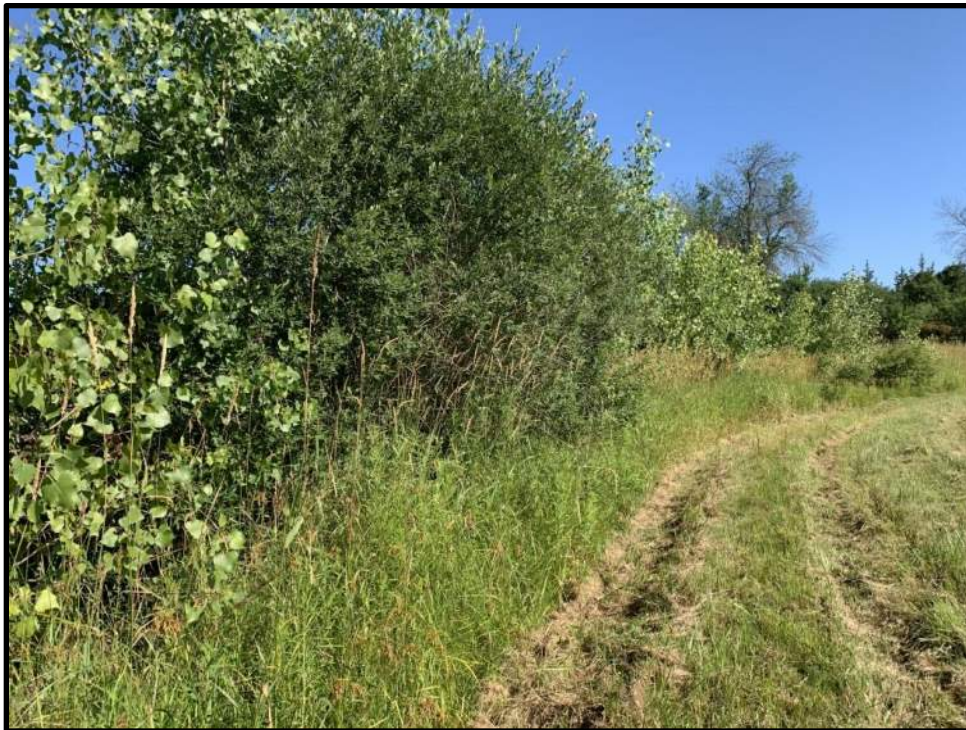
Photo 14: View facing north of the emergency spillway channel from Stormwater Pond 3. Thick vegetation is present in the channel.

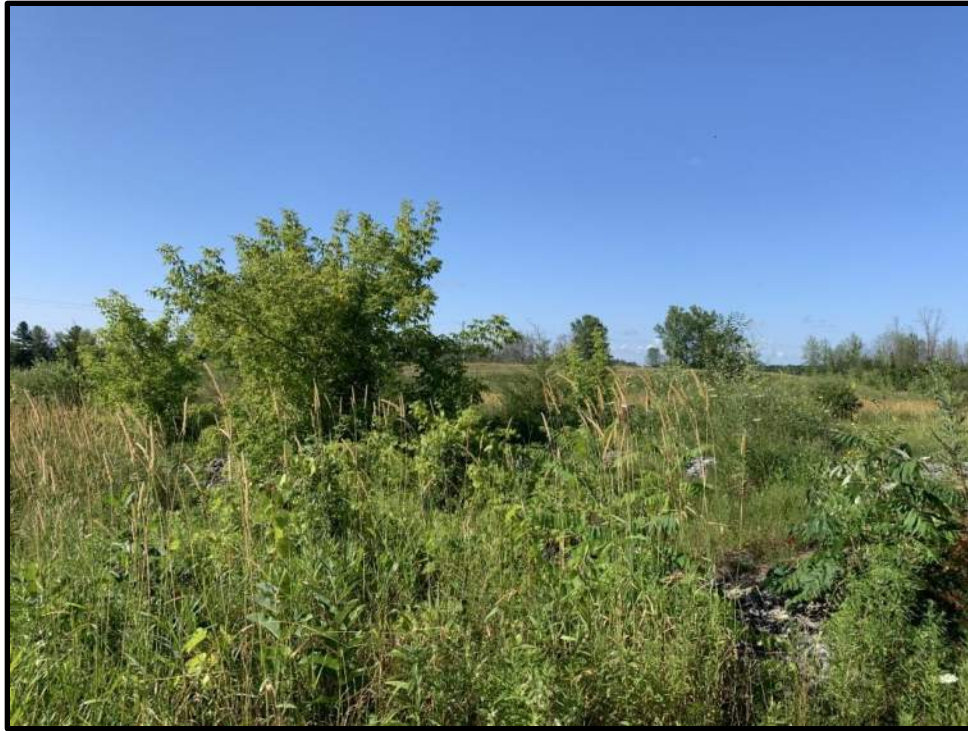
Photo 15: View facing southwest of emergency spillway channel at Stormwater Pond 3. Thick vegetation is present in the area.

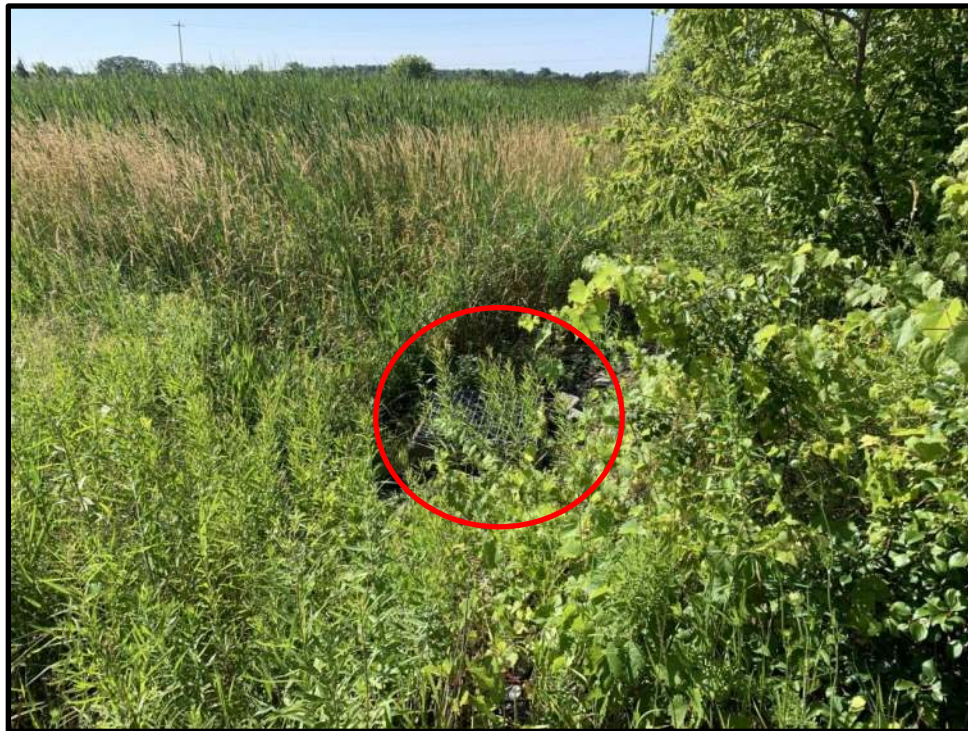
Photo 16: View facing south of the inlet structure (circled) at the west end of Stormwater Pond 3. Vegetation is obscuring visibility of the structure.

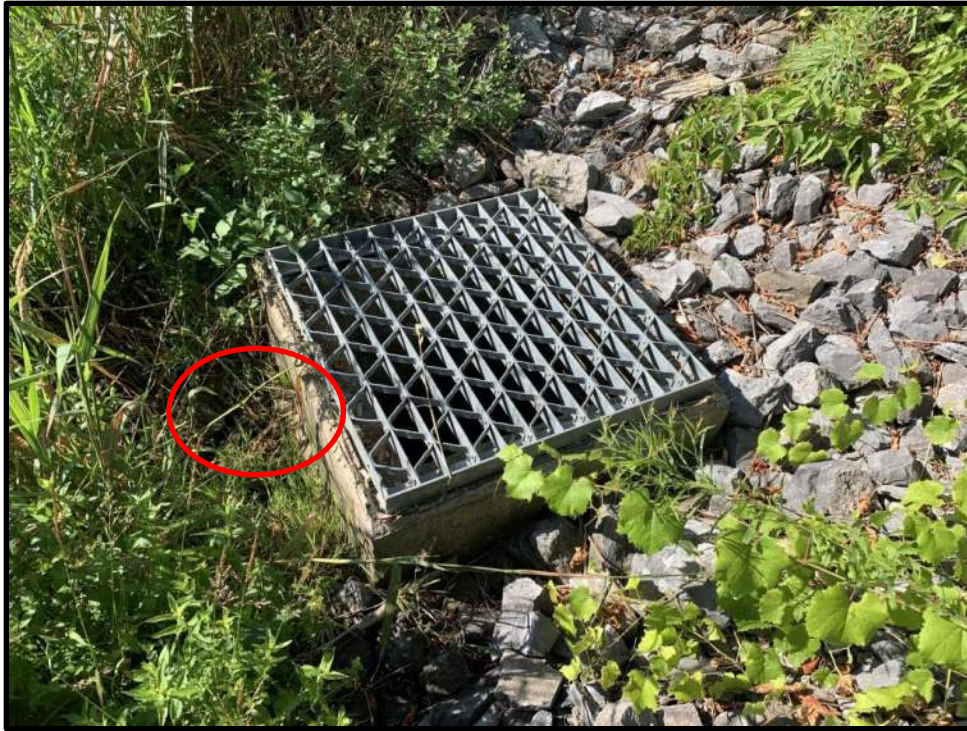
Photo 17: View of the inlet structure on the west side of Stormwater Pond 3, east of the emergency spillway. Vegetation is surrounding the inlet side of the structure (circled) but water can still enter the inlet.

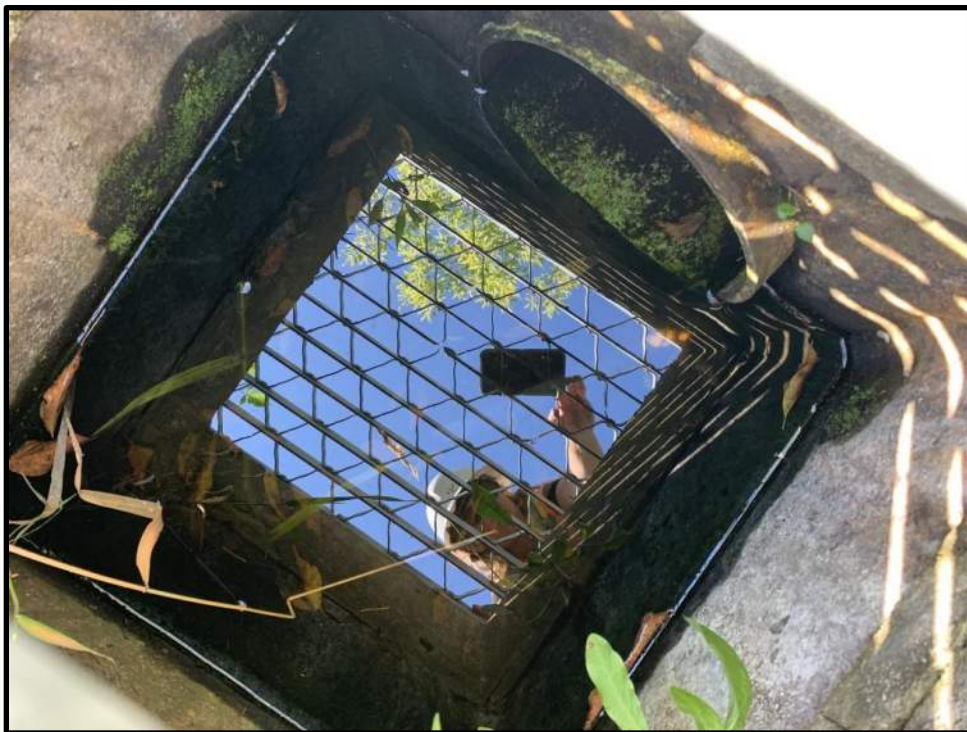
Photo 18: View inside the inlet structure at Stormwater Pond 3, east of the emergency spillway. Water can freely exit the structure once levels are high enough.

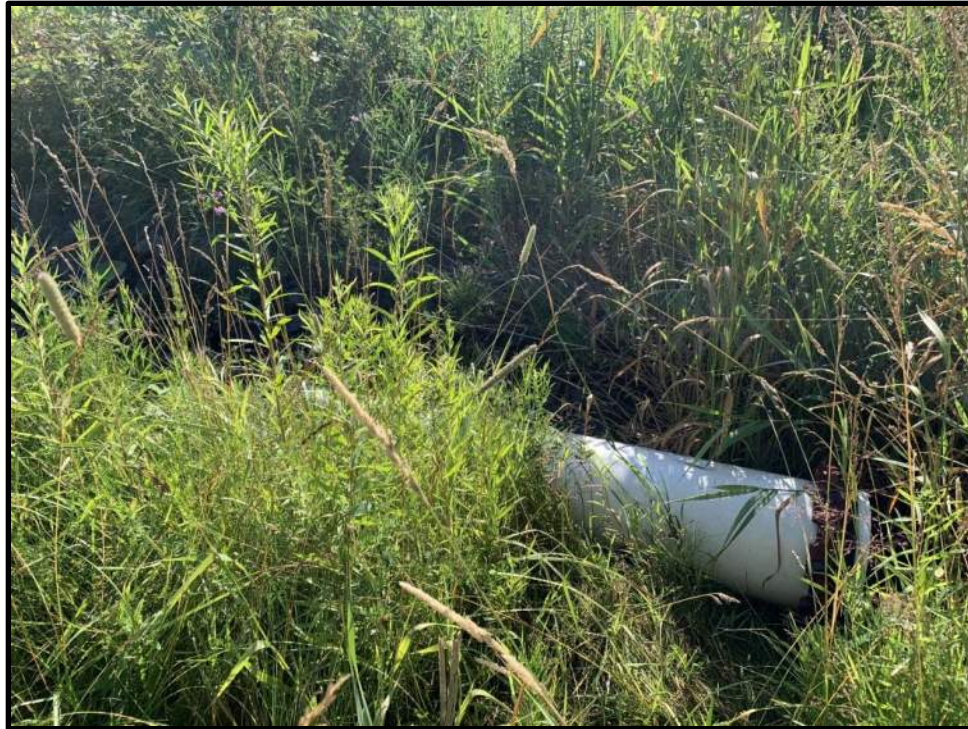
Photo 19: View of the outlet pipe at the west end of Stormwater Pond 3. The pipe is becoming obscured by vegetation.

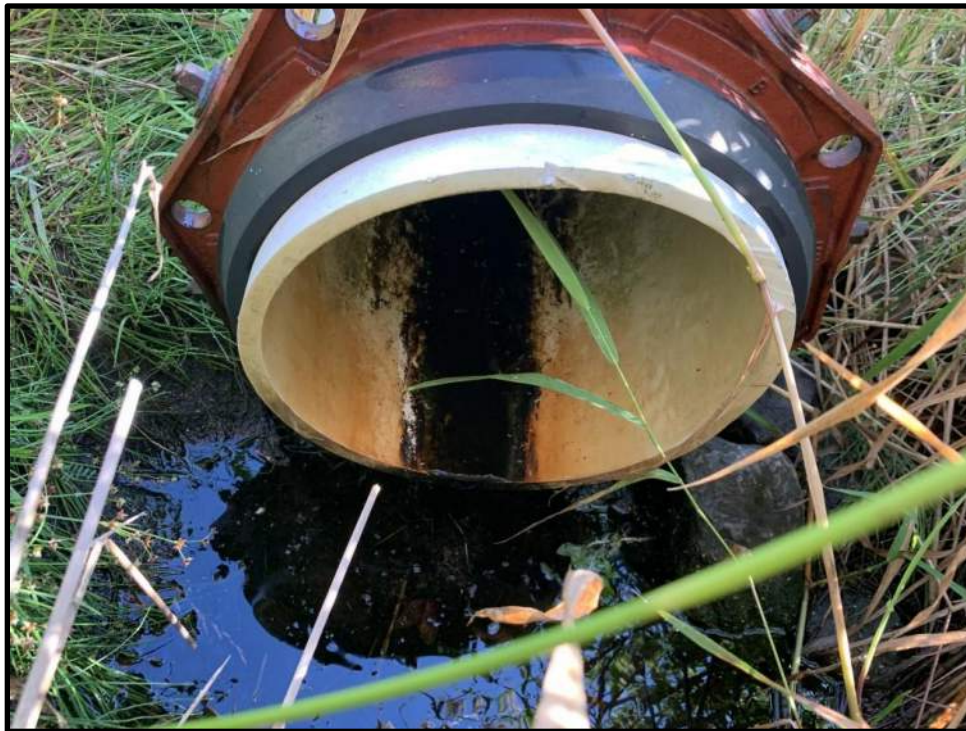
Photo 20: View of the outlet pipe to the emergency spillway channel at Stormwater Pond 3. A small pool of water is present under the pipe.

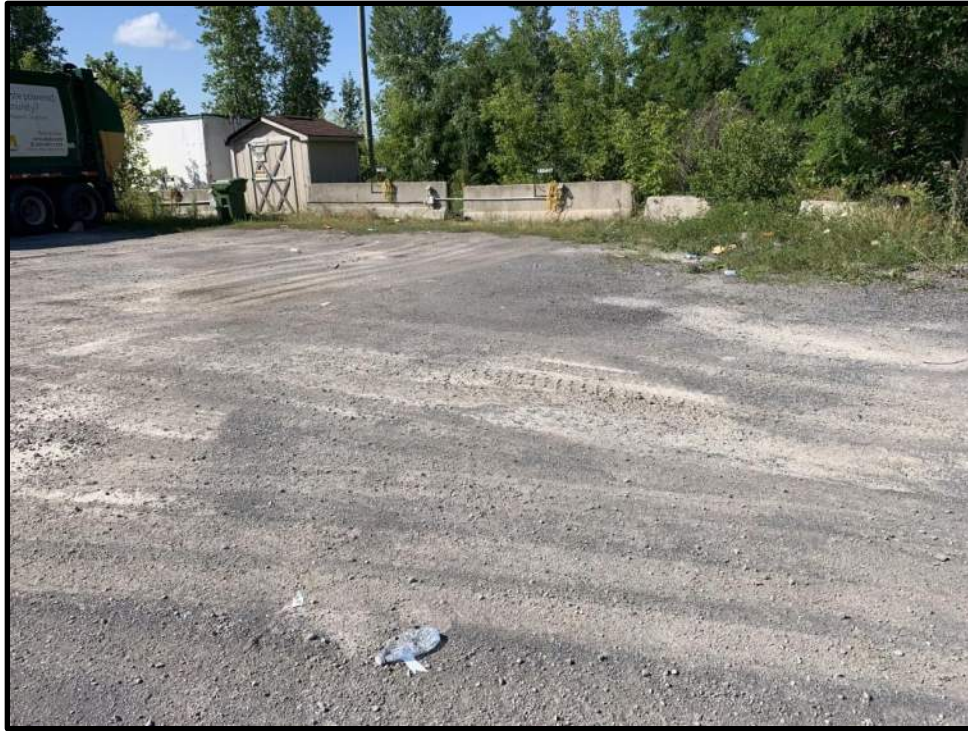
Photo 21: View facing west of the northwest side of the former public drop off area west of the flare compound. Loose litter is present in the area.

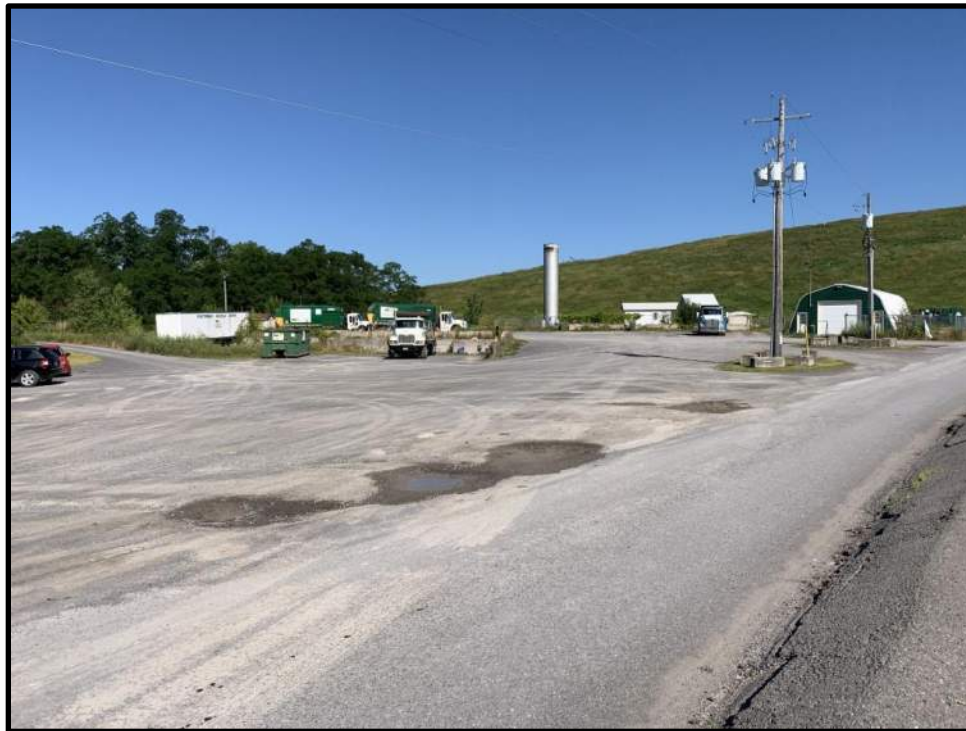
Photo 22: View facing northwest of the gravel area west of the scales and south of the former public drop off area. Several potholes are present.

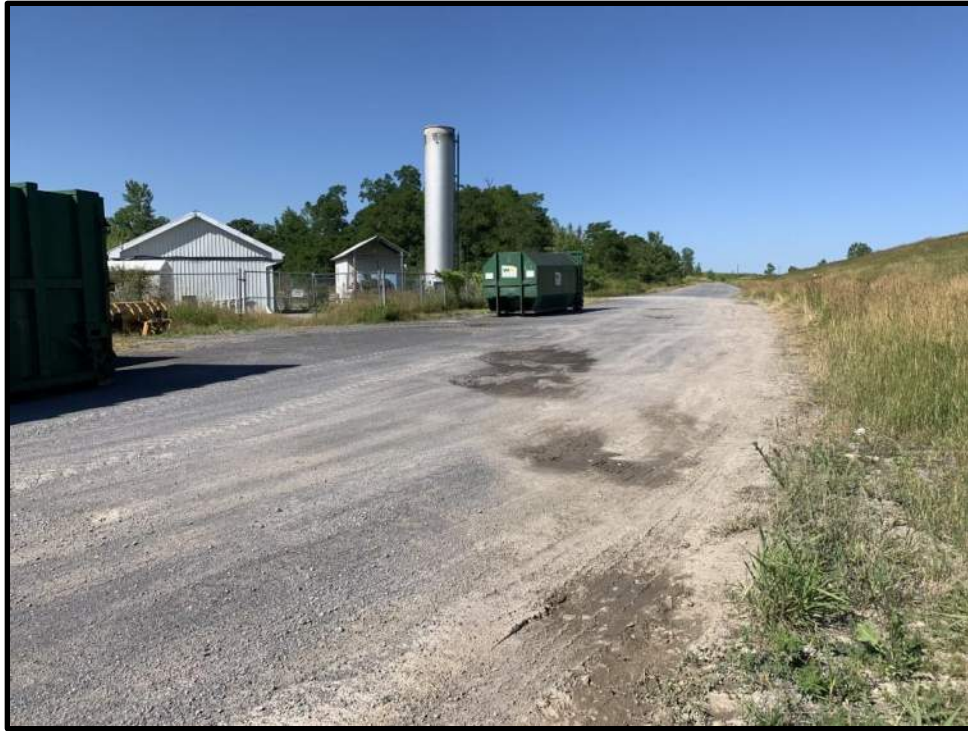
Photo 23: View facing west of the south access road east of the flare compound. The trench containing the electrical cable from PS3 near the leachate storage tank has experienced settlement and potholes are visible.

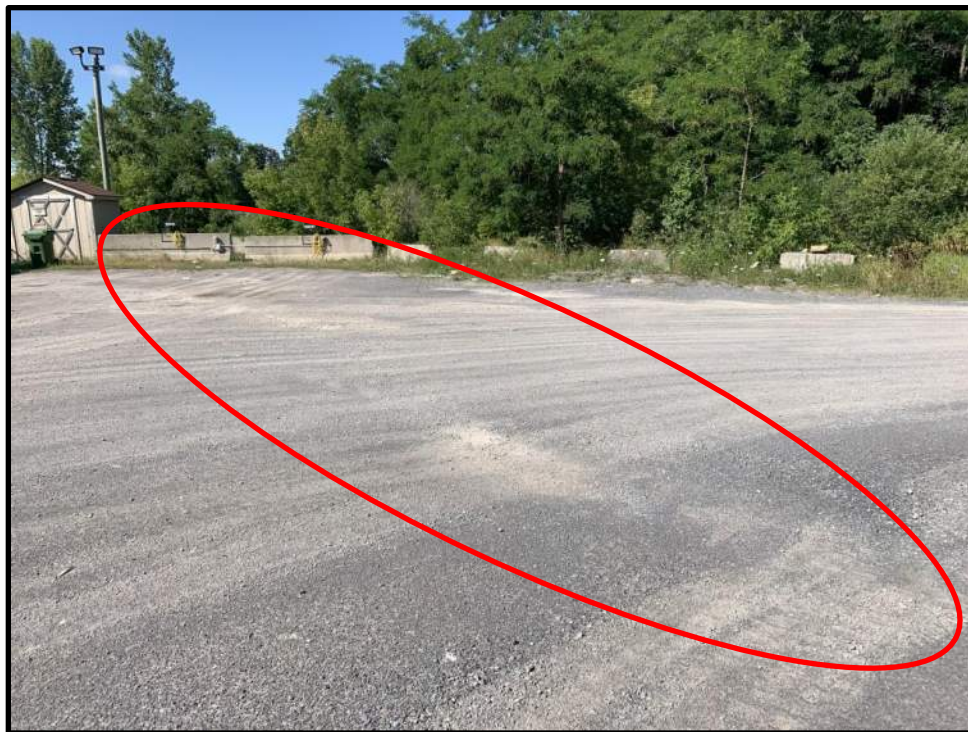
Photo 24: View facing west of a trench leading to the west side of the former public drop off facility southwest of the flare compound. Settlement of the trench (circled) has occurred, resulting in uneven road surface.

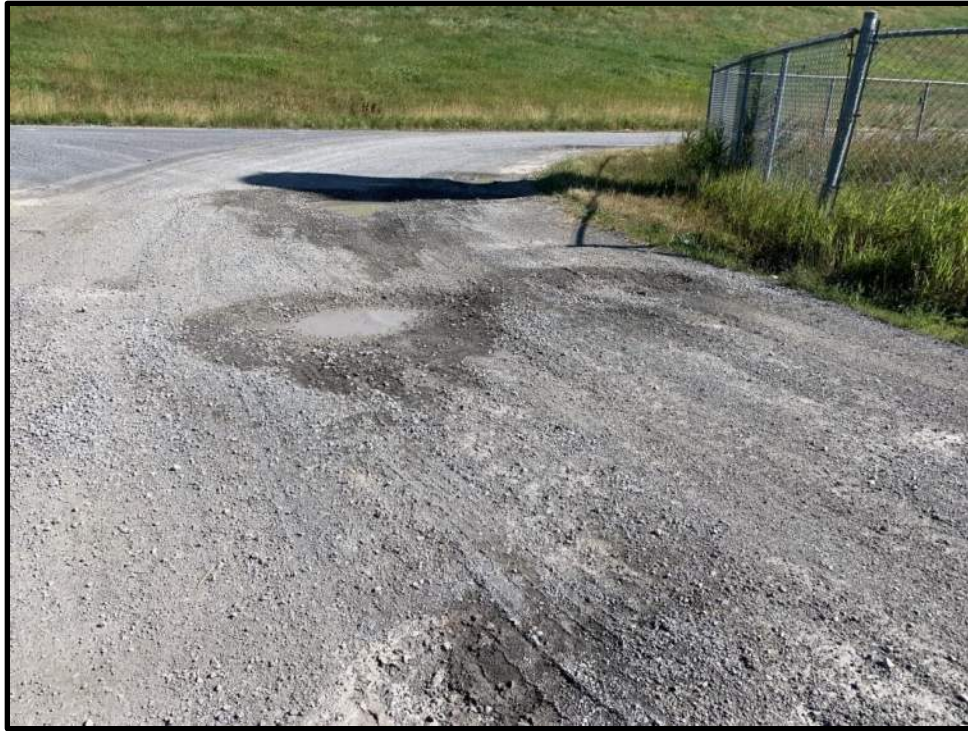
Photo 25: View facing north of several deep potholes present in the road surface to the west of the flare compound.

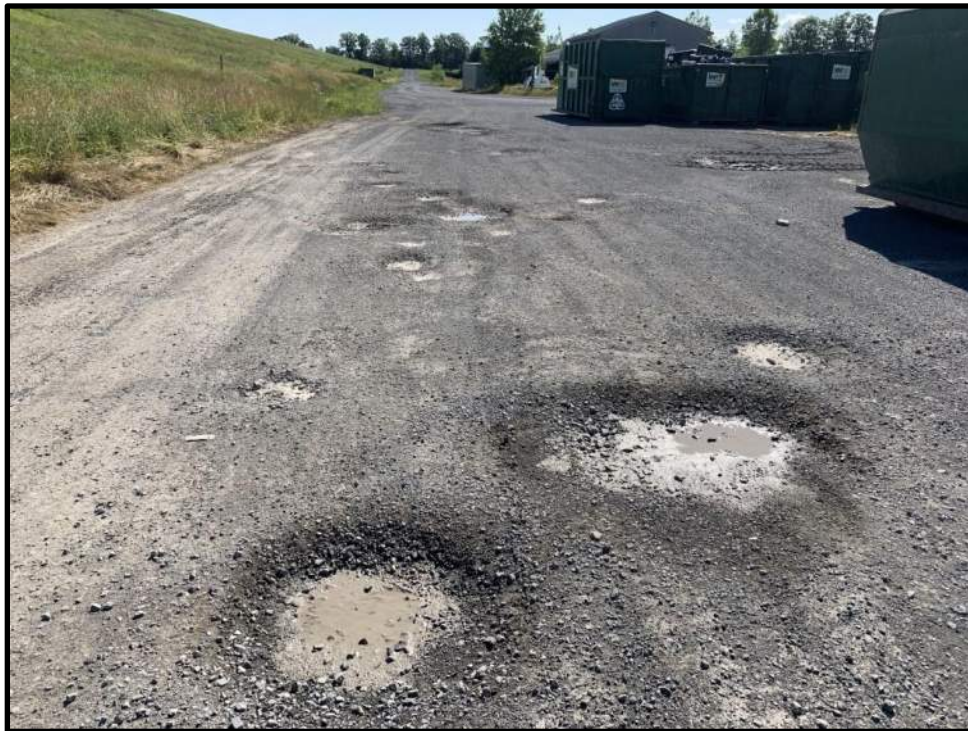
Photo 26: View facing east of the south perimeter road, east of the flare compound. Several roll off bins are present at the tee intersection, which limits sight line for oncoming traffic. Several large potholes are also present in the road surface.

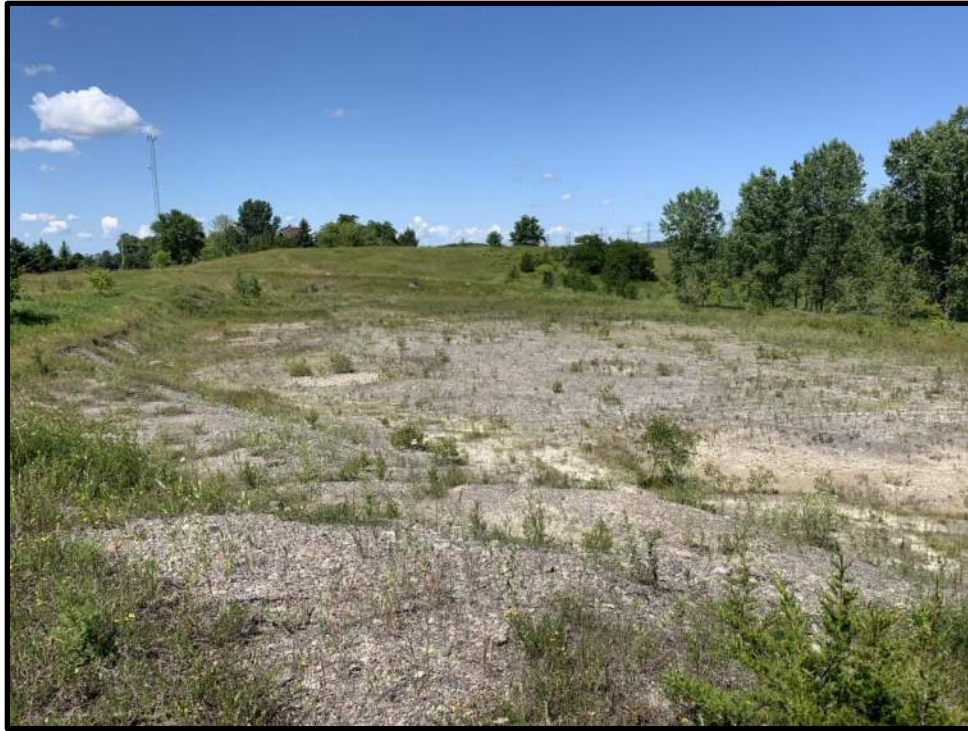
Photo 27: View facing west of the former borrow area. No evidence of excavation was observed.

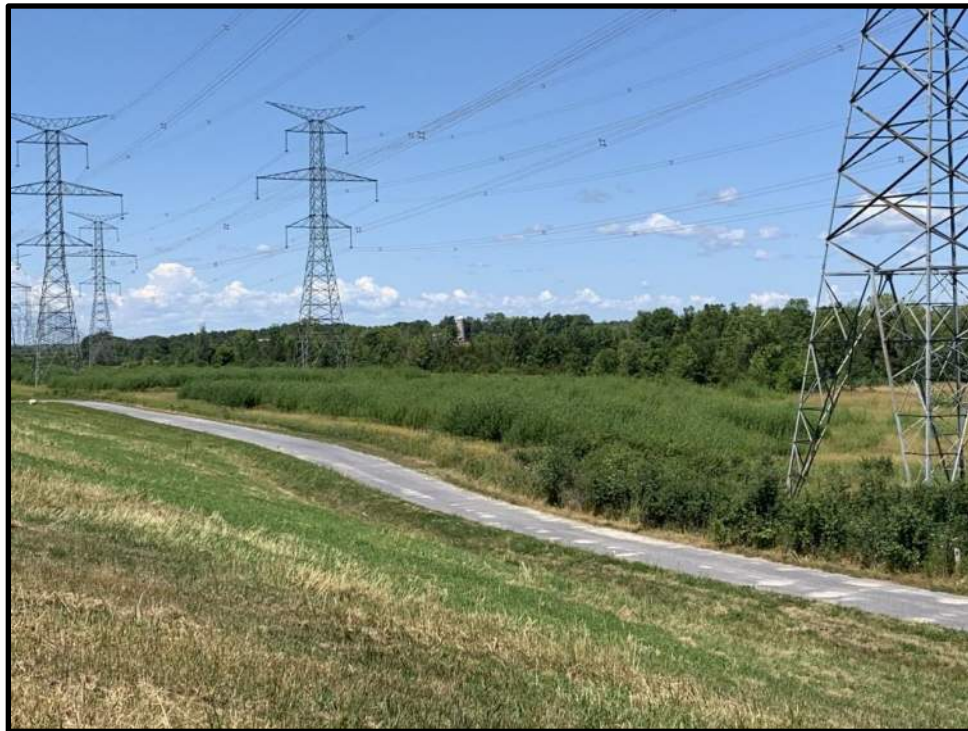
Photo 28: View facing northeast of the phytoremediation system. Vegetation has re-established well after pruning efforts completed by Hydro One in spring 2021.

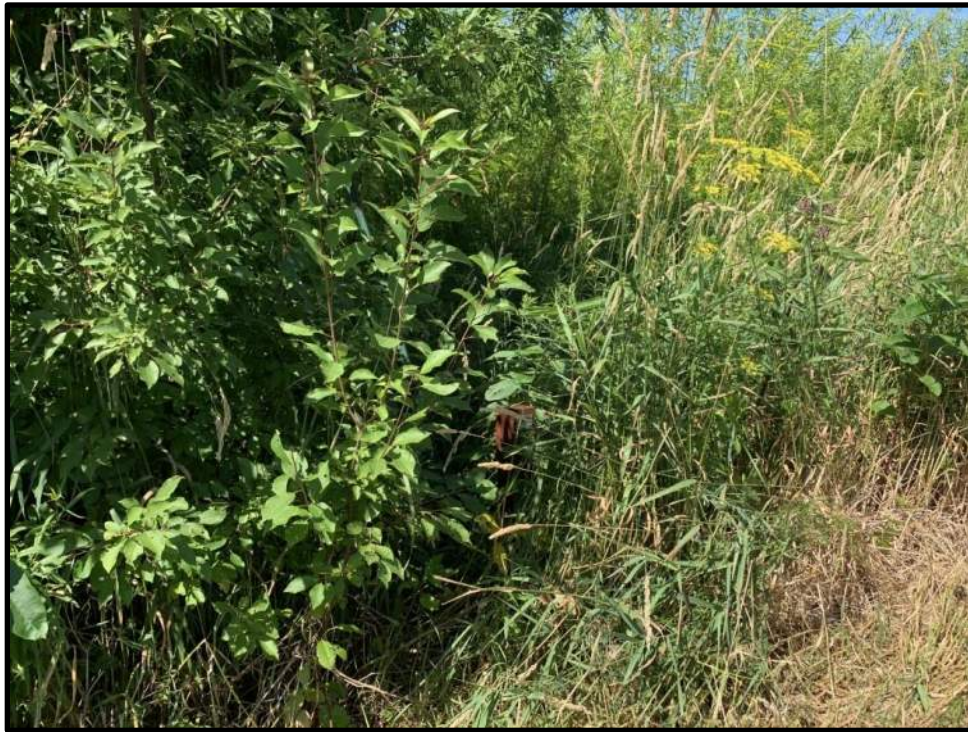
Photo 29: View facing northwest of monitoring well GM-5 off the northwest access road. The location is obscured by vegetation.

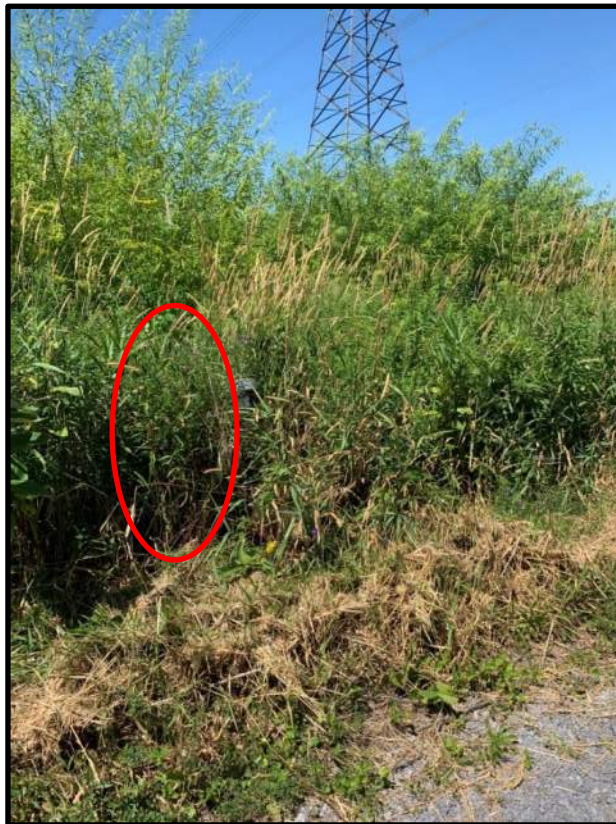
Photo 30: View facing northwest of monitoring well M30 (circled) off the northwest access road. The location is obscured by vegetation.
