RICHMOND SANITARY LANDFILL SITE, MONITORING REPORT NO. 36

PART OF LOTS 1, 2 AND 3, CONCESSION IV,
TOWN OF GREATER NAPANEE, COUNTY OF
LENNOX AND ADDINGTON

PROJECT NO.: 081-12459-04 (8570)
DATE: MARCH 27, 2023

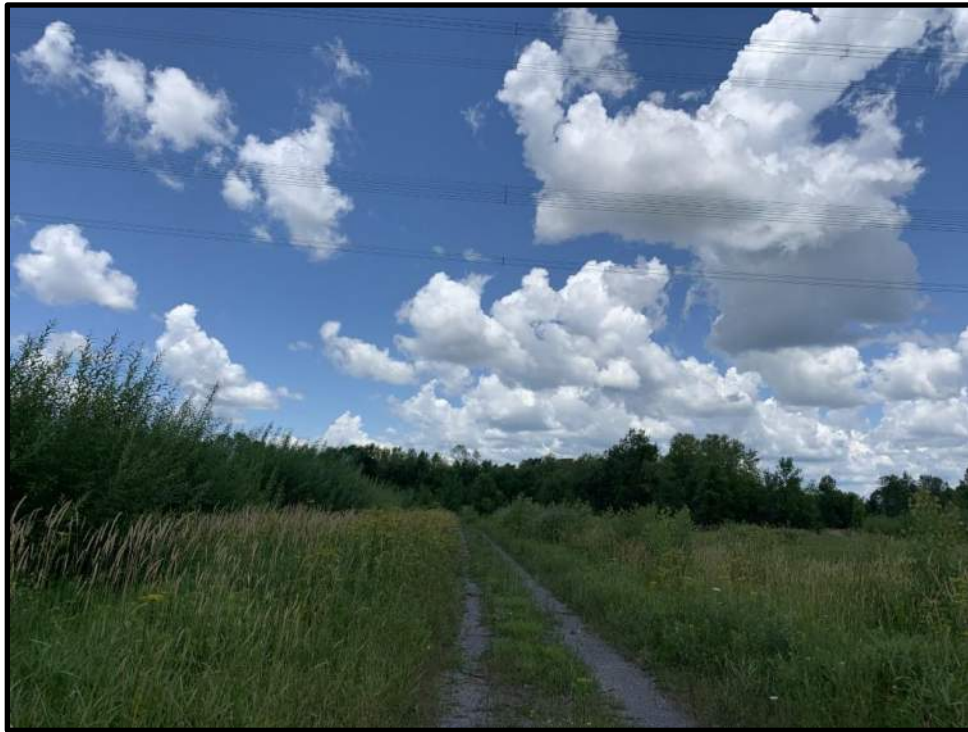
Photo 31: View facing north of the access path leading to Stormwater Pond 2. The path is in good condition.

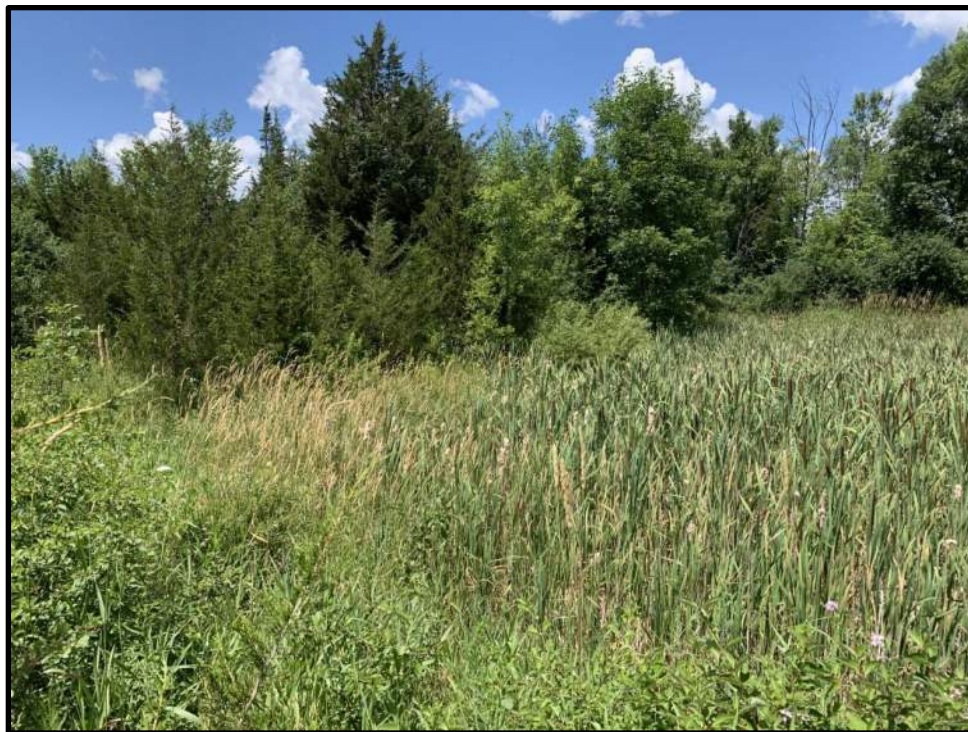
Photo 32: View facing west of the west bank of Stormwater Pond 2. Large trees are present on the interior of the pond.

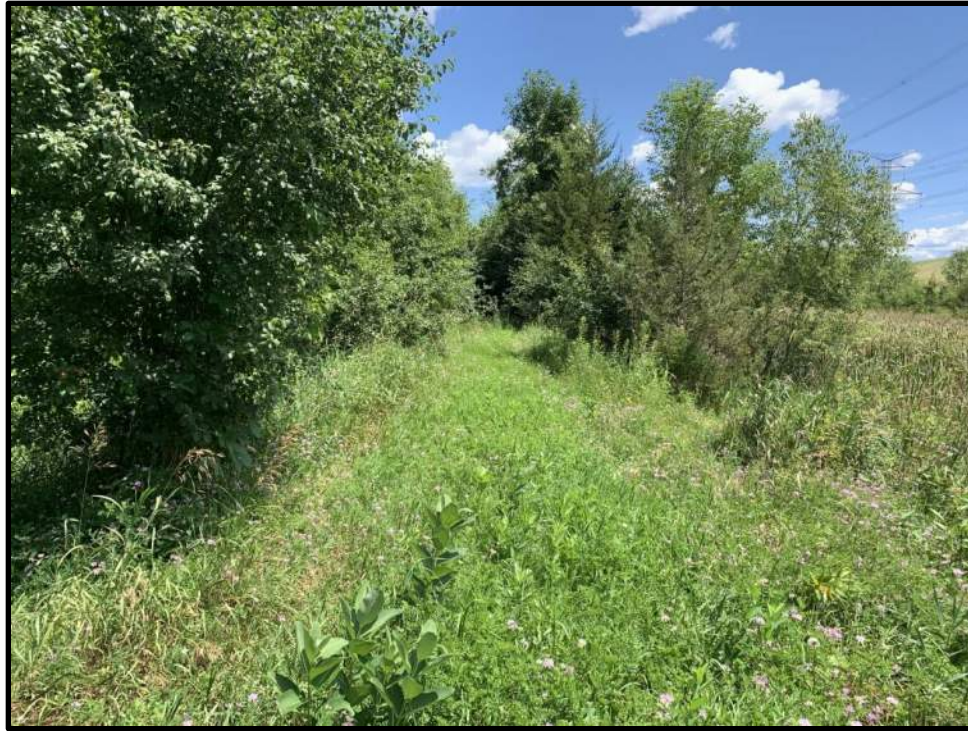
Photo 33: View facing east of the northeast path around Stormwater Pond 2. Vegetation has obscured the path, restricting access.

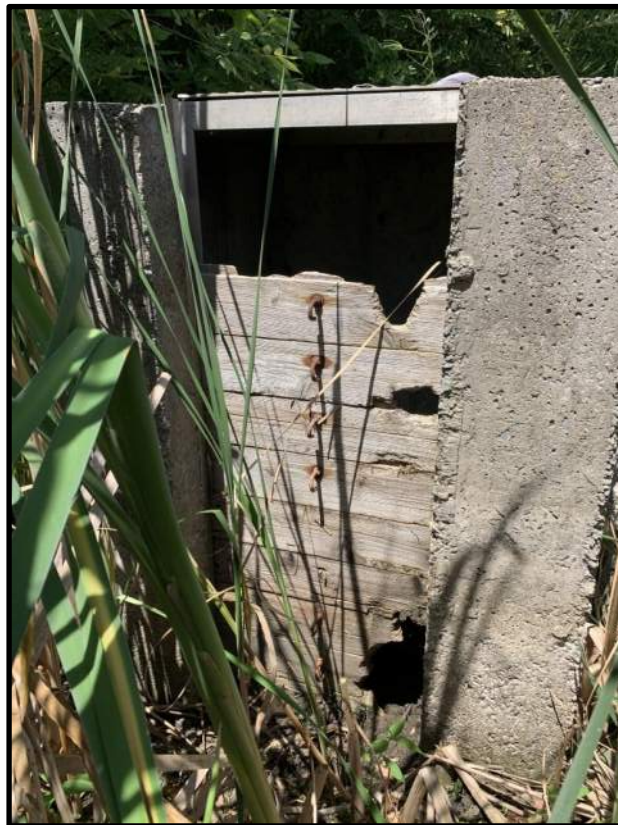
Photo 34: View of the stop logs present at the drawdown structure of Stormwater Pond 2. The logs have rotted and require replacement.

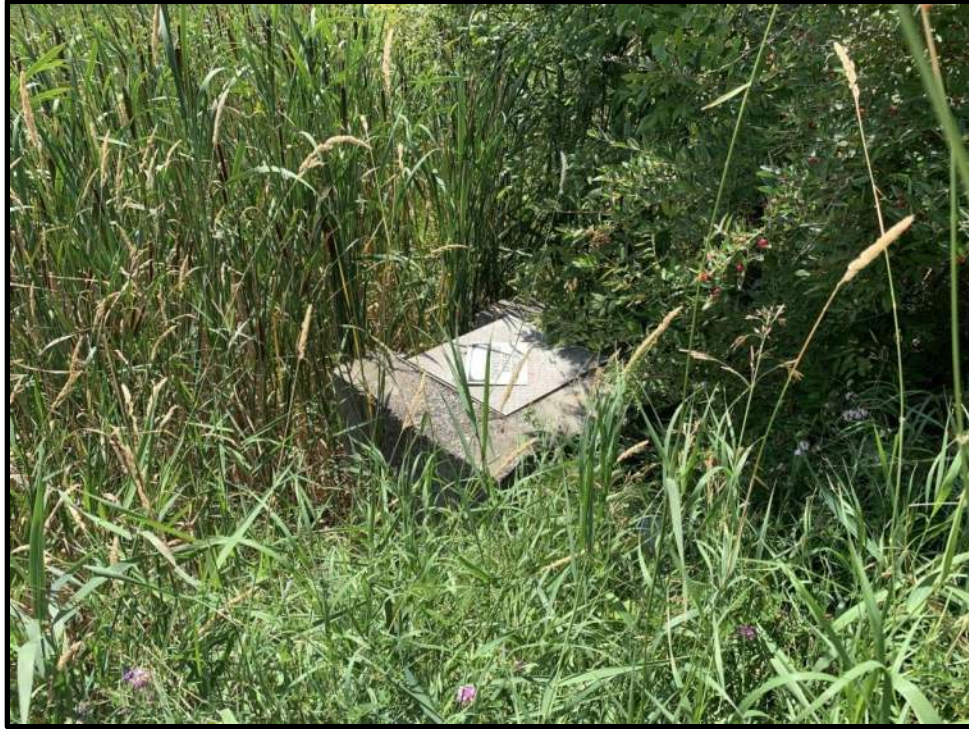
Photo 35: View of the drawdown structure at Stormwater Pond 2. Vegetation has obscured the ground at the structure, preventing observations of the access path to the structure.

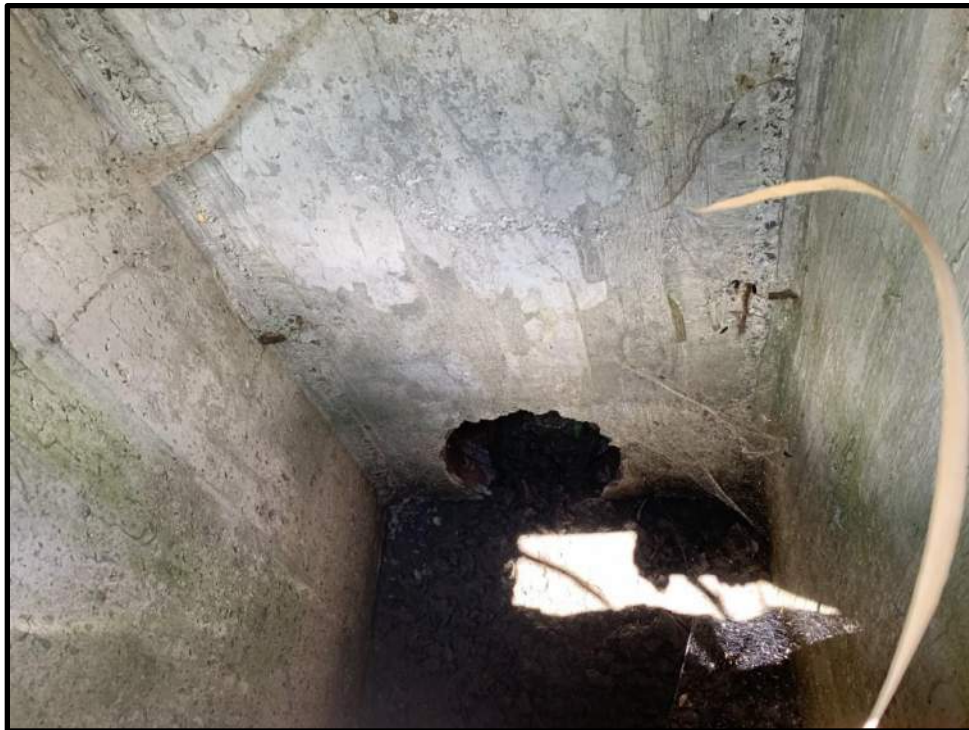
Photo 36: View inside the drawdown structure at Stormwater Pond 2. The inlet pipe is free of debris.

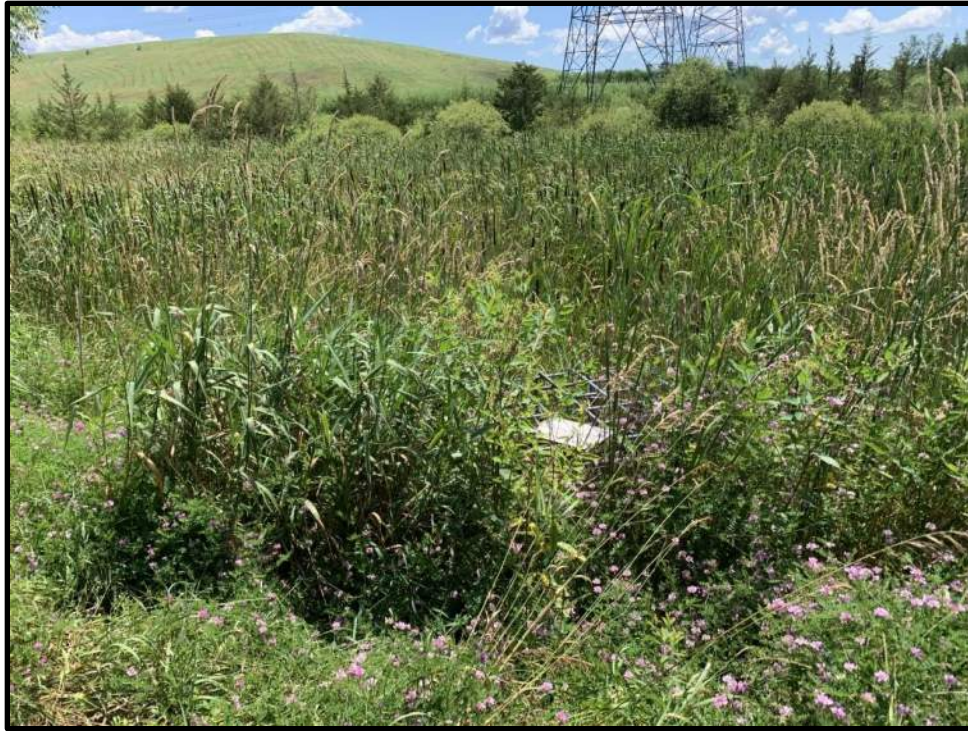
Photo 37: View facing south of the drop inlet pipe spillway structure at Stormwater Pond 2. Vegetation is obscuring access.

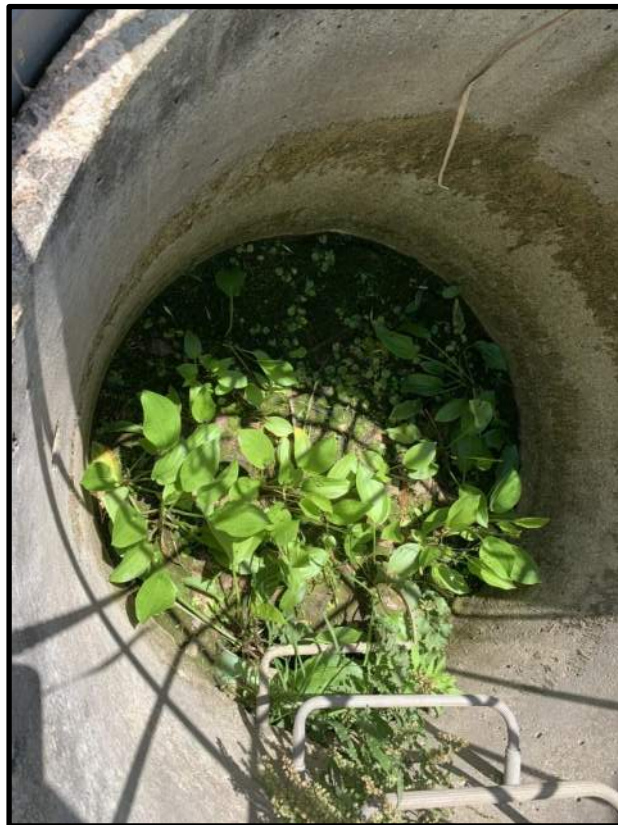
Photo 38: View inside drop inlet pipe structure at Stormwater Pond 2. Sediment is present in the structure along with vegetation. The outlet pipe (under the rungs) is not visible.

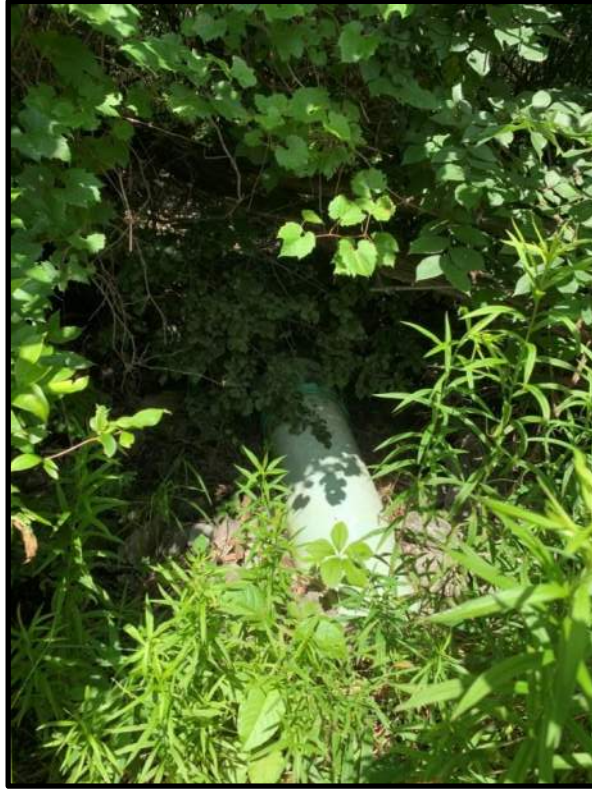
Photo 39: View of the outlet pipe from Stormwater Pond 2. Thick vegetation prevented a clear photographic view, but no evidence of silt exiting the site was observed.

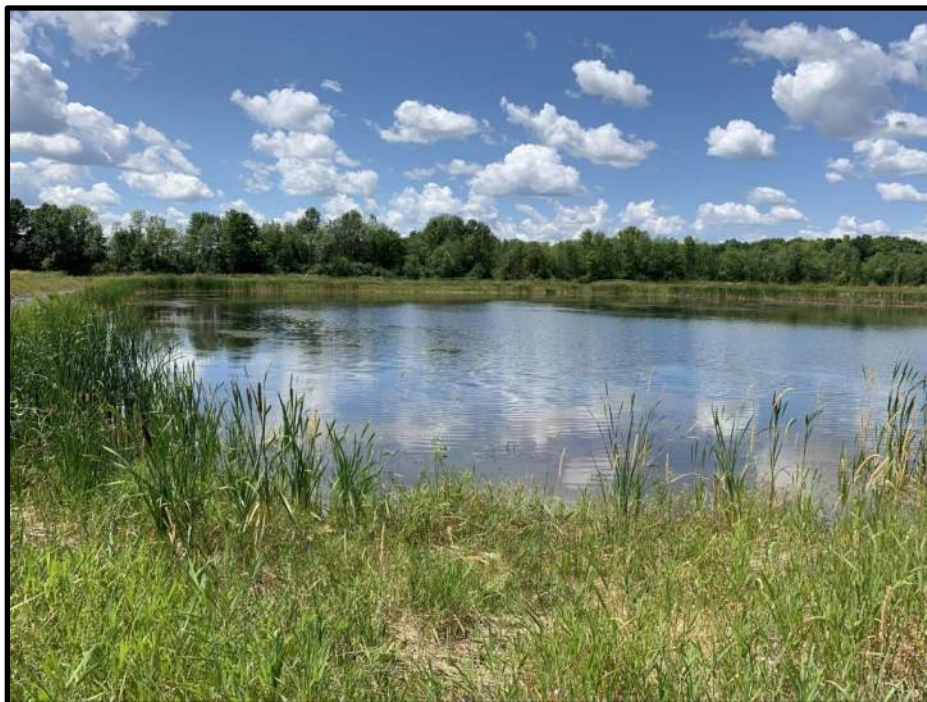
Photo 40: View facing west of the leachate holding lagoon. No evidence of rodents (no damage to the HDPE liner) was observed. Debris observed in the southeast corner of the lagoon during a previous inspection was not seen during this visit.

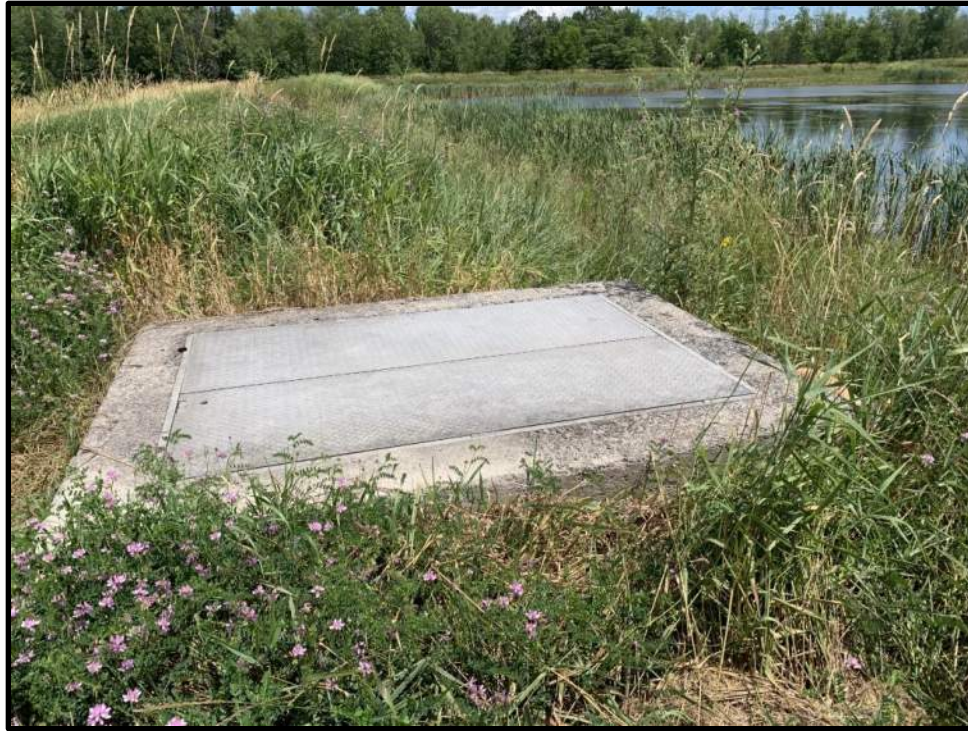
Photo 41: View facing east of the northwest structure at the leachate holding lagoon. “Confined Space” signage was not observed.

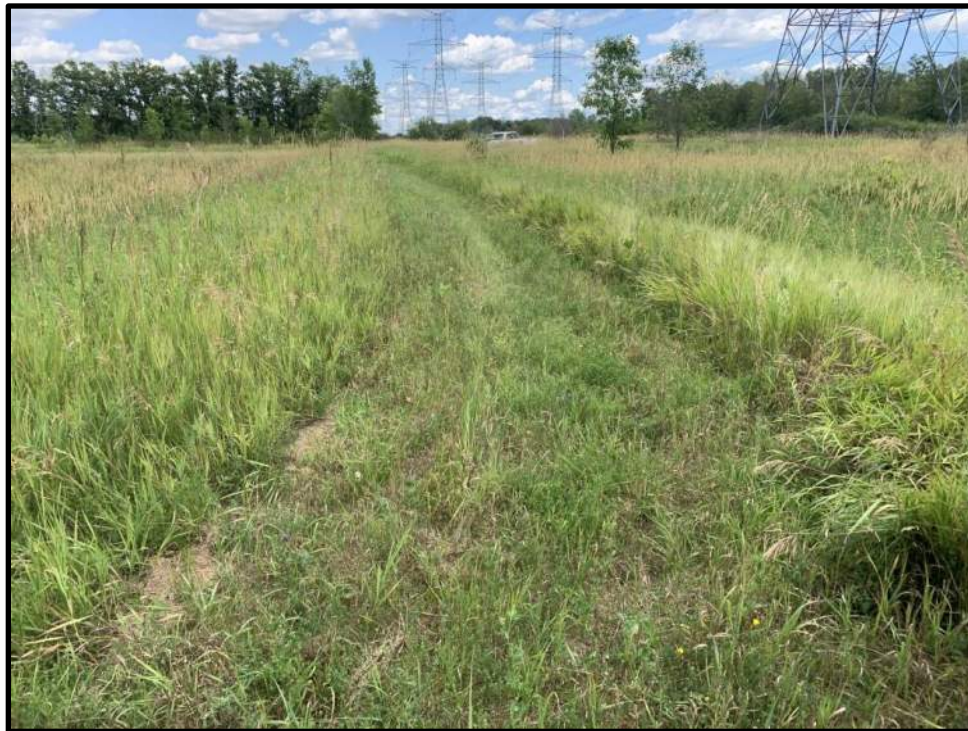
Photo 42: View facing east of the access path around the south portion of Stormwater Pond 1.

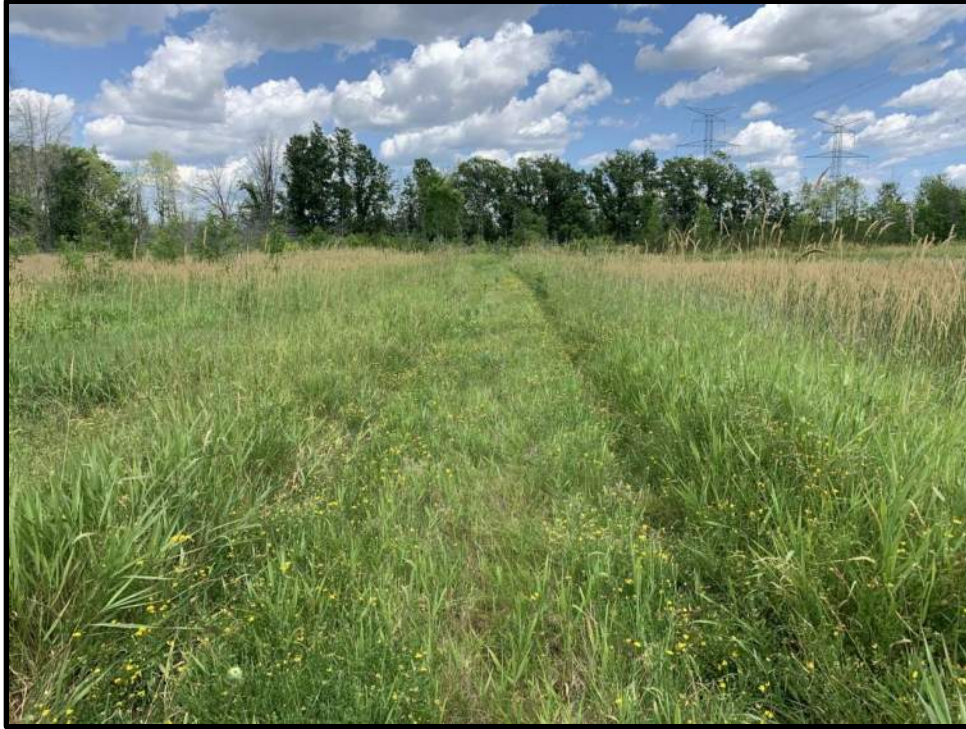
Photo 43: View facing east of the access path around the north side of Stormwater Pond 1.

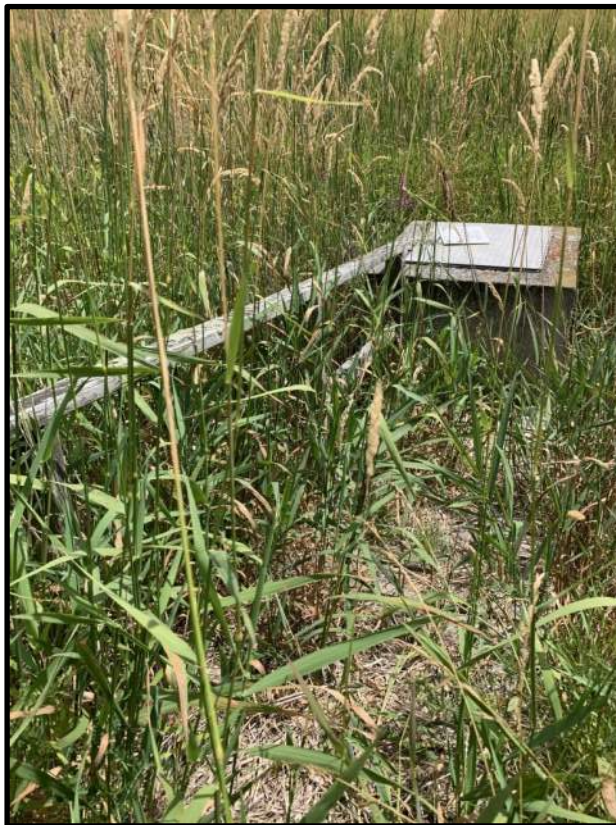
Photo 44: View of access to the draw down structure at Stormwater Pond 1. The wooden pathway is obscured by vegetation and is in fair to poor condition.

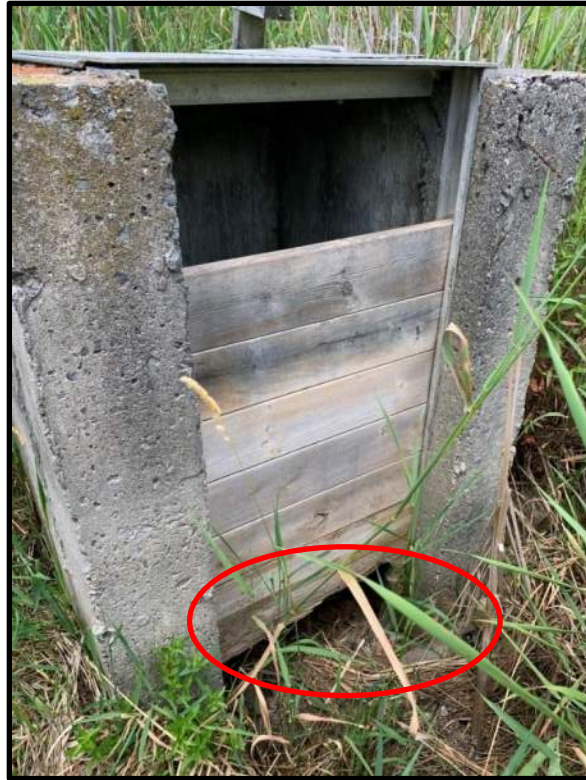
Photo 45: View of the stop logs on the draw down structure at Stormwater Pond 1. Boards at the base of the structure have rotted and require replacement.

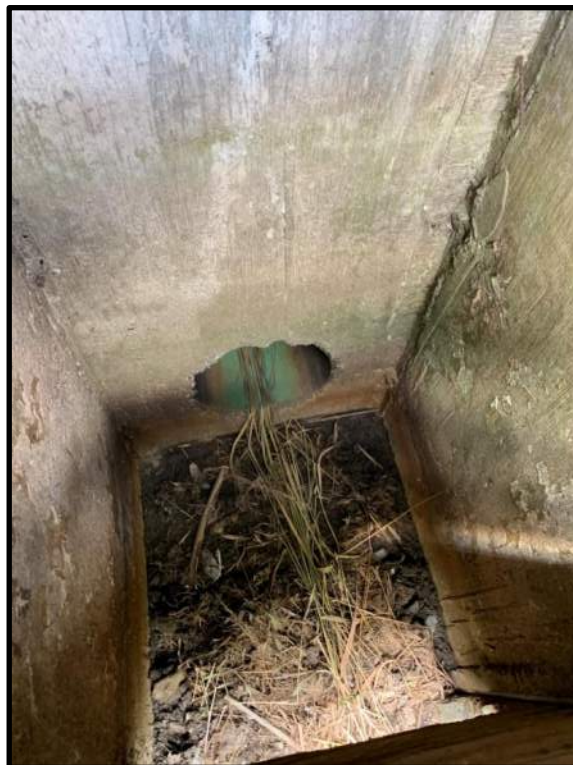
Photo 46: View of the interior of the drawdown structure at Stormwater Pond 1. The inlet is free of sediment.

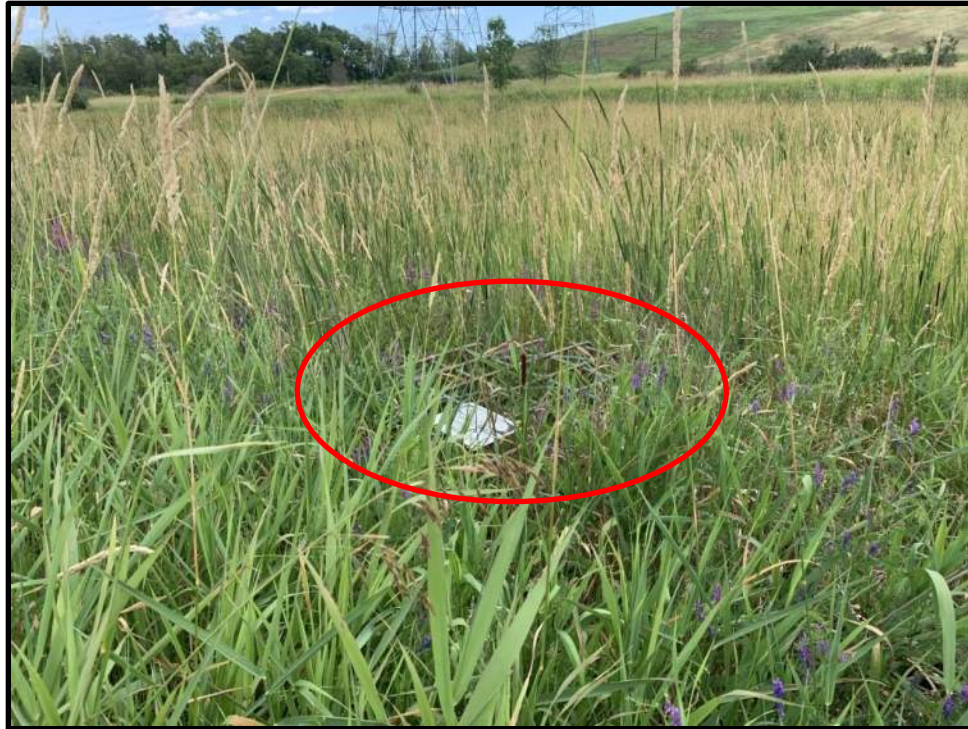
Photo 47: View of the drop inlet pipe structure (circled) at Stormwater Pond 1. Vegetation has obscured the structure.

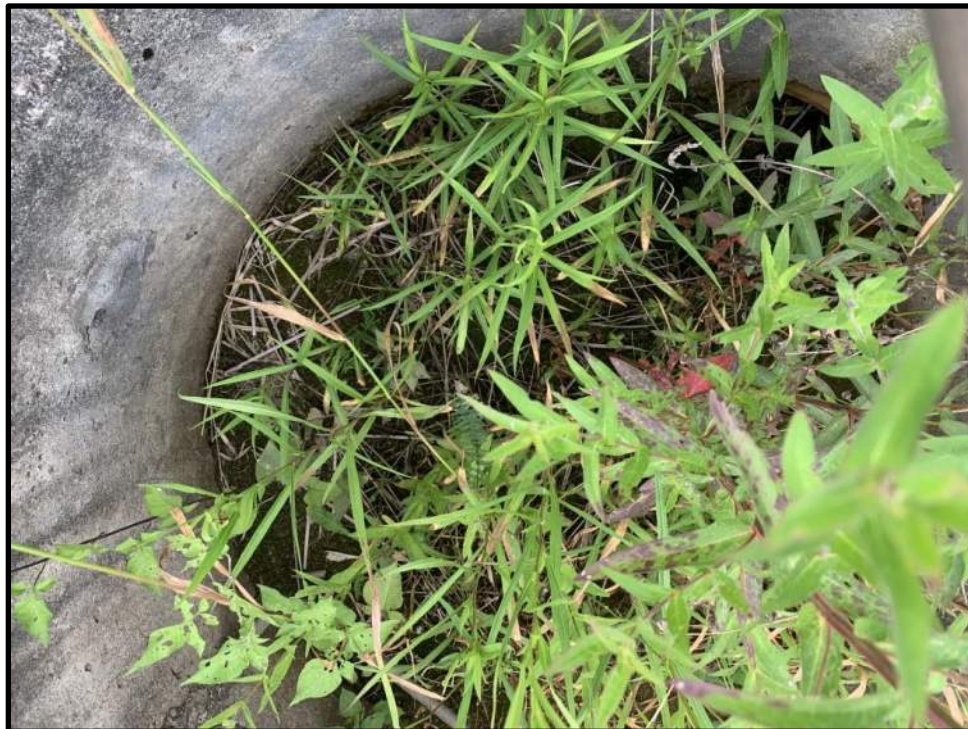
Photo 48: View looking down into the drop inlet structure at Stormwater Pond 1. The inlet pipe can be seen on the upper right side of the photo. The pipe is partially obscured by vegetation and sediment.

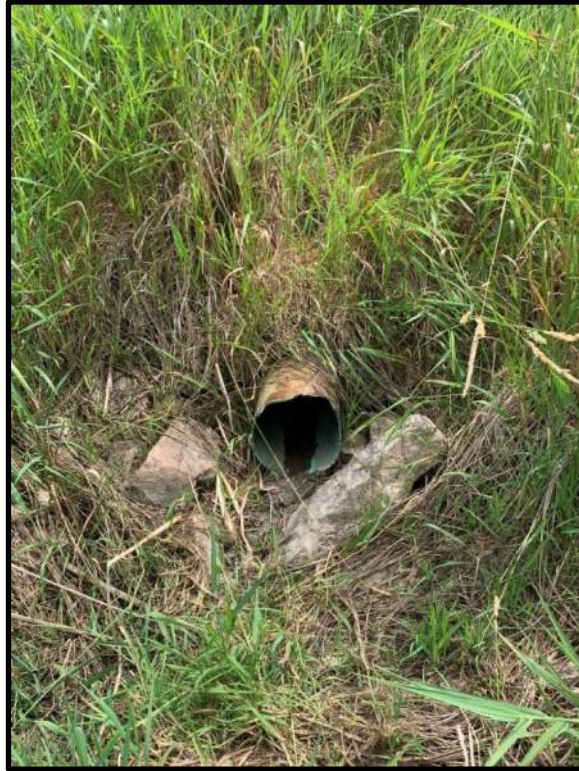
Photo 49: View of the outlet pipe from the drawdown structure at Stormwater Pond 1. No evidence of silt exiting the pond was observed.

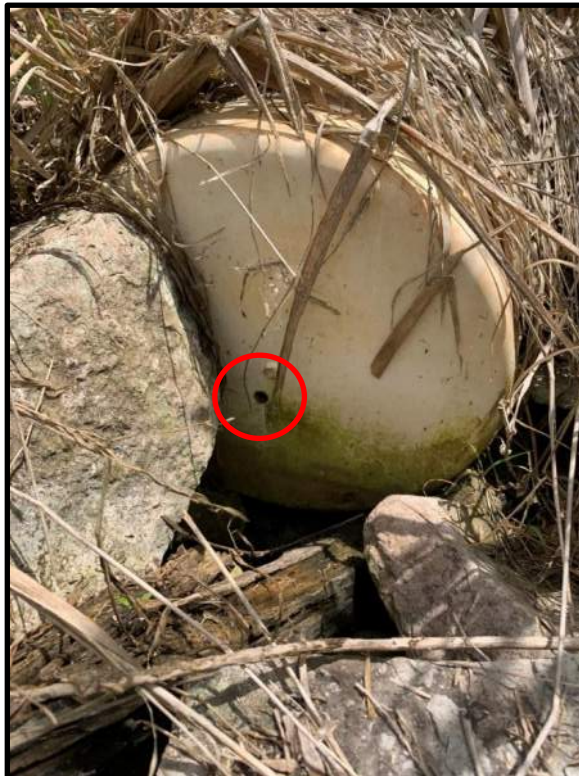
Photo 50: View of the outlet pipe from the drop inlet pipe structure at Stormwater Pond 1. A cap is present on the outlet pipe, but a small hole in the cap was noted (circled).

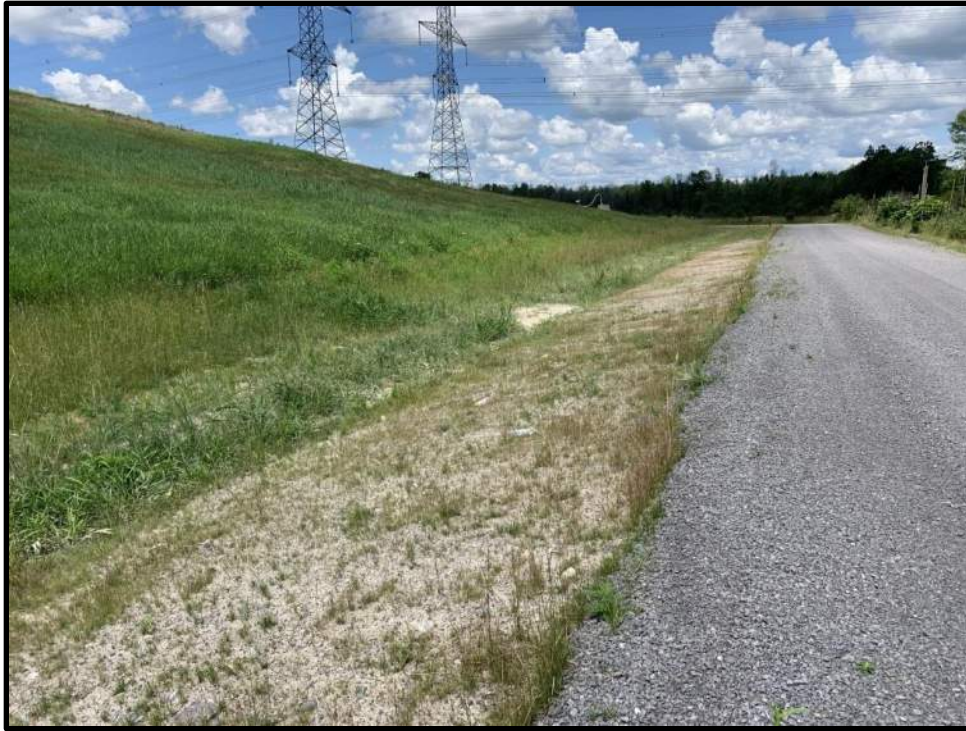
Photo 51: View facing north of the east landfill ditch. Minimal vegetation has established in the area.

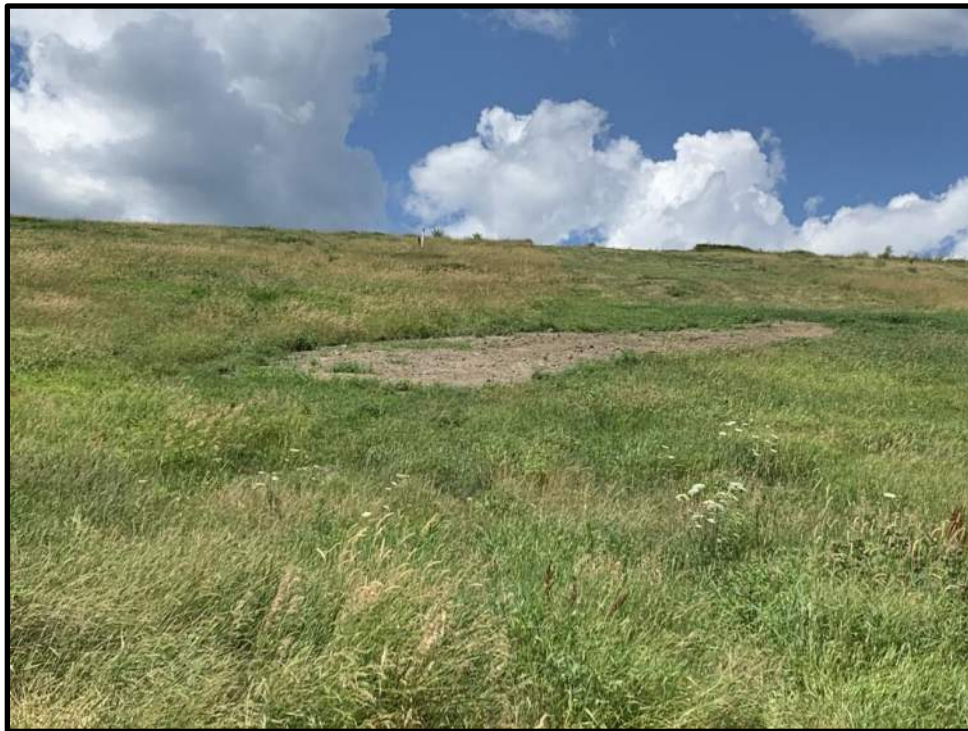
Photo 52: View facing north of a seep repair on the south slope of the landfill mound. The repair was completed by a subcontractor to WM in May 2022. Vegetation has yet to establish in the area.

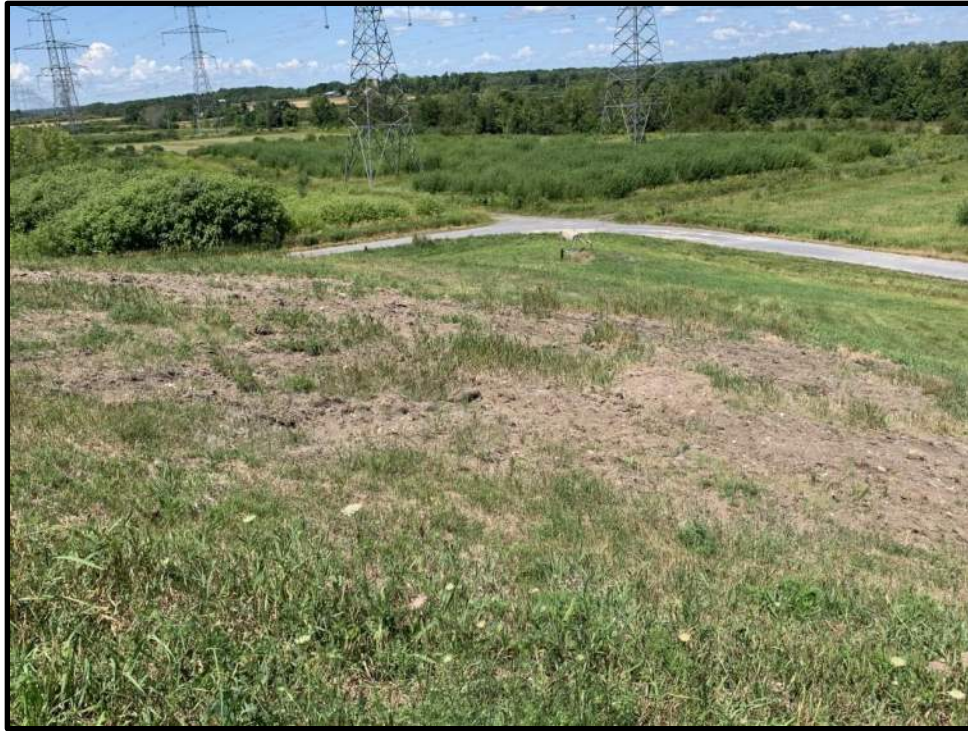
Photo 53: View facing northwest of a section of the upper northwest slope that is mostly barren.

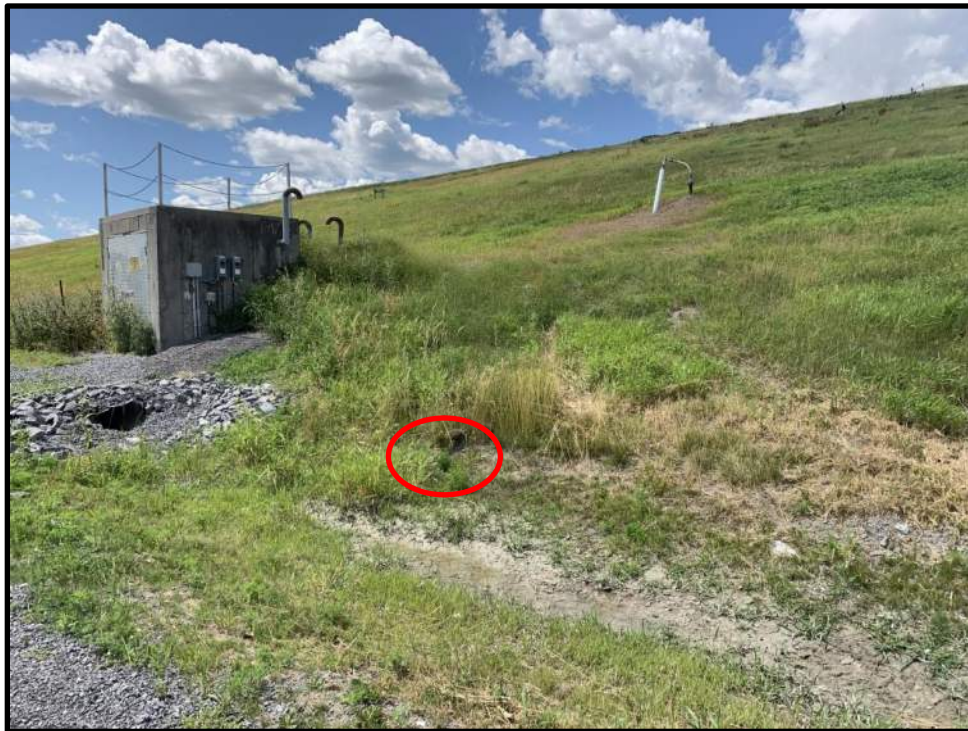
Photo 54: View facing northwest of a small section of staining (circled) present at the top of the south ditch east of PS1. A small amount of water is present in the ditch below the stained area.

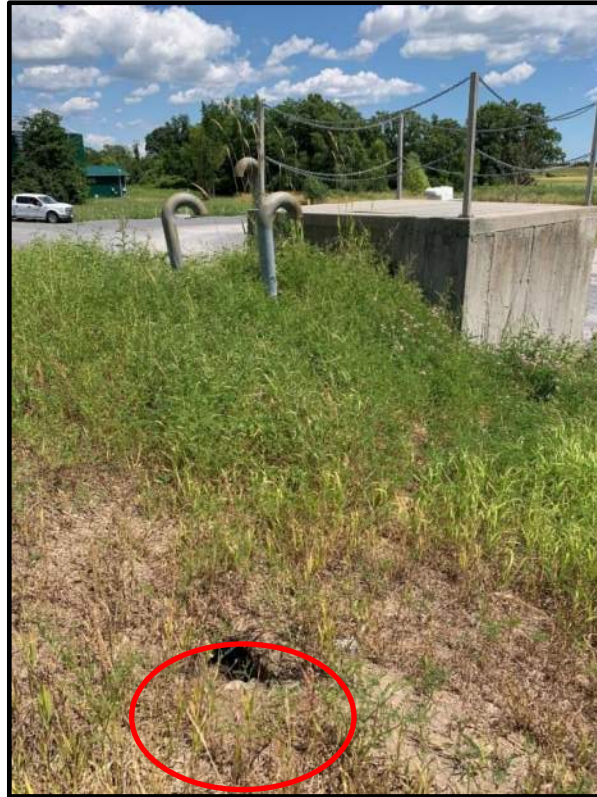
Photo 55: View facing southeast of the south slope with PS1 in the background. A hole (circled), potentially created by a rodent, is present in the area.

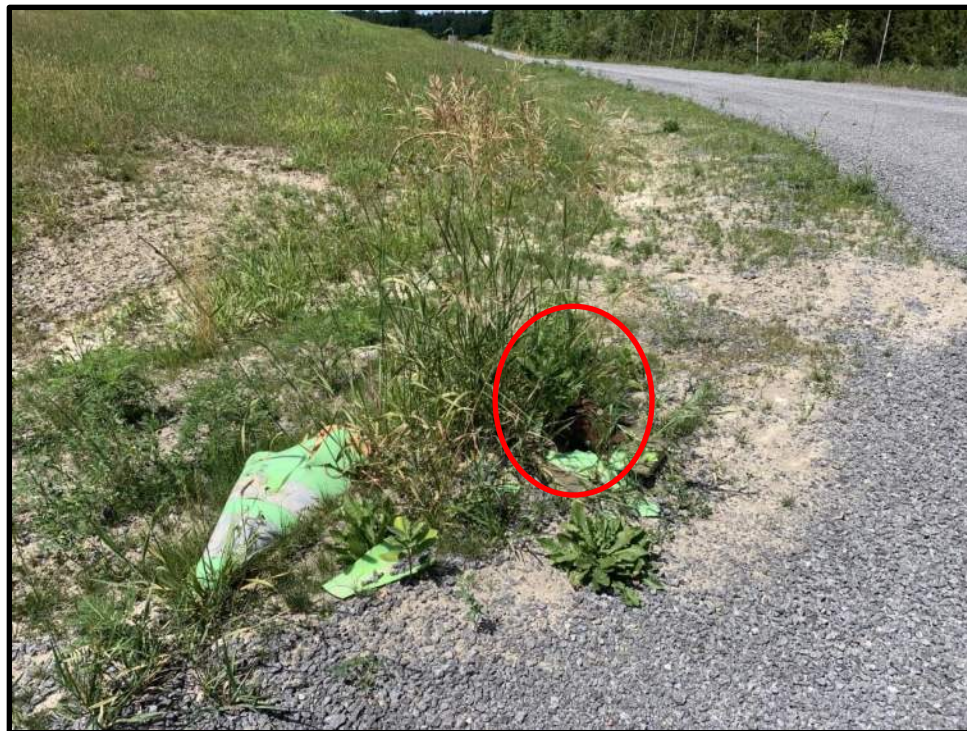
Photo 56: View (encircled) of damage to monitoring well M19 on the southeast corner of the landfill. It is not clear if the well is part of the site's monitoring network.

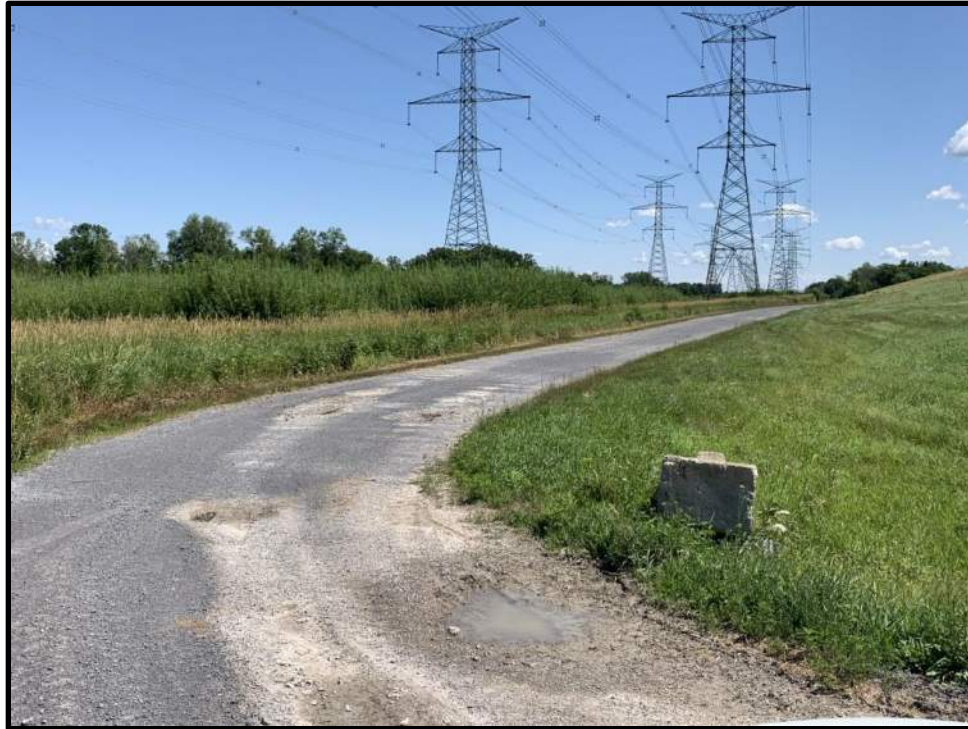
Photo 57: View facing northeast of standing water and potholes present in the surface of the northwest access road.

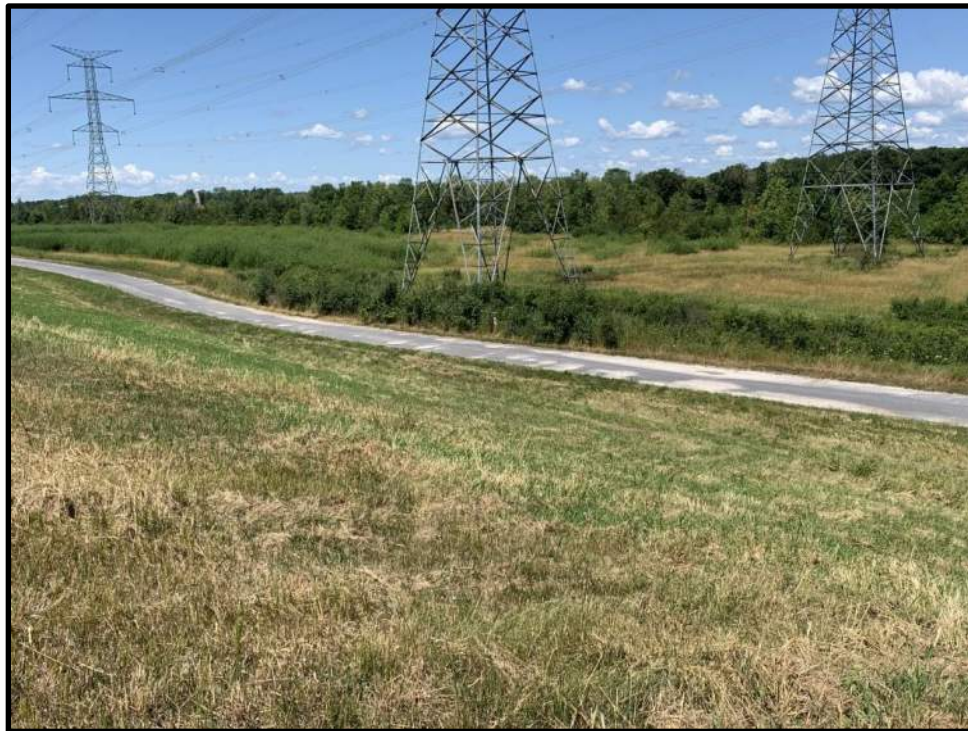
Photo 58: View facing northwest of several potholes along the northwest access road, west of PS2.

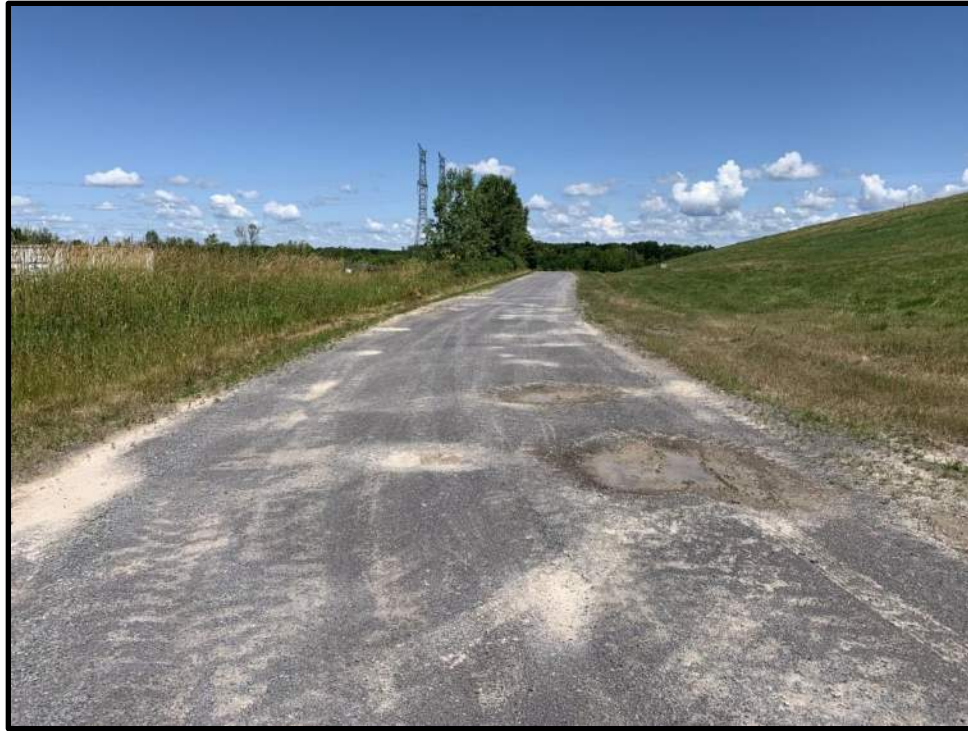
Photo 59: View facing north of several potholes along the southwest perimeter access road.

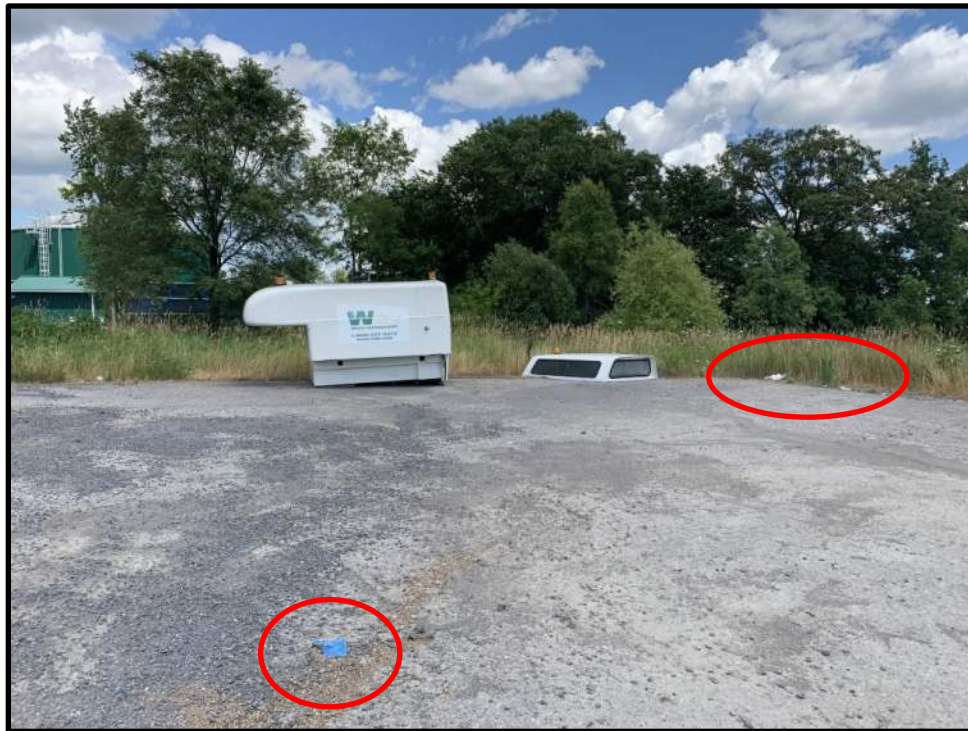
Photo 60: View facing east of litter present on the southeast corner of the former contaminated soil pad.

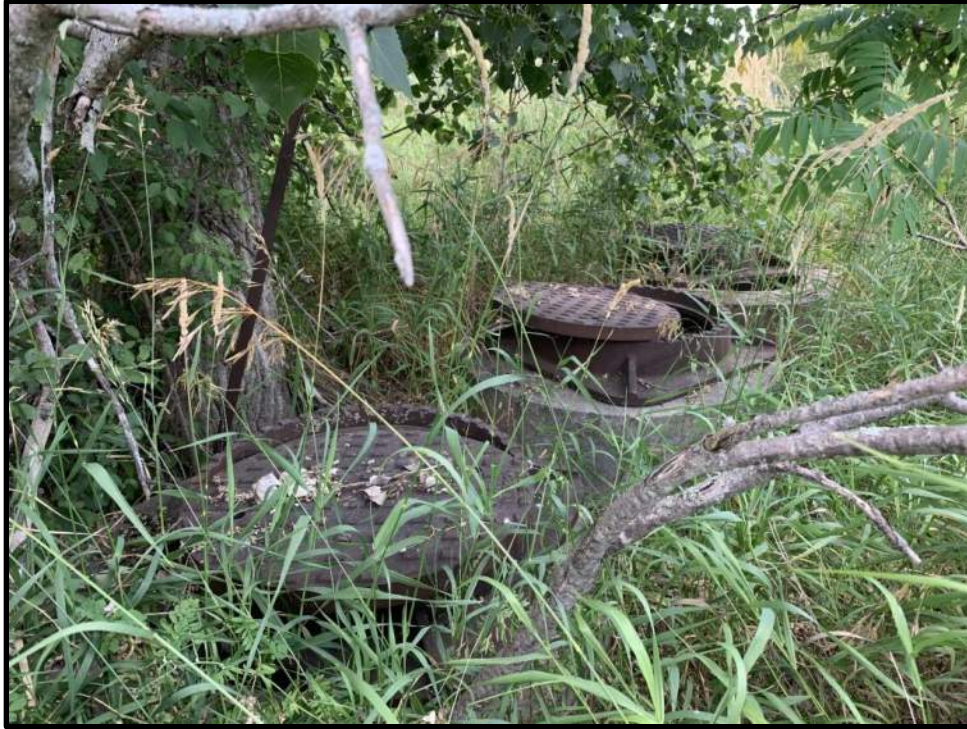
Photo 61: View facing south of dislodged lids at the interceptor chamber south of the former contaminated soil pad. No “Confined Space” signage is present.

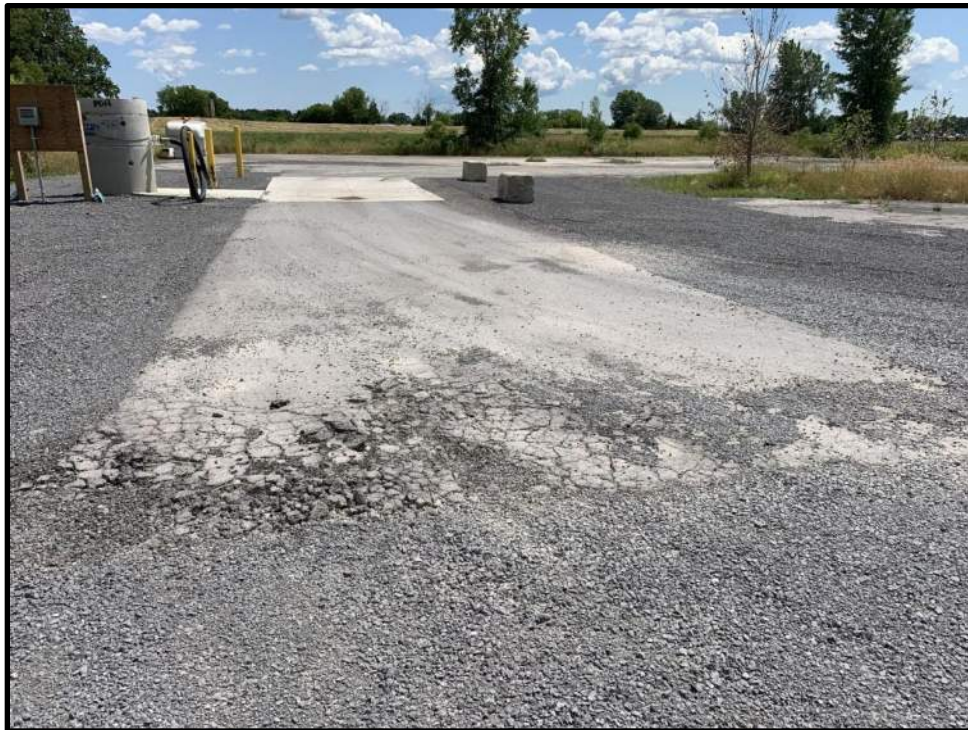
Photo 62: View facing south of the north side of the asphalt at the leachate storage Tank loading area on the east side of the former contaminated soil pad. The asphalt is displaying signs of wear.

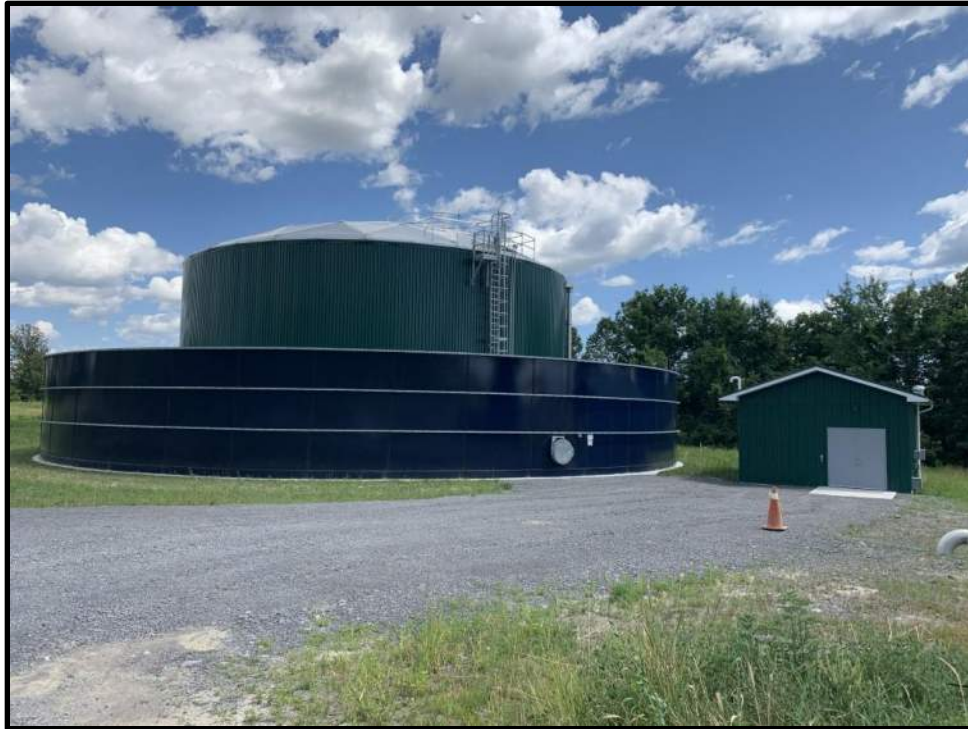
Photo 63: View facing southeast of the leachate storage tank and pumping station PS3.

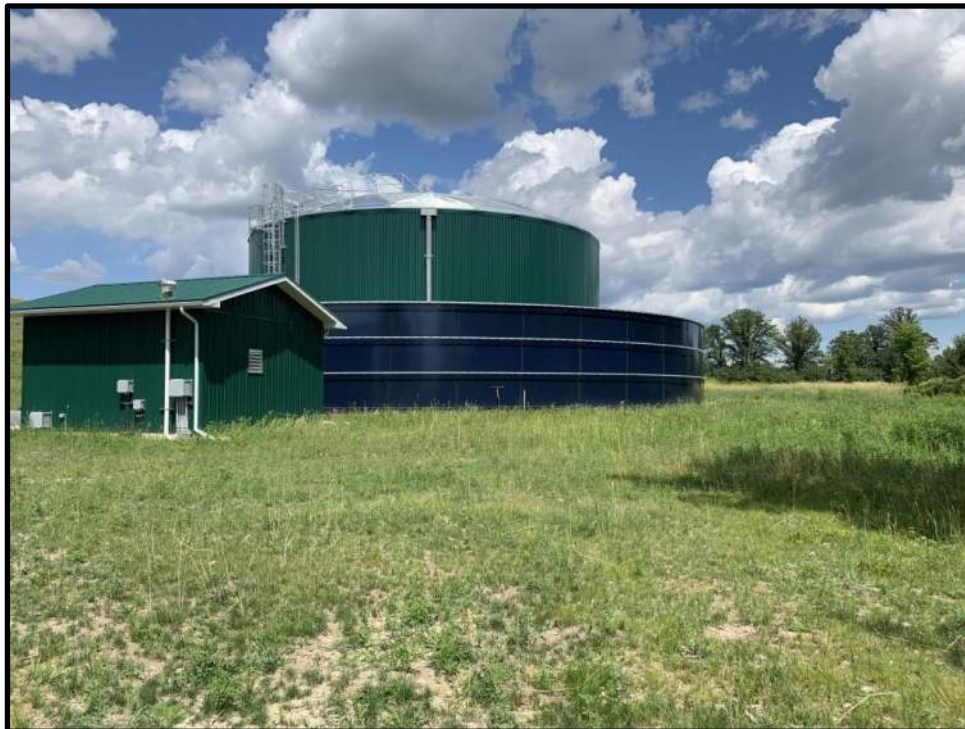
Photo 64: View facing east of vegetation re-establishing around the south side of the leachate storage tank and PS3.
