RICHMOND SANITARY LANDFILL SITE, MONITORING REPORT NO. 36

PART OF LOTS 1, 2 AND 3, CONCESSION IV,
TOWN OF GREATER NAPANEE, COUNTY OF
LENNOX AND ADDINGTON

PROJECT NO.: 081-12459-04 (8570)
DATE: MARCH 27, 2023

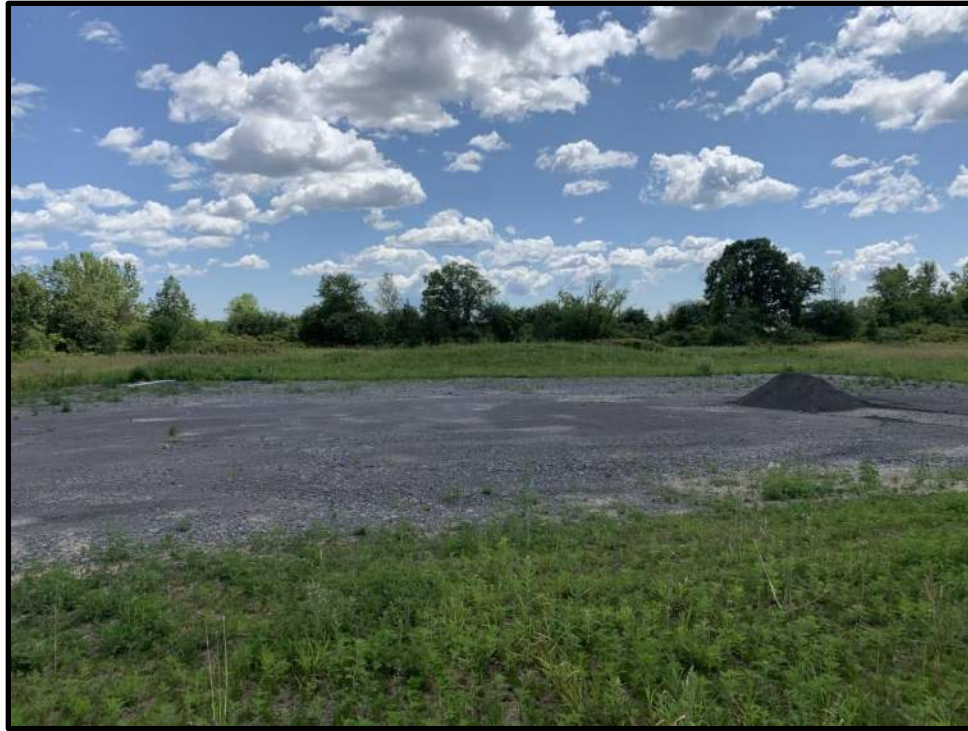
Photo 65: View facing south of the former staging area created by the leachate storage tank and storage system contractor. The area has not been restored to native conditions.

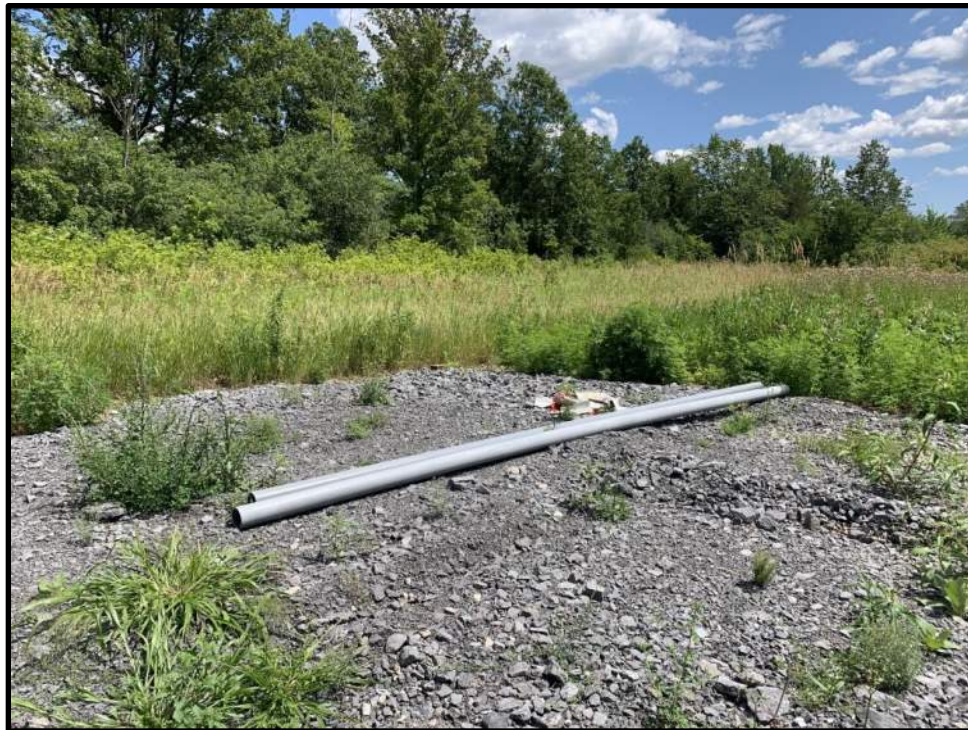
Photo 66: View of debris present on the southeast side of the staging area created by the leachate storage tank and storage system contractor.
