DATE: 14 June 2023
TO: Cathy Chisholm, District Manager, Ministry of the Environment, Conservation and Parks (MECP)
CC: Craig Dobiech (MECP)
Chris Prucha, Noah Wayt and Chad Moose (WMCC)
FROM: François Richard and Matthew DeGeer (BluMetric)
PROJECT NO: 230130-00
SUBJECT: Sampling Results Following On-Site Leachate Release, WM Richmond Landfill, Town of Greater Napanee
Ref: MECP Spill Action Centre Reference Number: 1-33QFL

WASTE MANAGEMENT RICHMOND LANDFILL LEACHATE RELEASE INVESTIGATION

SITE PLAN AND MARCH 2023 RELEASE LOCATION

PHOTOGRAPHIC RECORD OF LEACHATE RELEASE AND CLEANUP

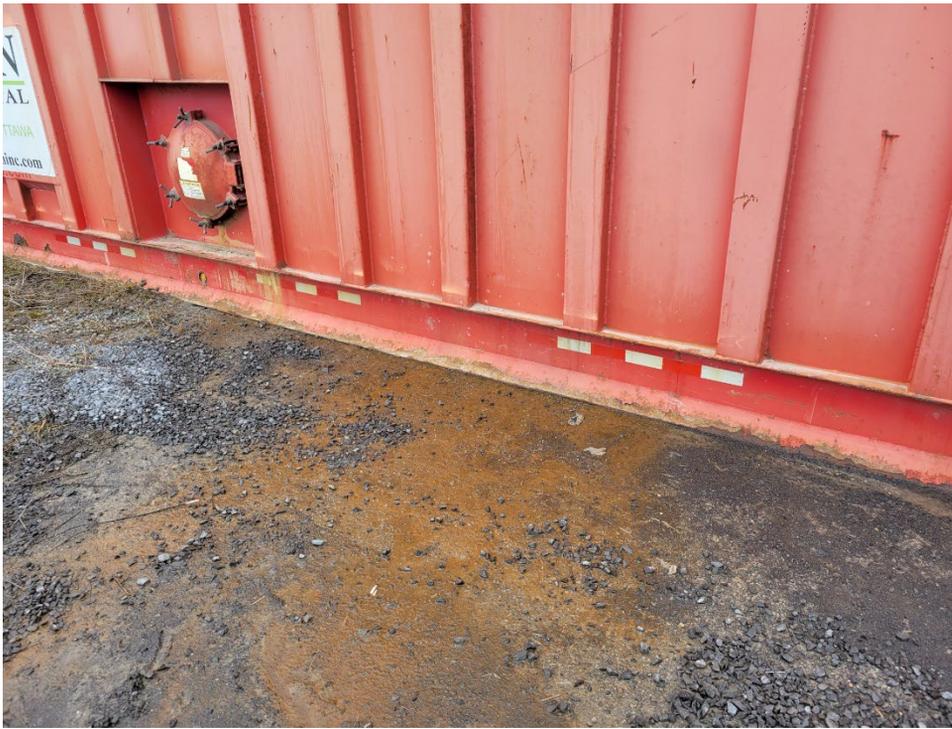
Photo 1: Soil staining resulting from leachate released from leaking frac tank (March 27, 2023)

On Monday March 27, 2023, BluMetric field personnel observed moisture originating from under the in-use temporary frac tank. Closer examination revealed a small drip leak on the under belly of the tank. The location of the release is shown on **Figure 1** while photographs of the soil staining observed are attached (see **Photos 1 and 2**). Upon discovery, WMCC reported the spill to the MECP Spill Action Centre and BluMetric personnel immediately implemented initial corrective actions to stop the release by coordinating with the leachate hauler to transfer leachate from the damaged frac tank to the second frac tank already on-site.

Once the leachate transfer was complete and the leakage stopped, BluMetric personnel investigated and were able to confirm that the release was limited to the asphalt surface and gravel/soil area immediately adjacent to the temporary frac tanks. The release did not leave the site or enter any stormwater feature. The impacted area was determined based on visual inspection of the rust-colored stains to be relatively limited in lateral extent (approximately 20 m²). Based upon the volume in the tank at the time of discovery, it is estimated that approximately 8.9 m³ of leachate leaked onto the ground. An MECP Environmental Officer visited the site on March 27, 2023 to verify that the release was localized and did not enter surface water or leave the site.

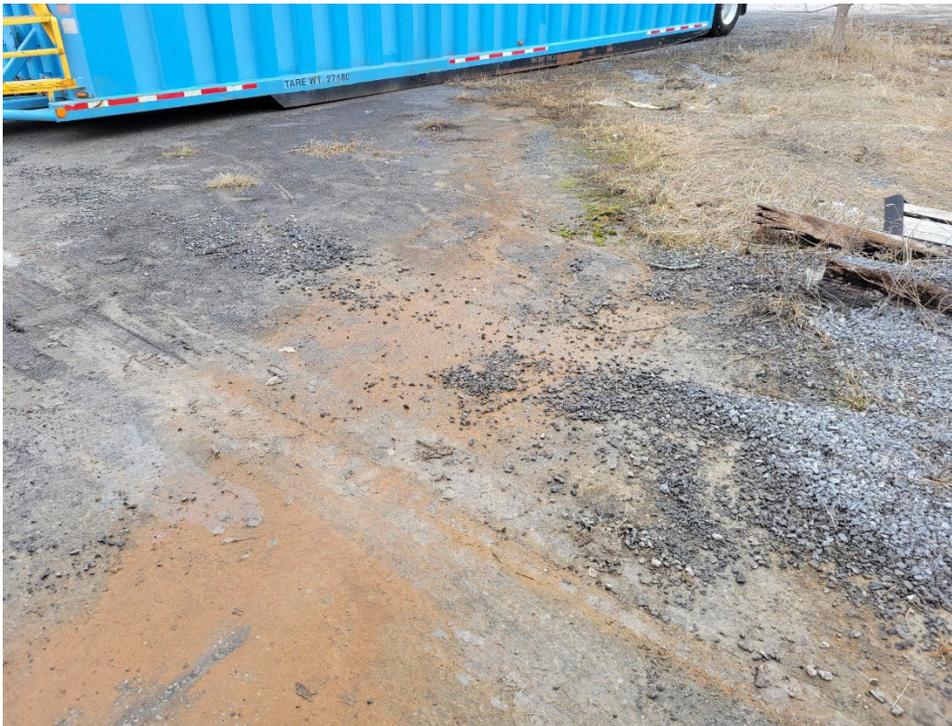
Photo 2: Soil staining resulting from leachate released from leaking frac tank (March 27, 2023)

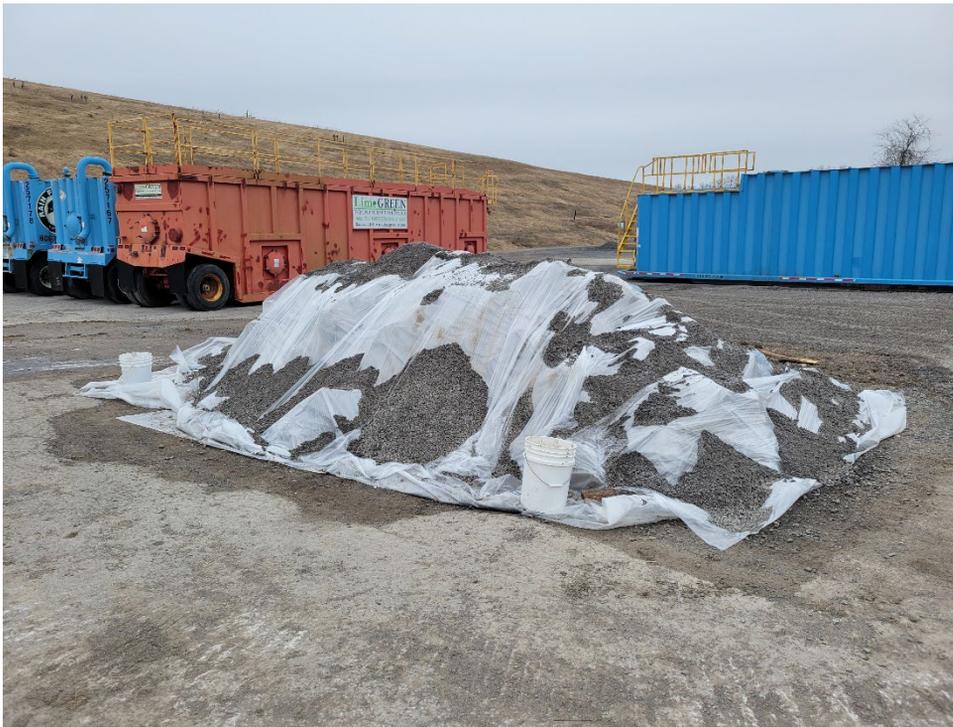
Photo 3: Stockpiled impacted soil (March 30, 2023)

On March 30, 2023, the soil and gravel identified as impacted (total volume approximately 80 m³) was excavated and stockpiled onto, and covered with, tarps (see attached **Photo 3**). The area of the excavation was covered with fresh gravel and graded to original condition (see attached **Photo 4**). On March 30, 2023, a soil sample was collected from the stockpiled material for pre-disposal analysis. The soil was removed from site on May 8, 2023, and disposed of at an authorized accepting facility.

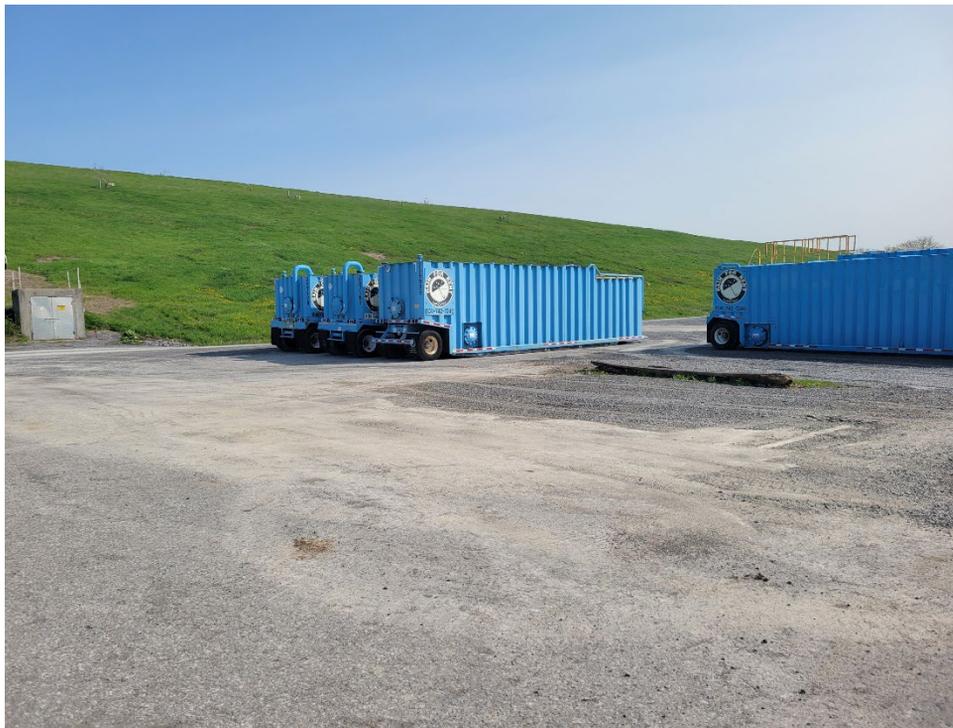
Photo 4: Site conditions following removal of impacted soil and final grading with clean gravel (May 8, 2023)
