## APPENDIX J:

**Table J-1**  
**Methane Monitoring Results - Compliance Monitoring**  
**Twin Creeks Environmental Centre**

TABLE L1:  
Warwick D&O – October 1997 | Drawings

TCEC 2021 CQA CQC Liner System Summary - Final

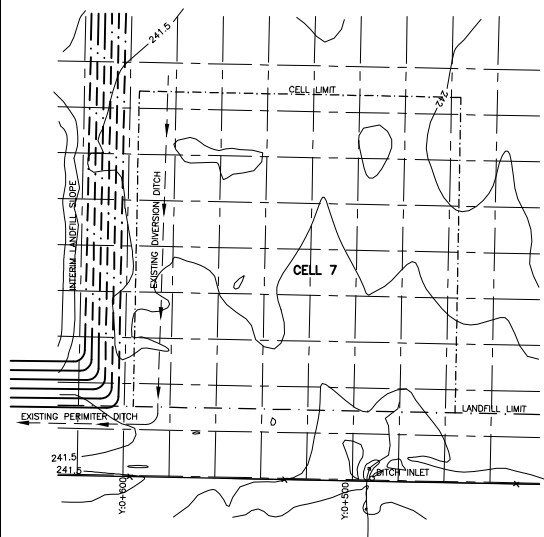
1) TYPICAL CELL CONDITIONS PRIOR TO DEVELOPMENT

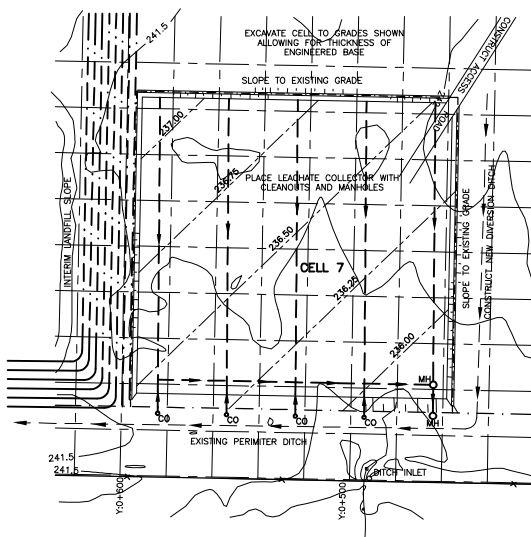
2) CELL CONSTRUCTION

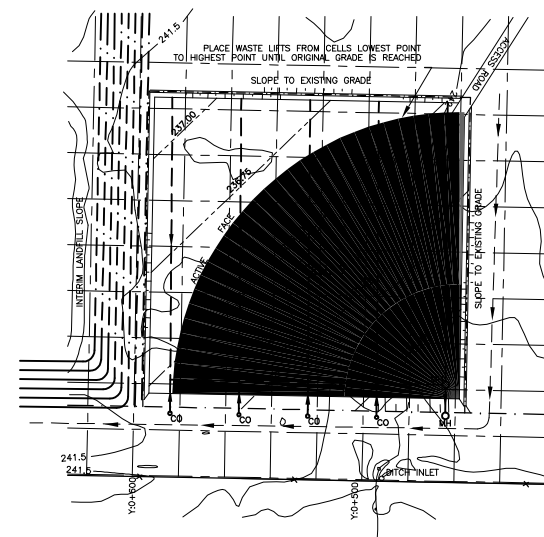
3) PLACING FIRST WASTE LIFT IN NEW CELL

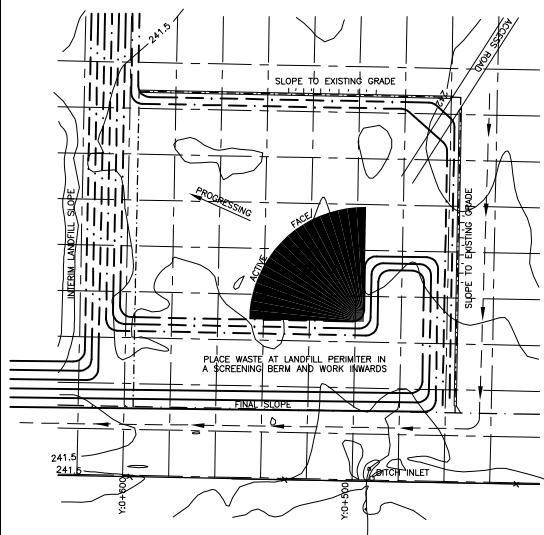
4) PLACING WASTE ABOVE GRADE

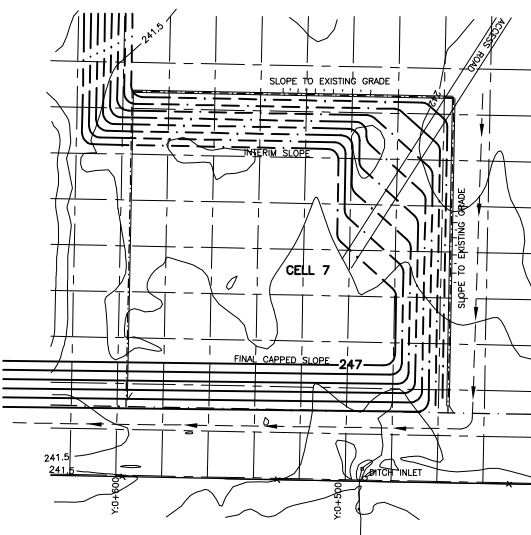
5) NEARING CELL CLOSURE

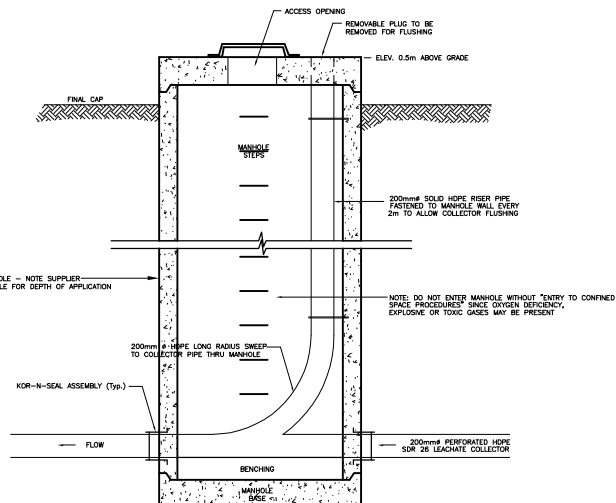
CLEANOUT MANHOLE - CELL 3S - DETAIL  
SCALE: 1 : 25

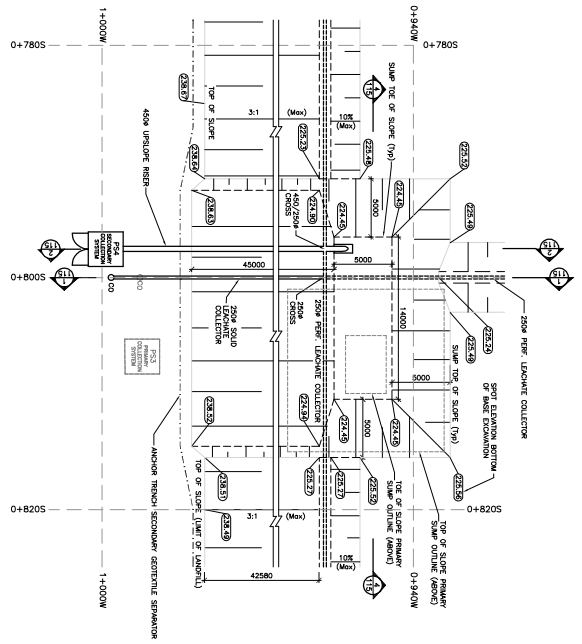
SECONDARY LEACHATE COLLECTION SYSTEM  
SUMP 2 PLAN
