WASTE MANAGEMENT OF CANADA CORPORATION

WATFORD, ONTARIO

TWIN CREEKS ENVIRONMENTAL CENTRE: 2022 FOURTH QUARTER & ANNUAL MONITORING REPORT VOLUME 2C OF 5 – COMPLIANCE MONITORING APPENDICES J TO S

RWDI #2202861.01 March 1, 2023

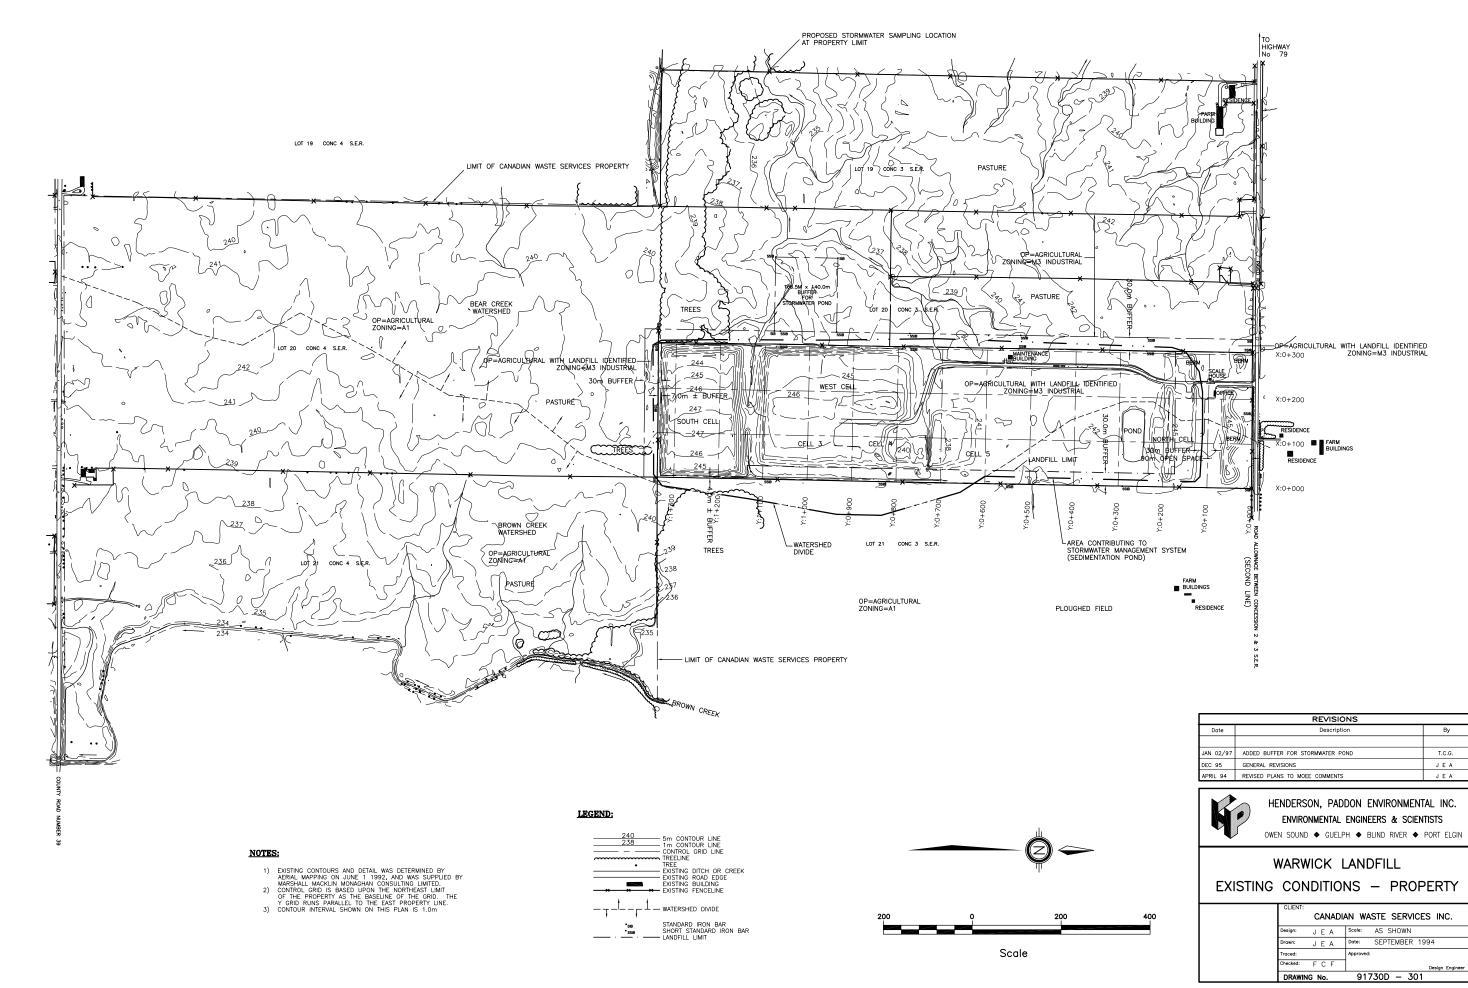
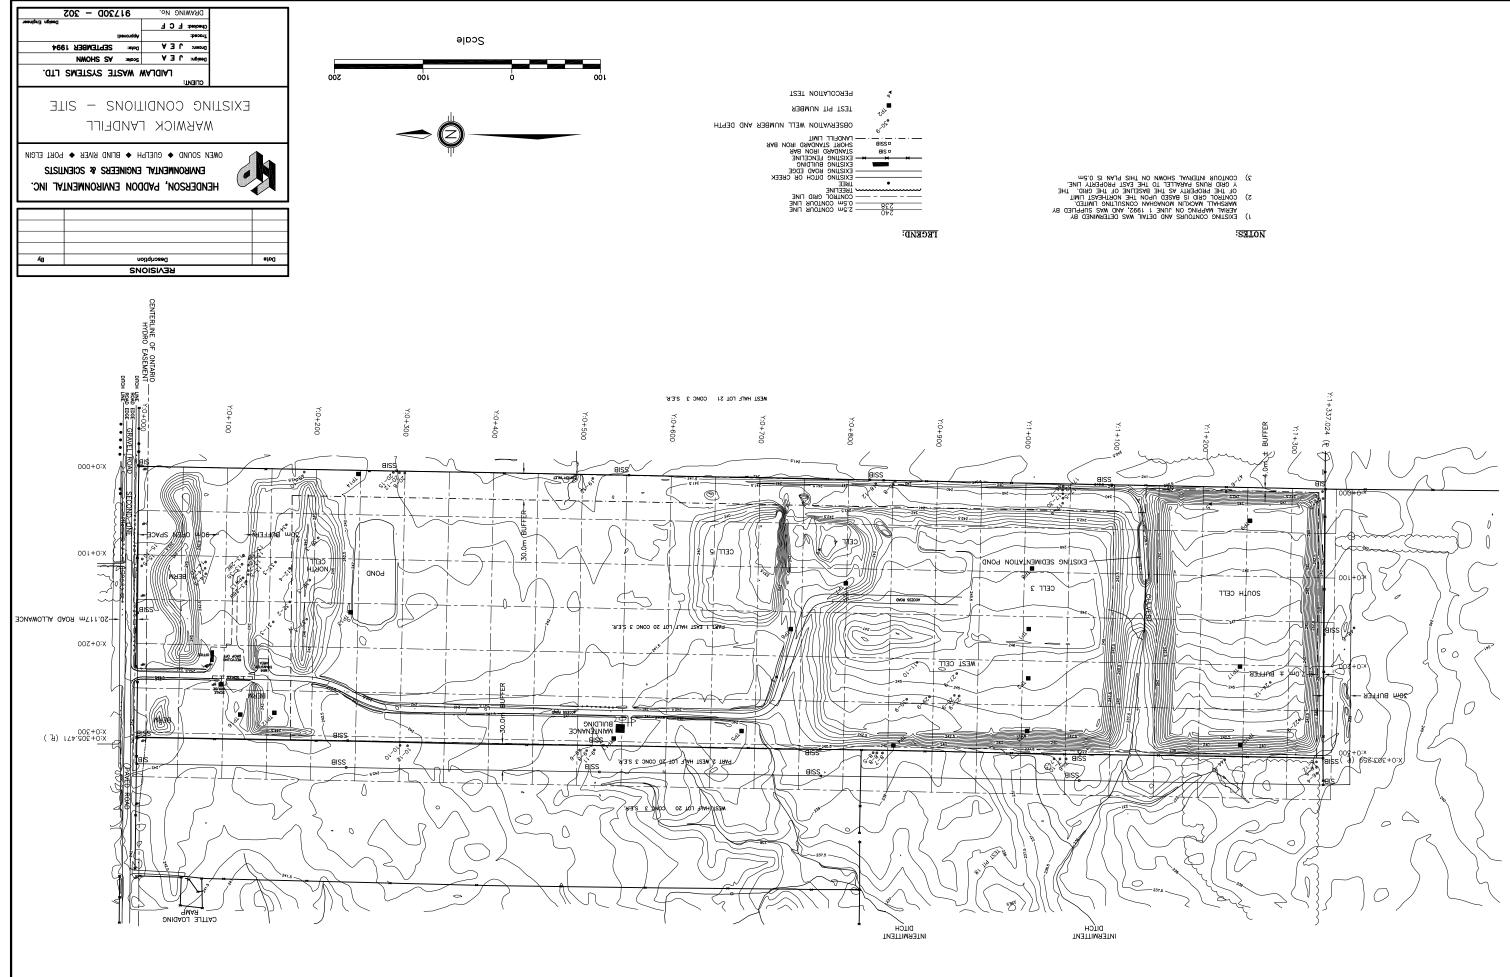
91730D-300	TITLE SHEET			
91730D-301	EXISTING CONDITIONS - PROPERTY			
91730D-302	EXISTING CONDITIONS - SITE - SEPTEMBER 1995			
91730D-303	EXISTING CONDITIONS - NORTH			
91730D-304	EXISTING CONDITIONS - SOUTH			
91730D-305	EXISTING LEACHATE COLLECTORS AND CUT-OFF WALL			
91730D-306	FINAL CONTOURS - NORTH			
91730D-306A	LANDSCAPE & PLANTING PLAN - NORTH (100% COMPLETE)			
91730D-306B	LANDSCAPE & PLANTING PLAN - NORTH (75% COMPLETE)			
91730D-307	FINAL CONTOURS - SOUTH			
91730D-307A	LANDSCAPE & PLANTING PLAN - SOUTH (100% COMPLETE)			
91730D-307B	LANDSCAPE & PLANTING PLAN - SOUTH (25% COMPLETE)			
91730D-307C	LANDSCAPE & PLANTING PLAN - SOUTH (50% COMPLETE)			
91730D-308	BASE CONTOURS - NORTH			
91730D-309	BASE CONTOURS - SOUTH			
91730D-310	STORMWATER MANAGEMENT - NORTH			
91730D-311	STORMWATER MANAGEMENT - SOUTH			
91730D-312	SEDIMENTATION POND DETAILS			
91730D-313	PHASING PLAN			
91730D-314	SECTION A-A AND SECTION B-B
