## WASTE MANAGEMENT OF CANADA CORPORATION

WATFORD, ONTARIO

TWIN CREEKS ENVIRONMENTAL CENTRE: 2024 FOURTH  
QUARTER & ANNUAL MONITORING REPORT VOLUME 2C OF 5  
– COMPLIANCE MONITORING

RWDI #2402553.01

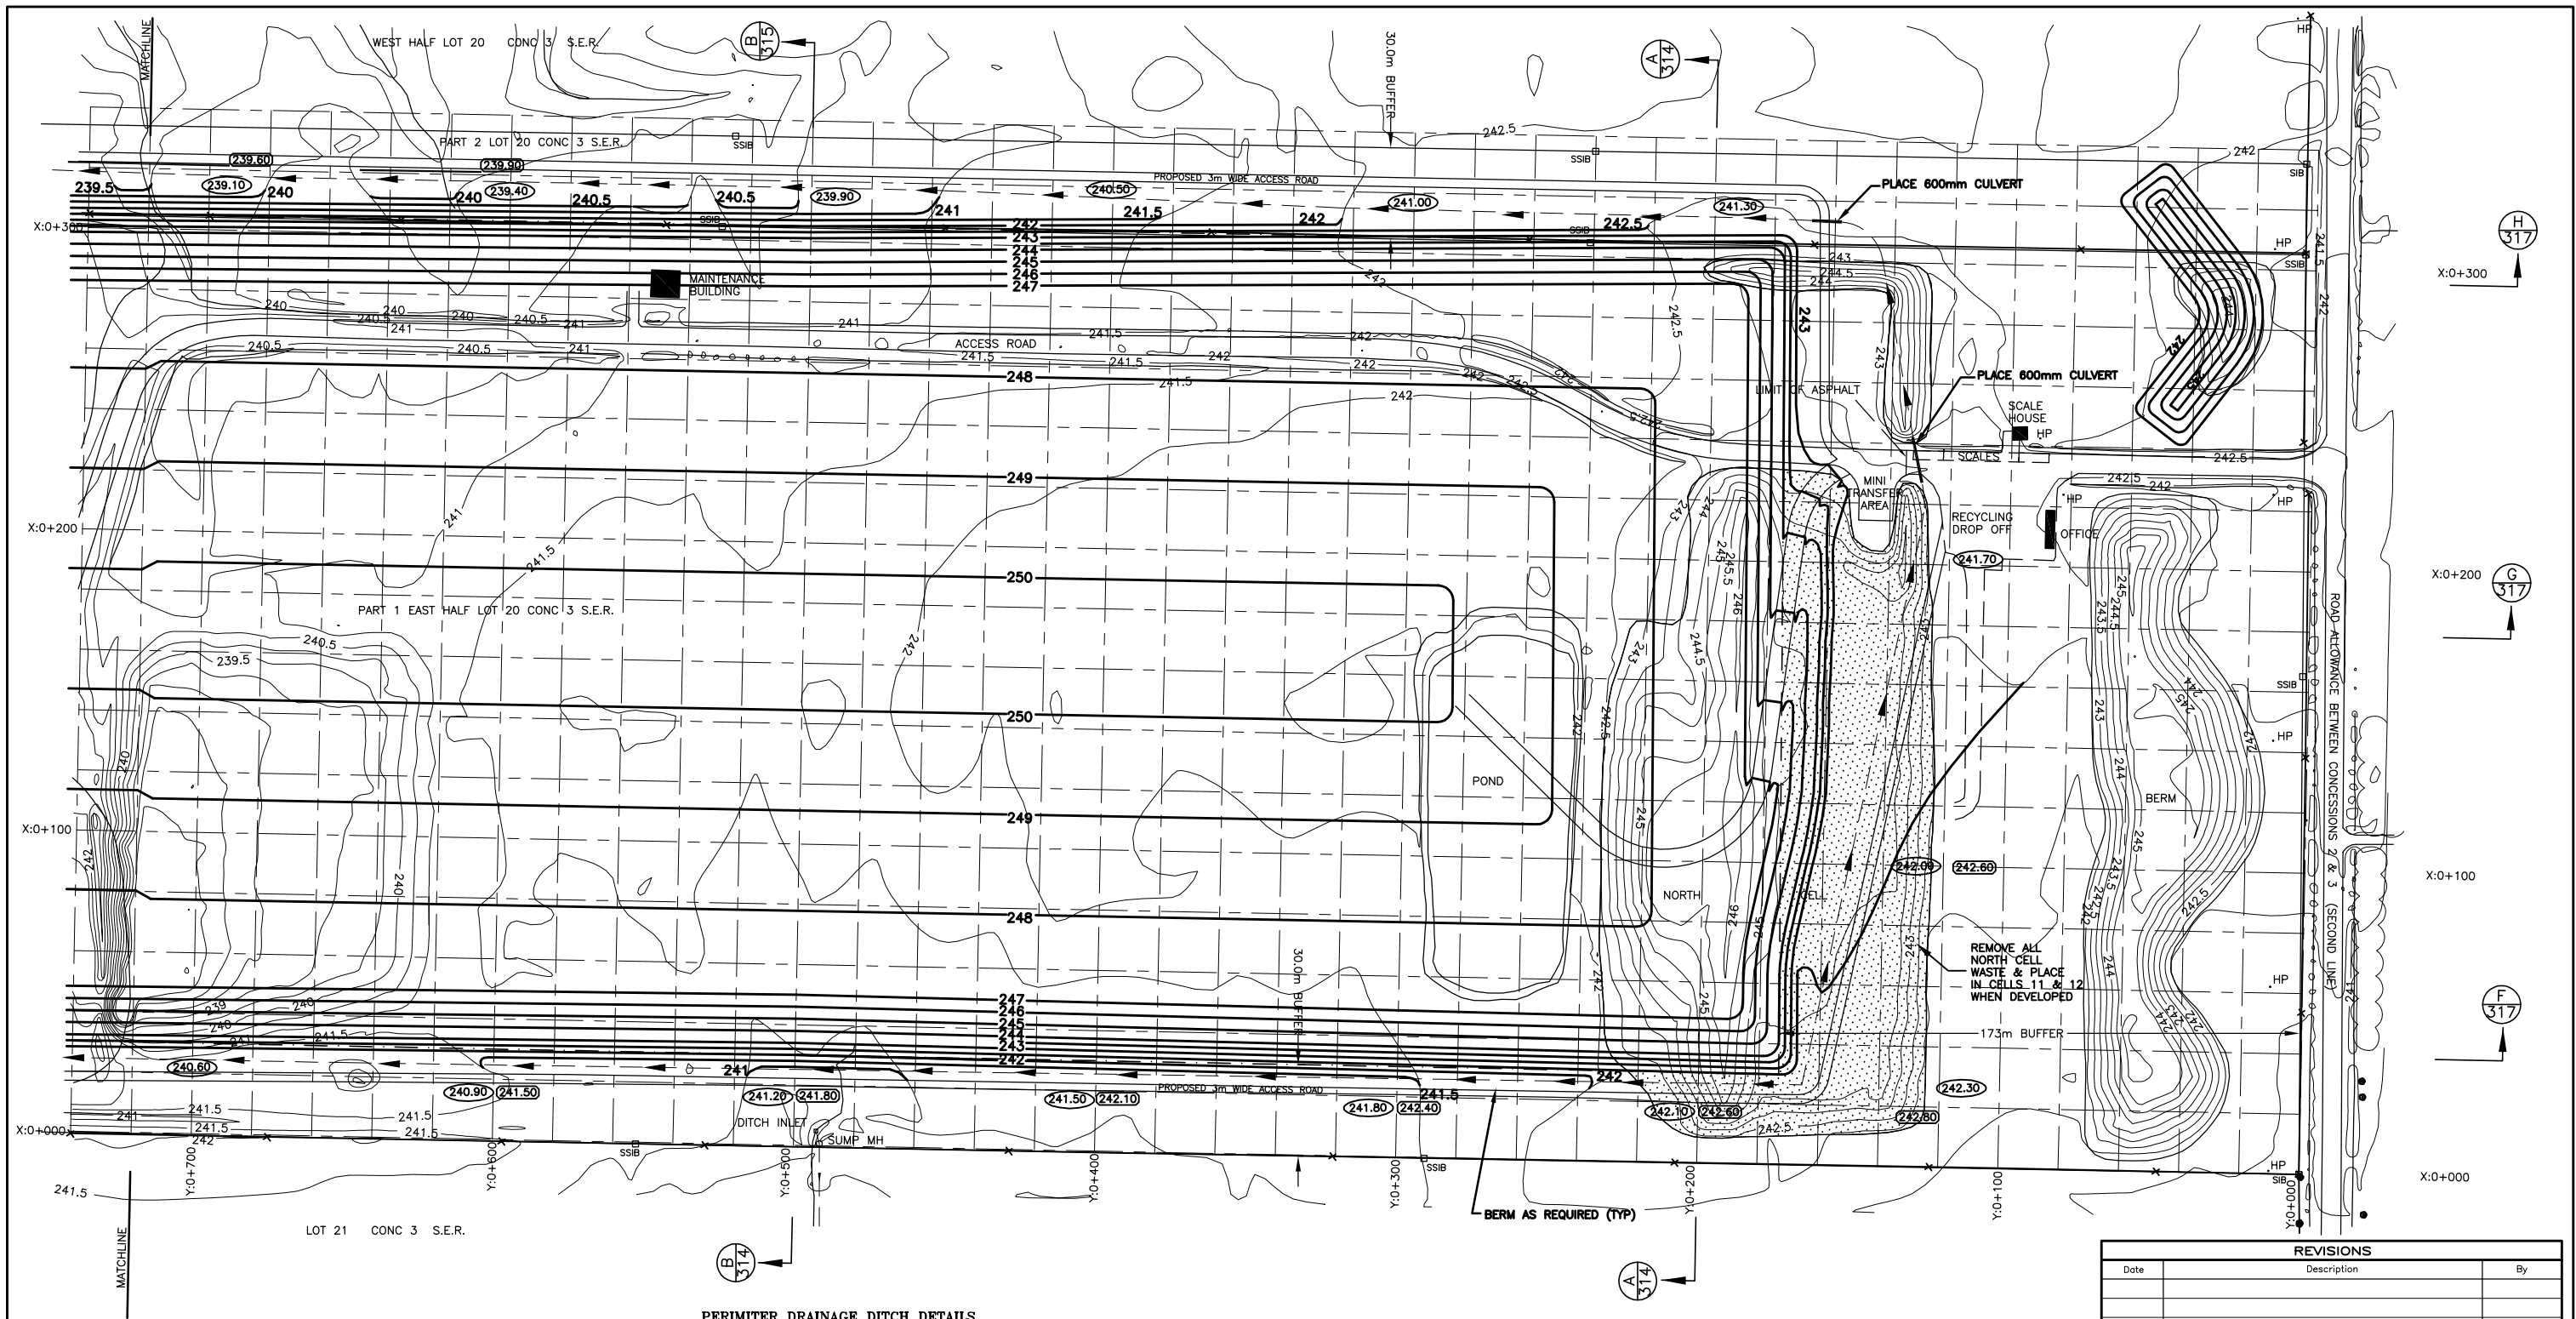
CLIENT: <b>CANADIAN WASTE SERVICES INC.</b>	
Design: J E A	Scale: AS SHOWN
Drawn: J E A	Date: SEPTEMBER 1994
Traced:	Approved:
Checked: F C F	Design Engineer
DRAWING No.	91730D – 310

PERIMETER DRAINAGE DITCH DETAILS

STATION	BOTTOM WIDTH	SIDE SLOPES	MINIMUM DEPTH
Y:0+125 X:0+027	0.60m	2:1 *	0.50m
Y:0+500 X:0+025	0.60m	2:1 *	0.50m
Y:0+700 X:0+025	0.60m	2:1 *	0.50m
Y:0+123 X:0+200	0.60m	2:1 *	0.50m
Y:0+200 X:0+314	0.60m	2:1 *	0.50m
Y:0+500 X:0+318	0.60m	2:1 *	0.50m
Y:0+700 X:0+318	0.60m	2:1 *	0.50m

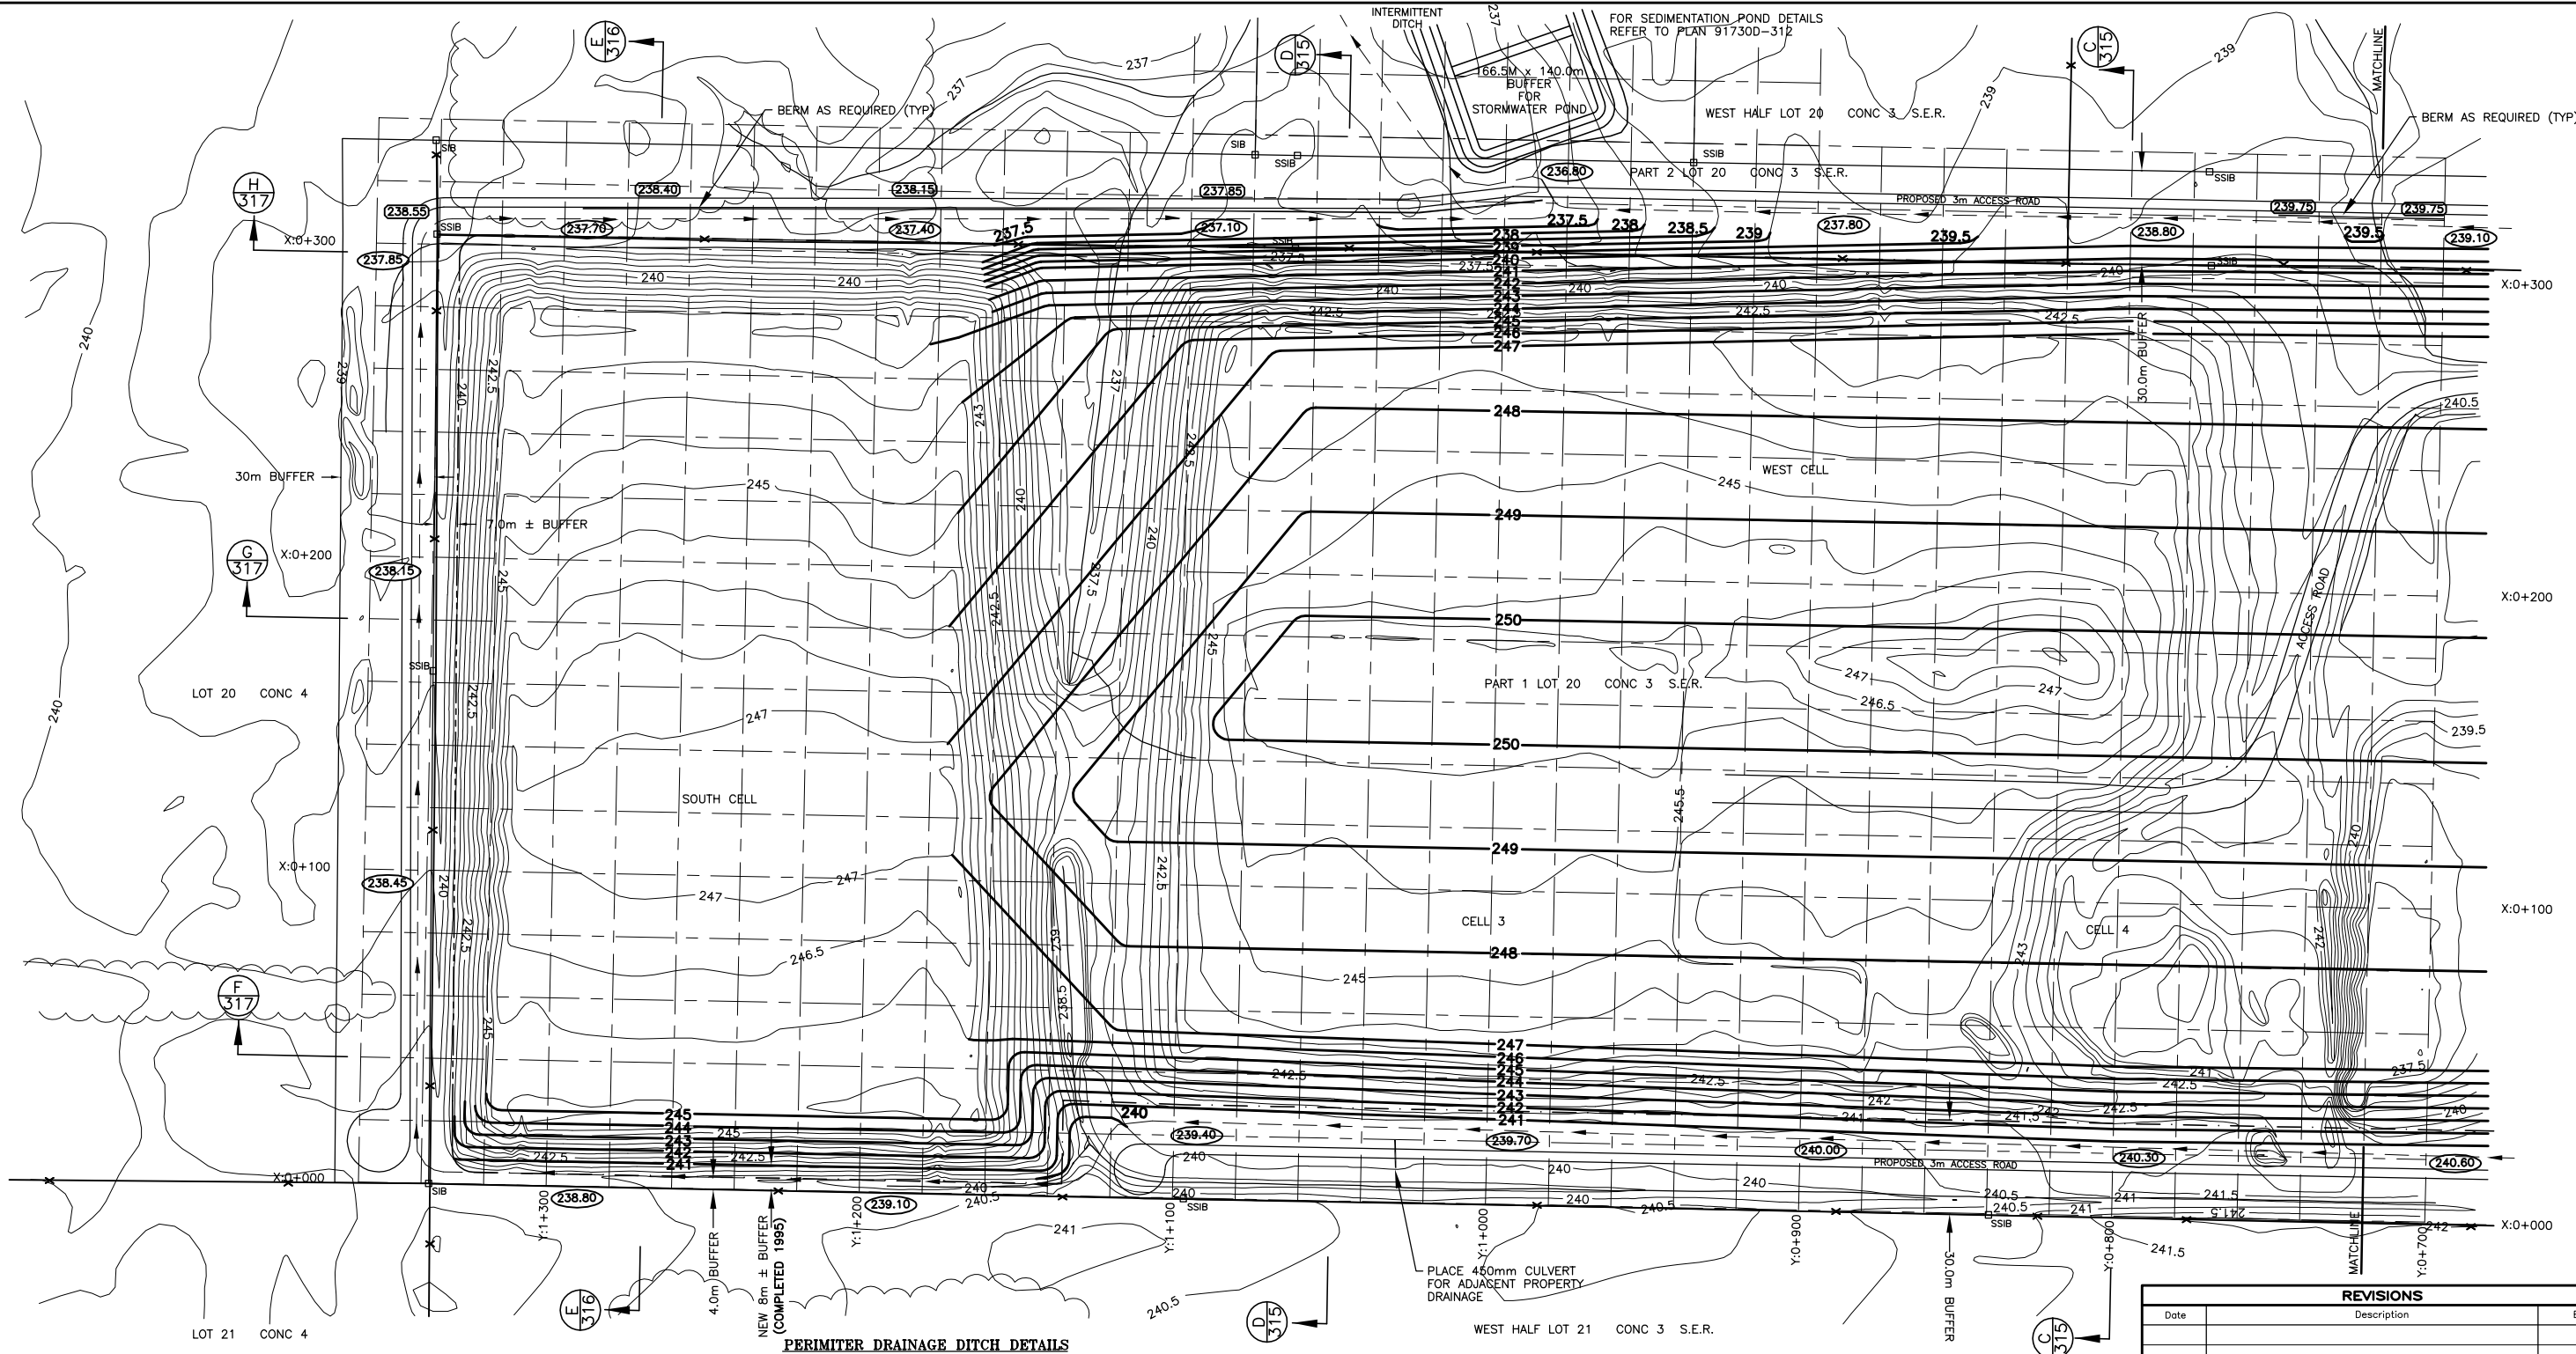
PERIMETER DRAINAGE DITCH DETAILS

STATION	BOTTOM WIDTH	SIDE SLOPES	MINIMUM DEPTH
Y:0+800 X:0+022	0.60m	2:1 *	0.60m
Y:1+100 X:0+024	0.60m	2:1 *	0.70m
Y:1+343 X:0+110	0.60m	2:1	0.70m
Y:1+150 X:0+312	0.60m	2:1	0.75m
Y:1+000 X:0+315	0.60m	2:1	0.90m
Y:0+800 X:0+319	0.60m	2:1	0.60m
Y:0+980 X:0+319	0.60m	2:1	0.60m

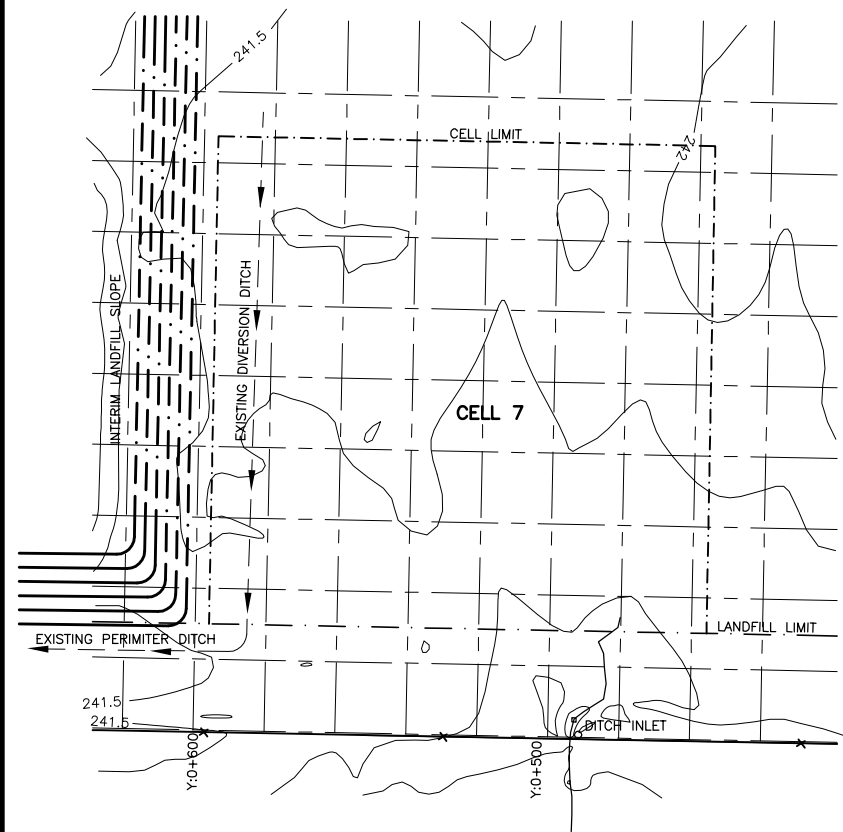
1) TYPICAL CELL CONDITIONS PRIOR TO DEVELOPMENT
