# Draft Visual Landscape Existing Conditions Report

Twin Creeks Environmental Centre Landfill
Optimization Project Environmental Assessment
WM Canada

Watford, Ontario

November 2023

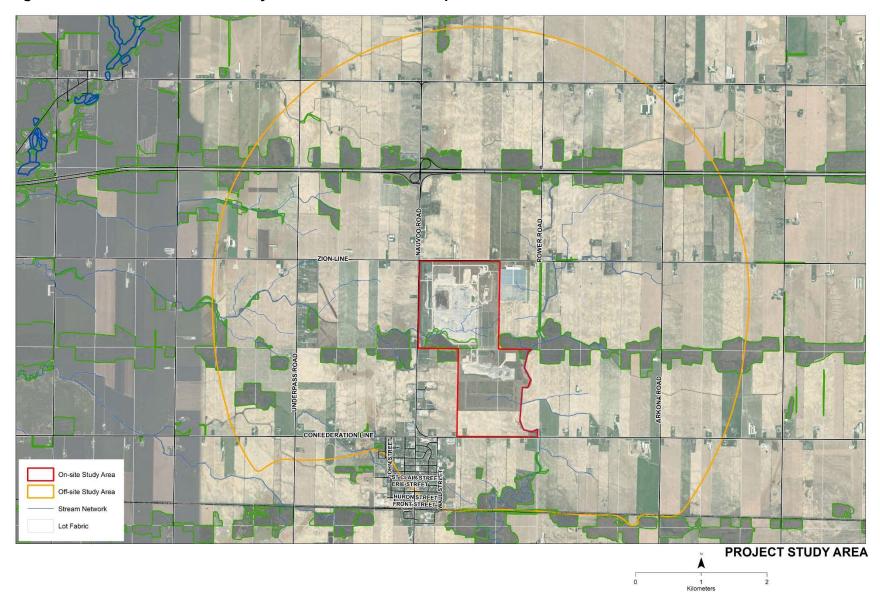
Figure 2-1. On-site and Off-site Study Areas for Visual Landscape

The On-site and Off-site Study Areas for Visual Landscape based on the existing conditions assessment are shown on Figure 2-1.

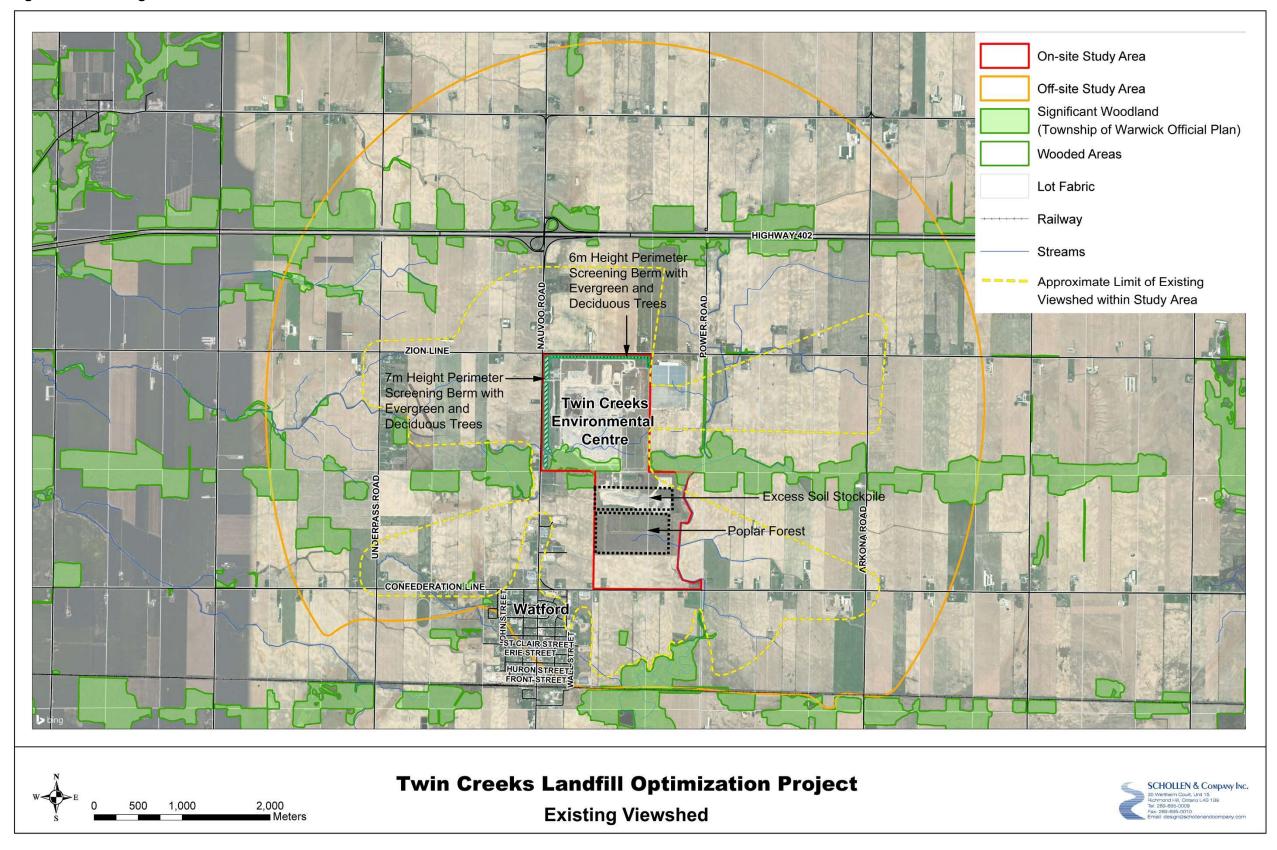
Figure 4-1. Existing Viewshed

- Figure 4.1 Illustrates the viewshed to the TCEC under the existing condition.
   Existing Significant Woodlands, the Twin Creeks Greenhouse Complex, buildings within the Industrial Park, and the screening berms and trees that were implemented as a component of the Landfill Expansion obstruct views to the TCEC.
- The future existing condition is described in the Visual Assessment (2005) corresponding with Year 26, Phase 11. The images generated as a component of this assessment from Viewpoints 1 to 6 illustrate that the landfill will be visible from various locations along County Road 29, Zion Line, Arkona Road, and Highway 7. The area described as the High Visual Impact Zone is located within a 1.5 km radius of the Twin Creeks facility. Figure 4.2 Illustrates the viewsheds to the TCEC under the future existing condition.

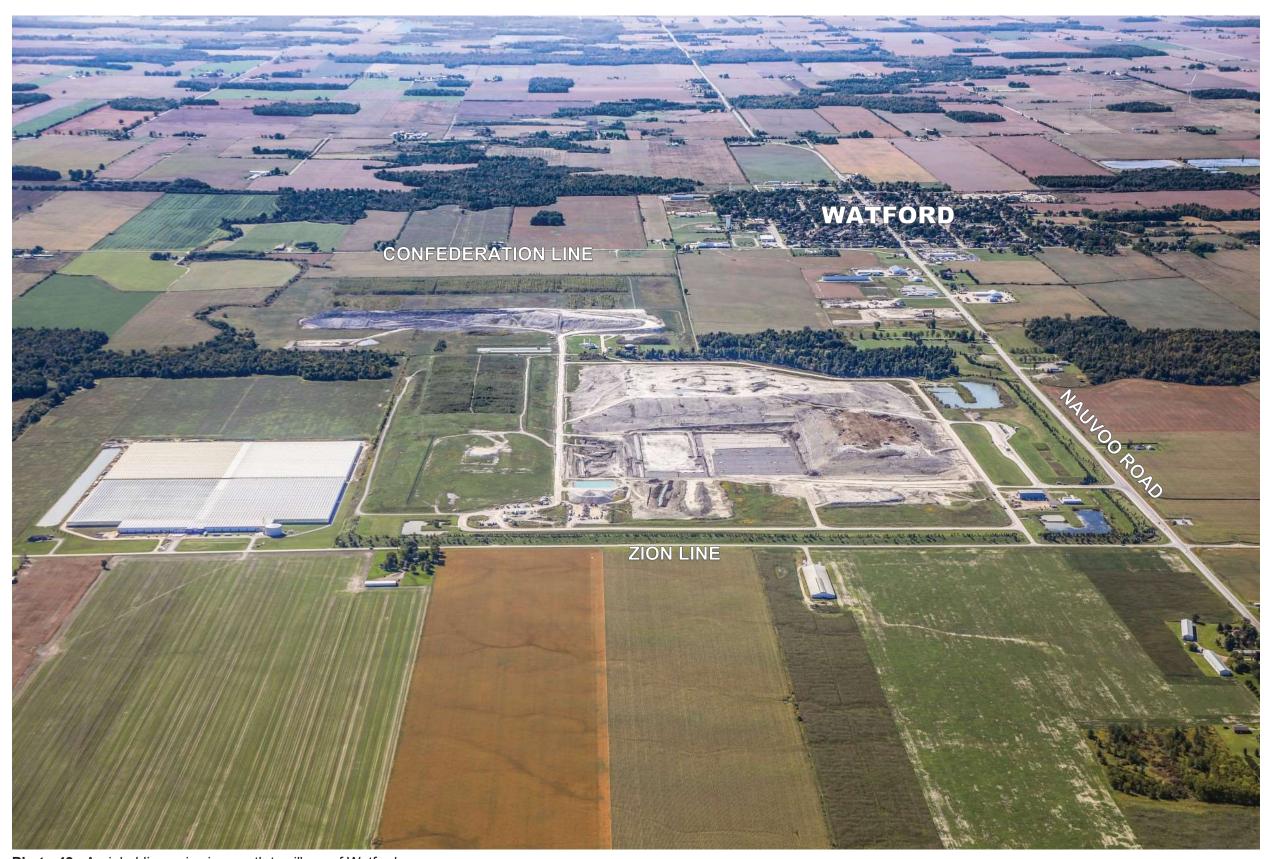
Photo 49 - Aerial oblique viewing south to village of Watford

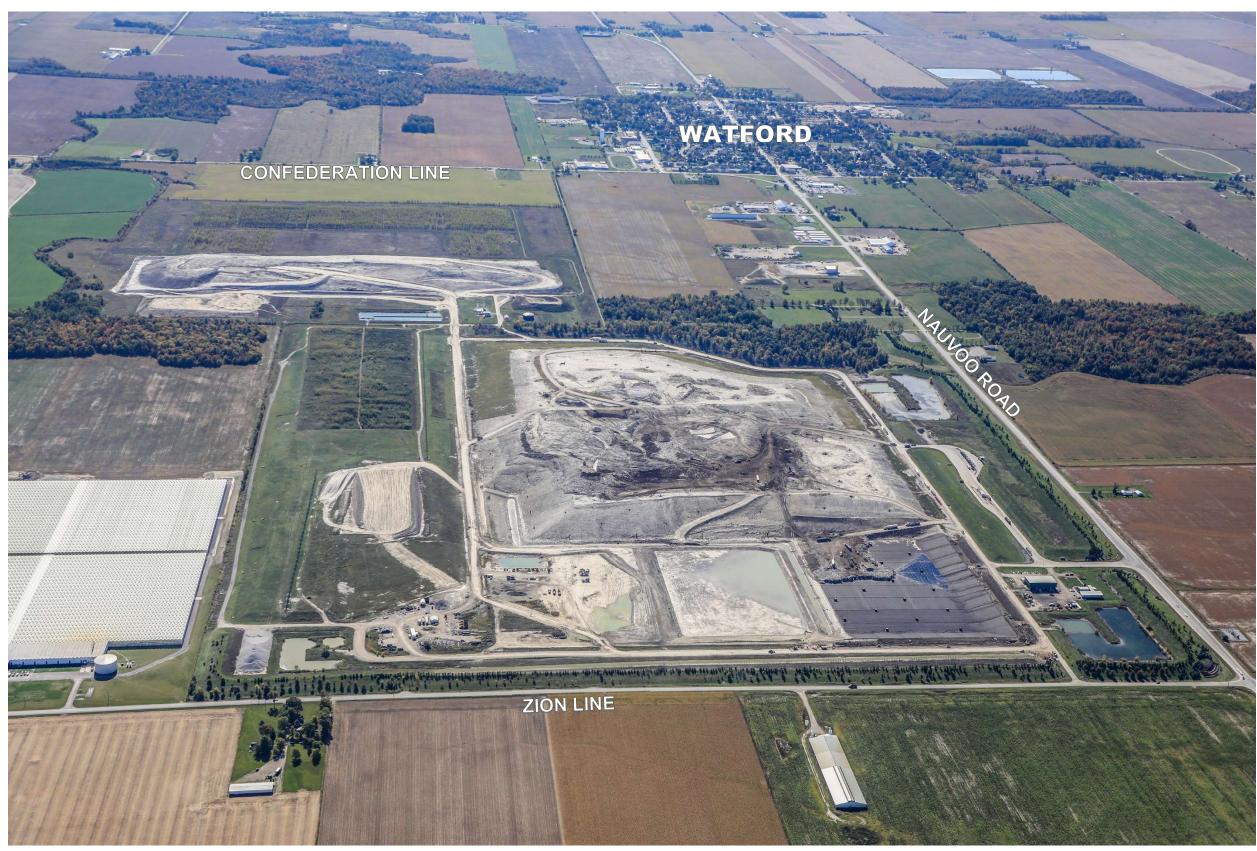
Photo 61 - Aerial oblique viewing south to village of Watford

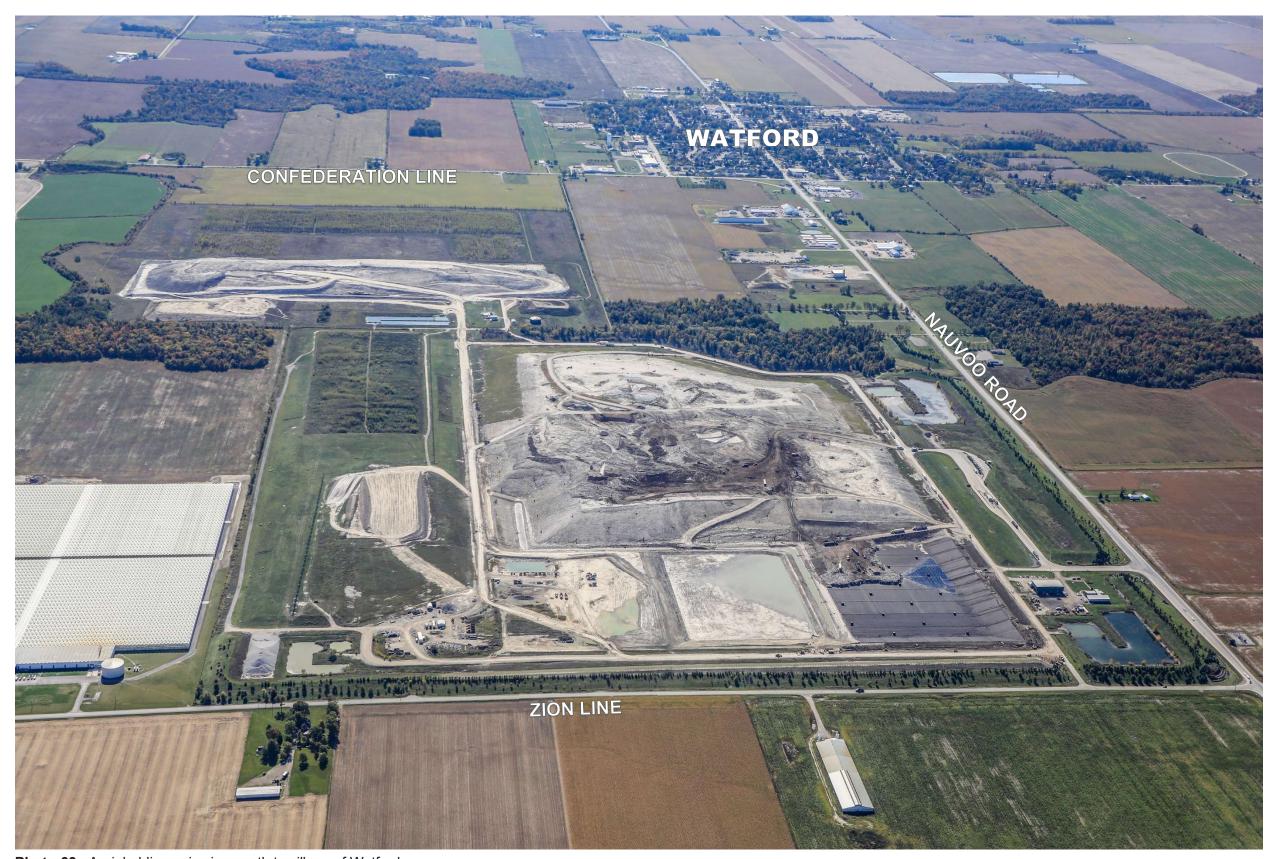
Photo 63 - Aerial oblique viewing south to village of Watford
