Visual Landscape Existing Conditions Report

Twin Creeks Environmental Centre Landfill
Optimization Project Environmental Assessment

WM Canada

May 2026

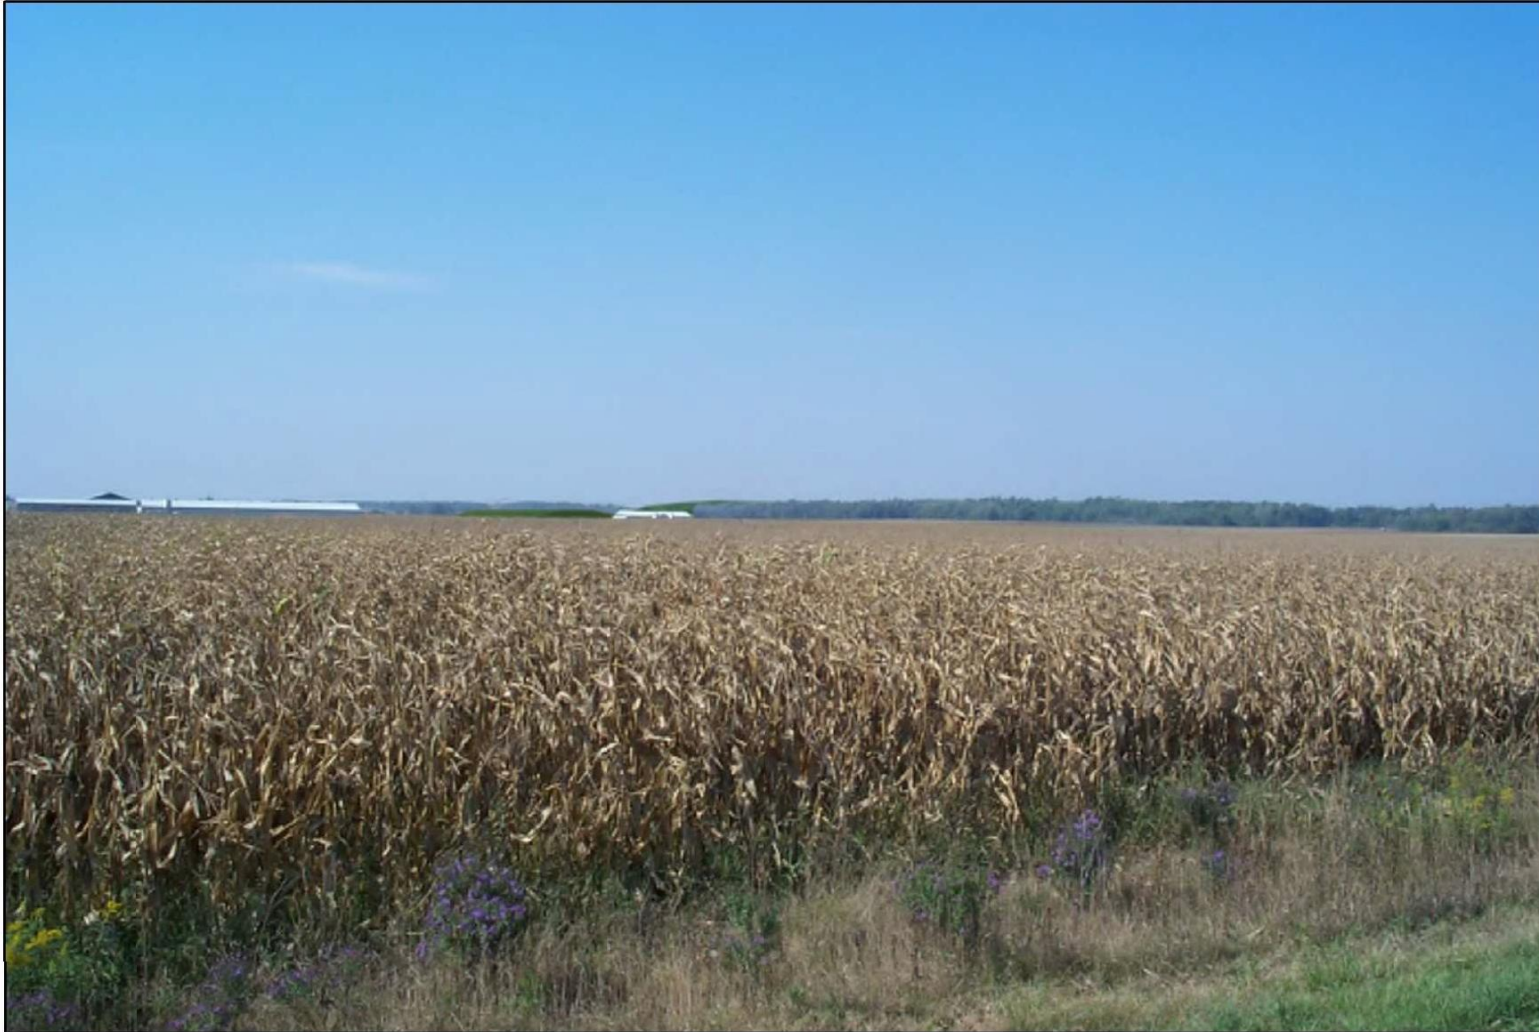
FIG.
4-41

FROM ARKONA ROAD AT COUNTY RD 39 VIEWING NORTH WEST

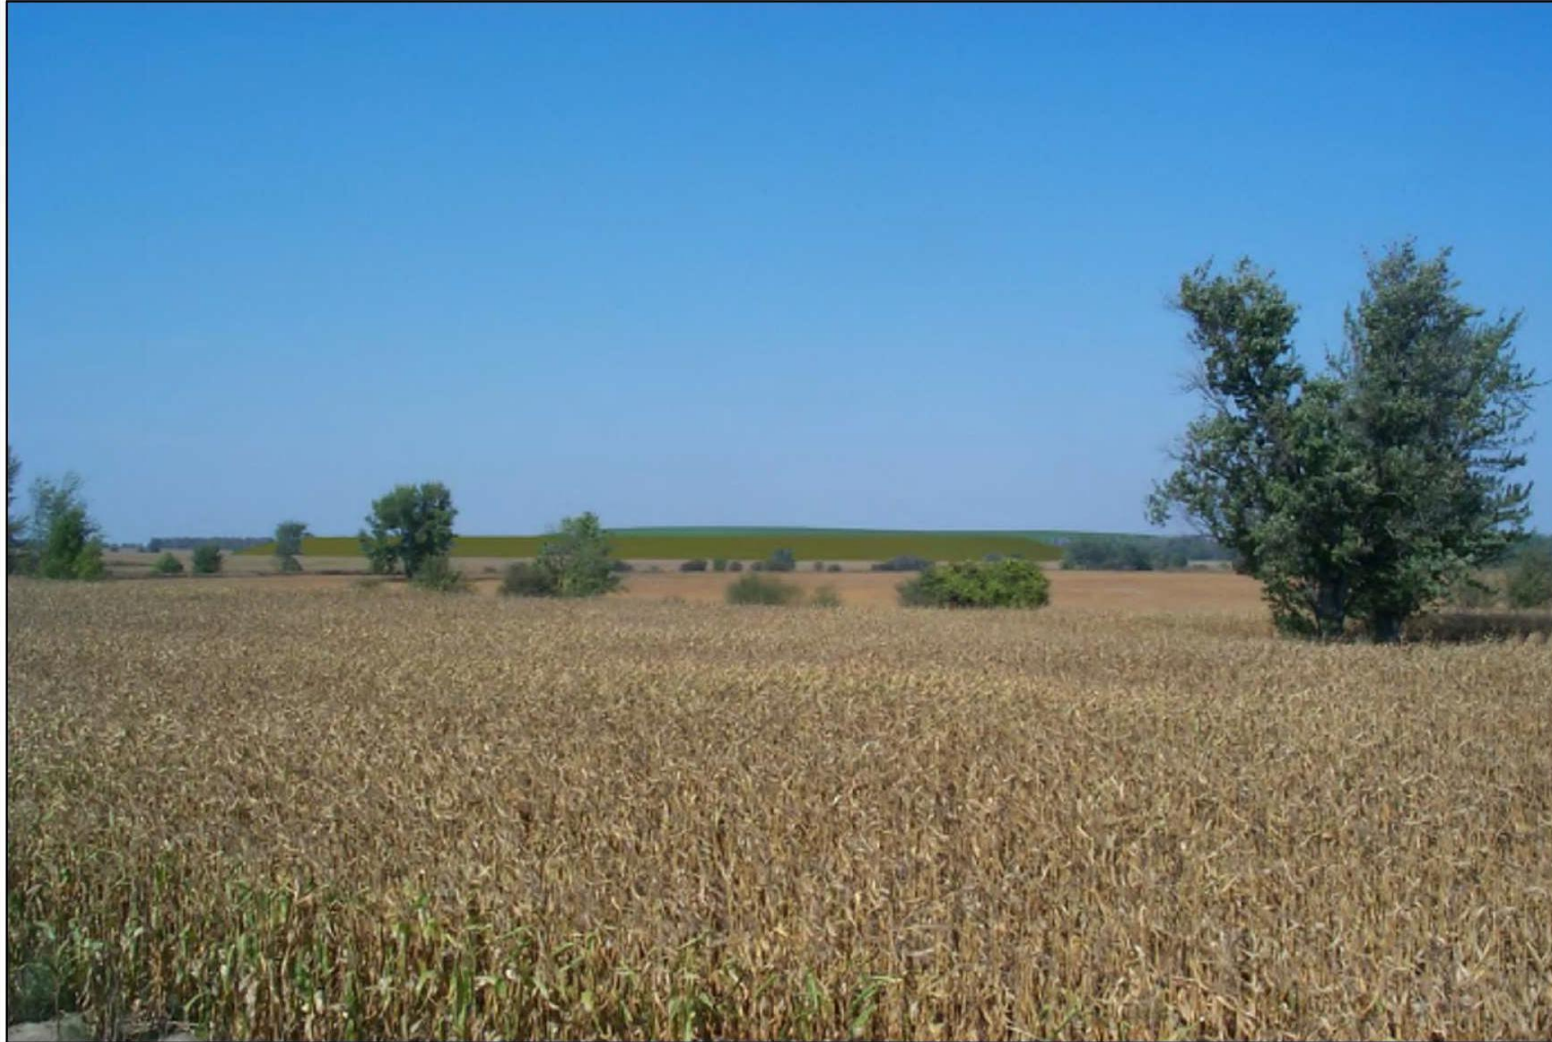
FIG.
4-42

FROM COUNTY RD. 39 @ BROWN CREEK VIEWING NORTH-WEST

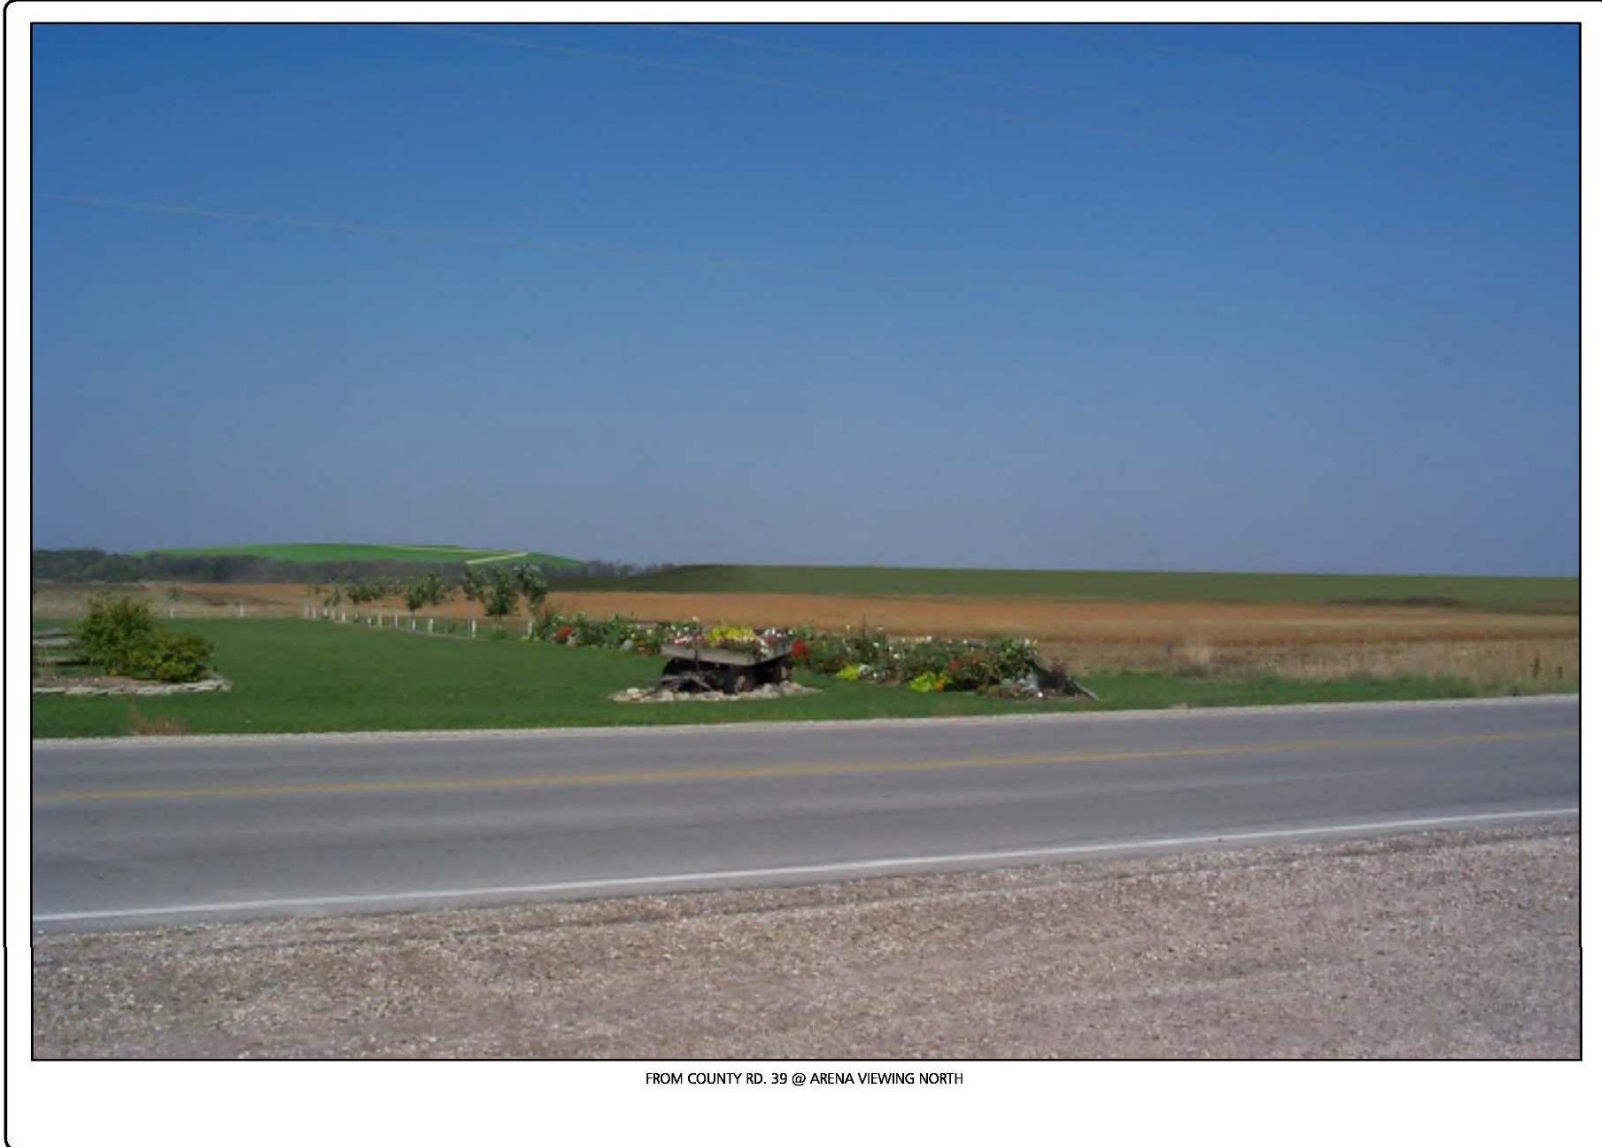
FROM COUNTY RD. 39 @ ARENA VIEWING NORTH

DWN BY: SH CHK BY: TT DATE: 03/18/08 SCALE: CANADIAN WASTE SERVICES, INC. DRAWING NO. 4 - 43	Year 26 - Phase 11 Simulation WARWICK LANDFILL	VIEWPOINT 4

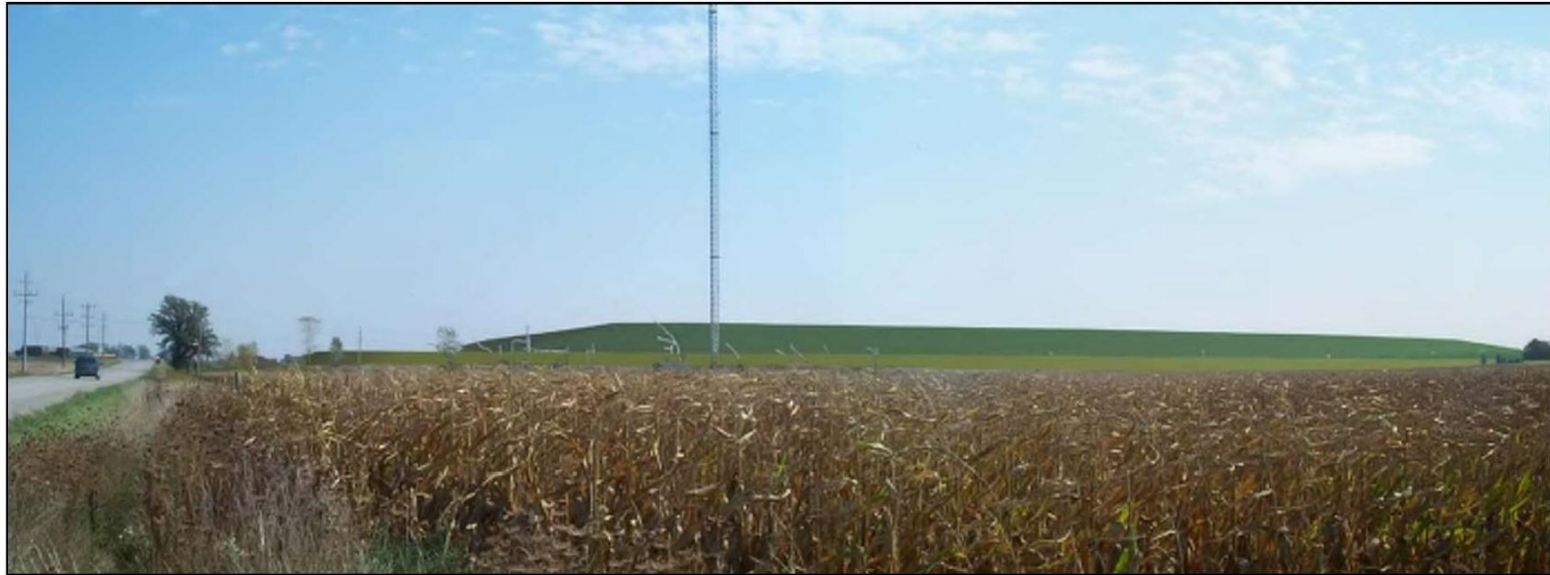
FROM ZION LINE VIEWING EAST

FIG. 4-44	DWN BY: SH CHK BY: DATE: SCALE: 23/12/18	Year 26 - Phase 11 Simulation	WM WASTE MANAGEMENT	BAKER Turner Inc. Landscape Architecture Site 200501 Malaga Road Brimley, Ontario L9Y 5G8 Tel: (905) 454-9388 Fax: (905) 454-9376
VIEWPOINT 5	WARWICK LANDFILL

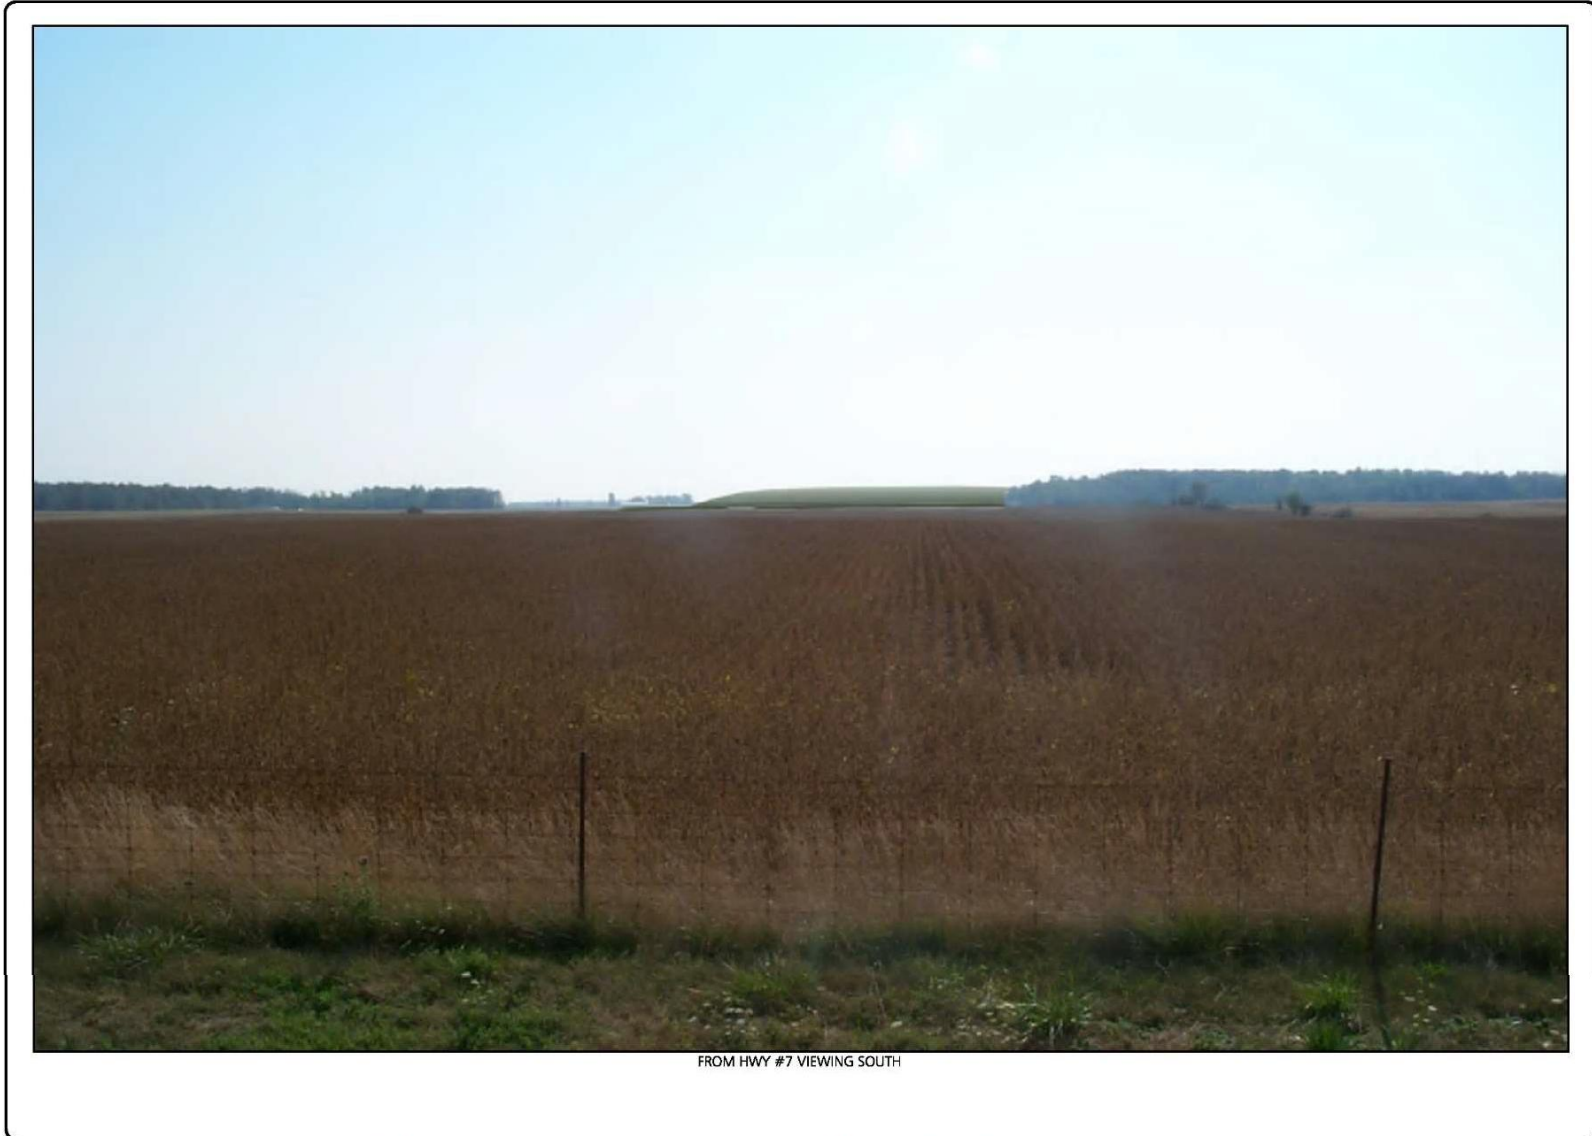
FIG.
4-45

FROM HWY #7 VIEWING SOUTH
