SKYLINE RECYCLING AND DISPOSAL FACILITY

APPENDIX IIE

ENDANGERED OR THREATENED SPECIES DOCUMENTATION

Re: Threatened and endangered species assessment for the proposed Skyline Recycling and Disposal Facility in Dallas and Ellis Counties, Texas

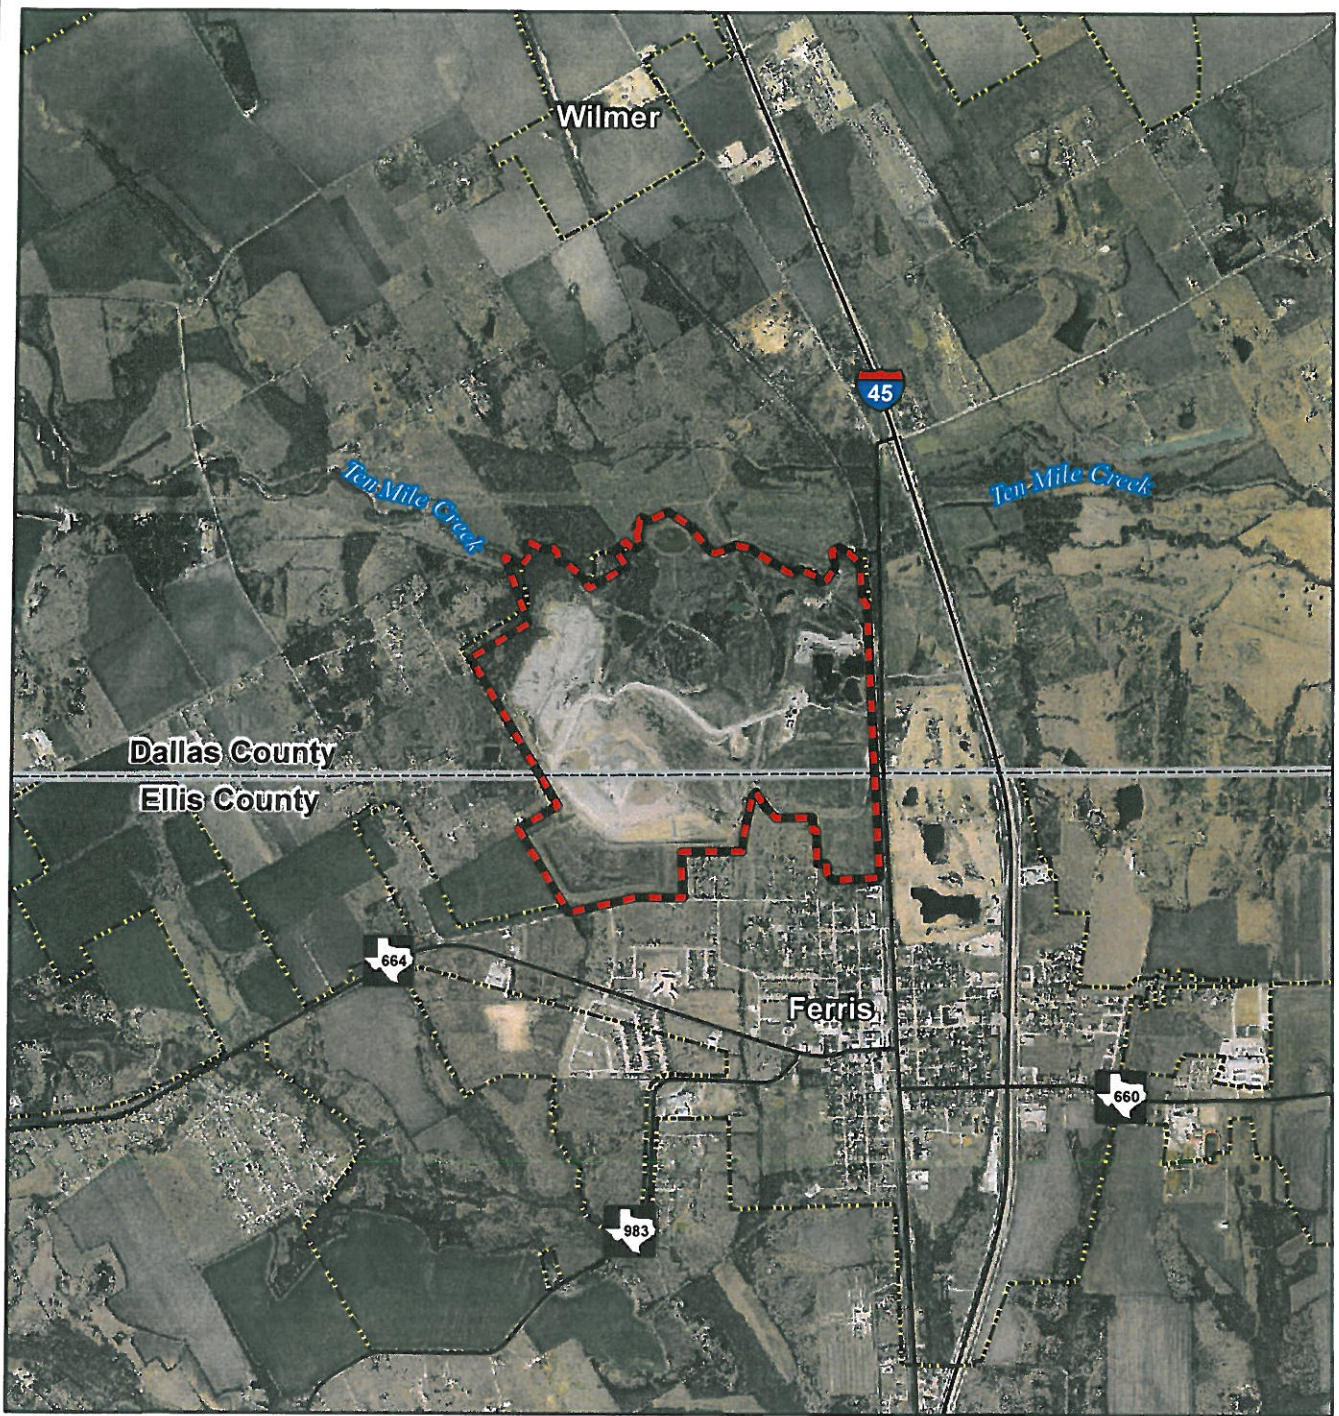
FIGURE 1

Waste Management of Texas, Inc. has proposed to expand the Skyline RDF in Ferris, Texas. The 666.9-acre Skyline RDF property is located west of Interstate 45 (IH 45), south of Ten Mile Creek, and north of Ferris, Texas. **Figure 1** shows the Skyline RDF in the general Dallas-Fort Worth vicinity, and **Figure 2** depicts the existing Skyline RDF landfill permit boundary (i.e. study area). The permitted Skyline RDF dates back over three decades, with a municipal solid waste (MSW) permit issued to Trinity Valley Reclamation (TVR), Inc. in 1976 (MSW 42A). In 1987, TVR was acquired by the Applicant, who then developed a landfill permit to expand the landfill operations (MSW 42C). MSW 42C was approved by the landfill regulatory agency in 1995. The Applicant is currently seeking to modify and expand the existing landfill operations under MSW 42C through a third MSW permit ("project"). Approximately 1,200,000 cubic yards of material would be excavated within the proposed expansion areas. This area would then be incorporated into landfill operations, eventually attaining a height to elevation 688.0 feet-msl, providing an additional 20 million cubic yards of waste volume over the 22.9 acres, for a total of 60.2 million cubic yards of waste for the entire landfill operation.

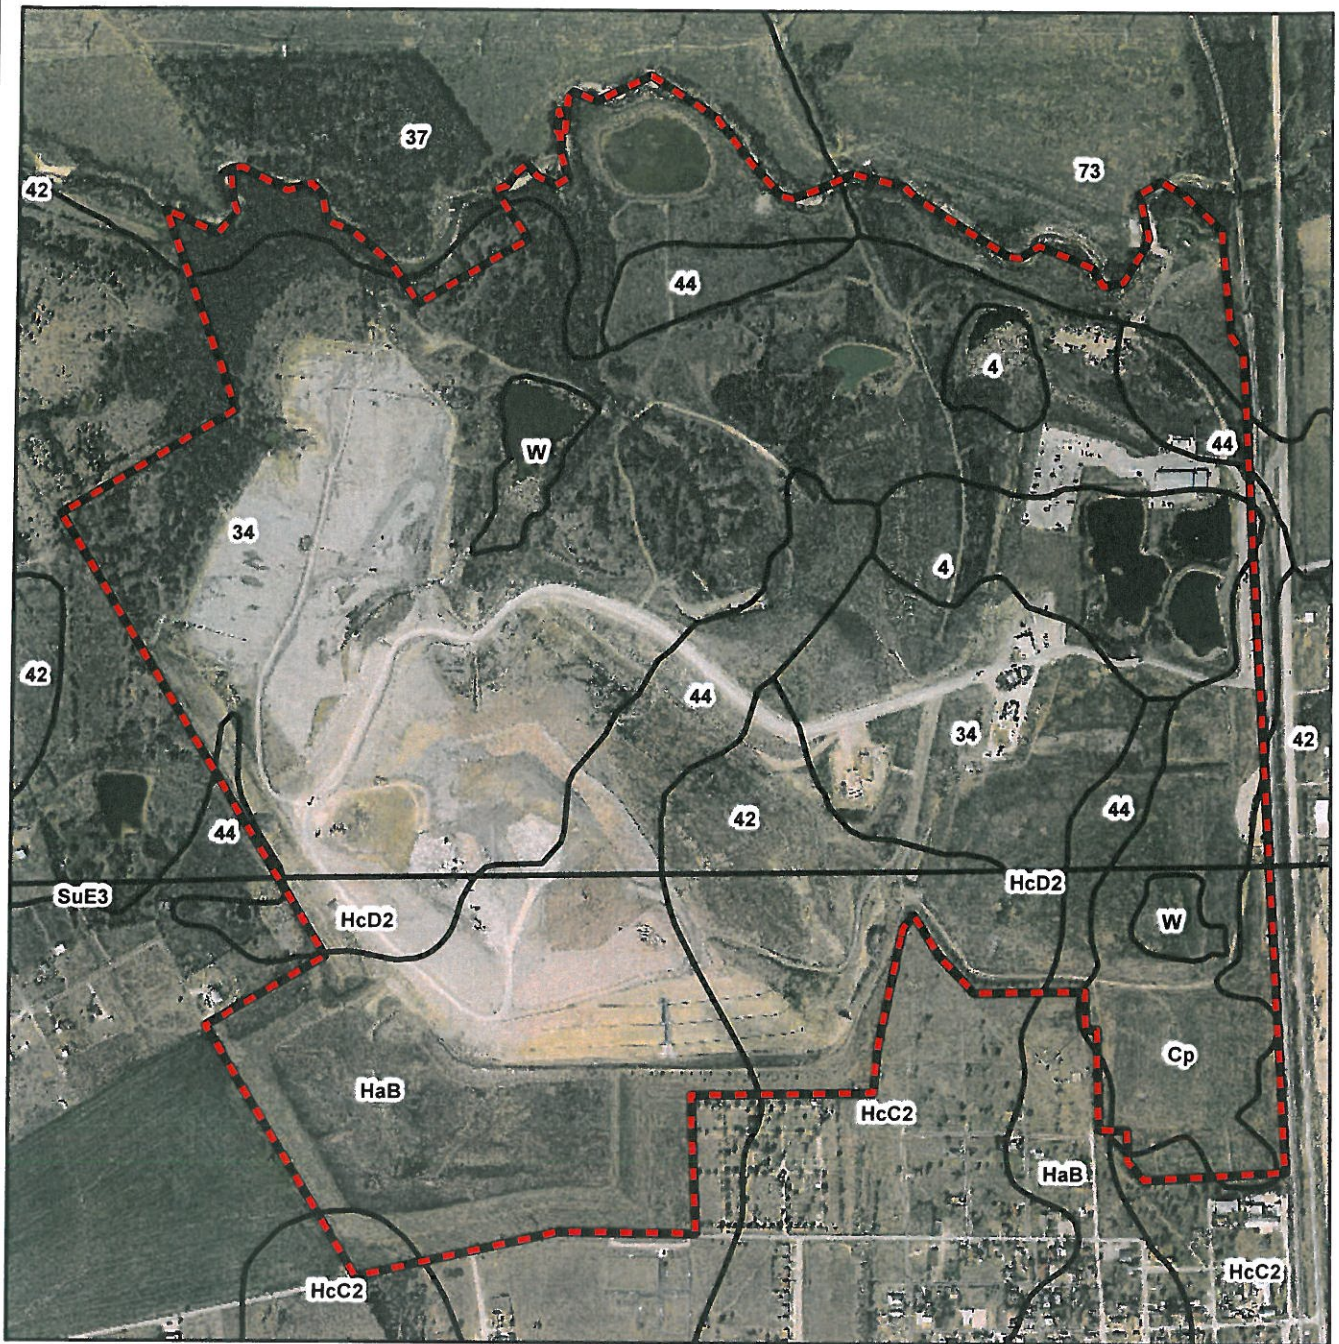
FIGURE 3

- Study Area
- 4 - Arents, clayey, gently undulating
- 34 - Ferris-Heiden complex, 5 to 12 percent slopes
- 37 - Frio silty clay, frequently flooded
- 42 - Heiden clay, 2 to 5 percent slopes, eroded
- 44/HaB - Houston black clay, 1 to 3 percent slopes
- 73 - Trinity clay, frequently flooded

According to the Natural Resource Conservation Service Soil Survey of Dallas and Ellis Counties, the following soils are mapped within the property boundary. A map of the soils is attached as **Figure 3**.

Soil ID	Soil Map Unit	Topography	Drainage Class	Permeability	Available Water Capacity	Runoff
4	Arents, clayey	gently undulating	--	slow	high	medium
34	Ferris-Heiden complex	5-12% slopes	well drained	very slow	high	rapid
37	Frio silty clay	frequently flooded	well drained	moderately slow	high	slow
42	Heiden clay	2-5% slopes, eroded	well drained	very slow	high	rapid
44	Houston Black clay	1-3% slopes	moderately well drained	very slow	high	medium
73	Trinity clay	frequently flooded	somewhat poorly drained	very slow	high	slow
Cp	Clay pits	--	--	--	--	--
HcC2	Houston clay	3-5% slopes	well drained	slow	high	medium
HcD2	Houston clay	5-8% slopes	well drained	slow	high	medium
W	Water	--	--	--	--	--

Three soil map units make up the majority of the study area: Ferris-Heiden complex, Houston Black clay, and Heiden clay.

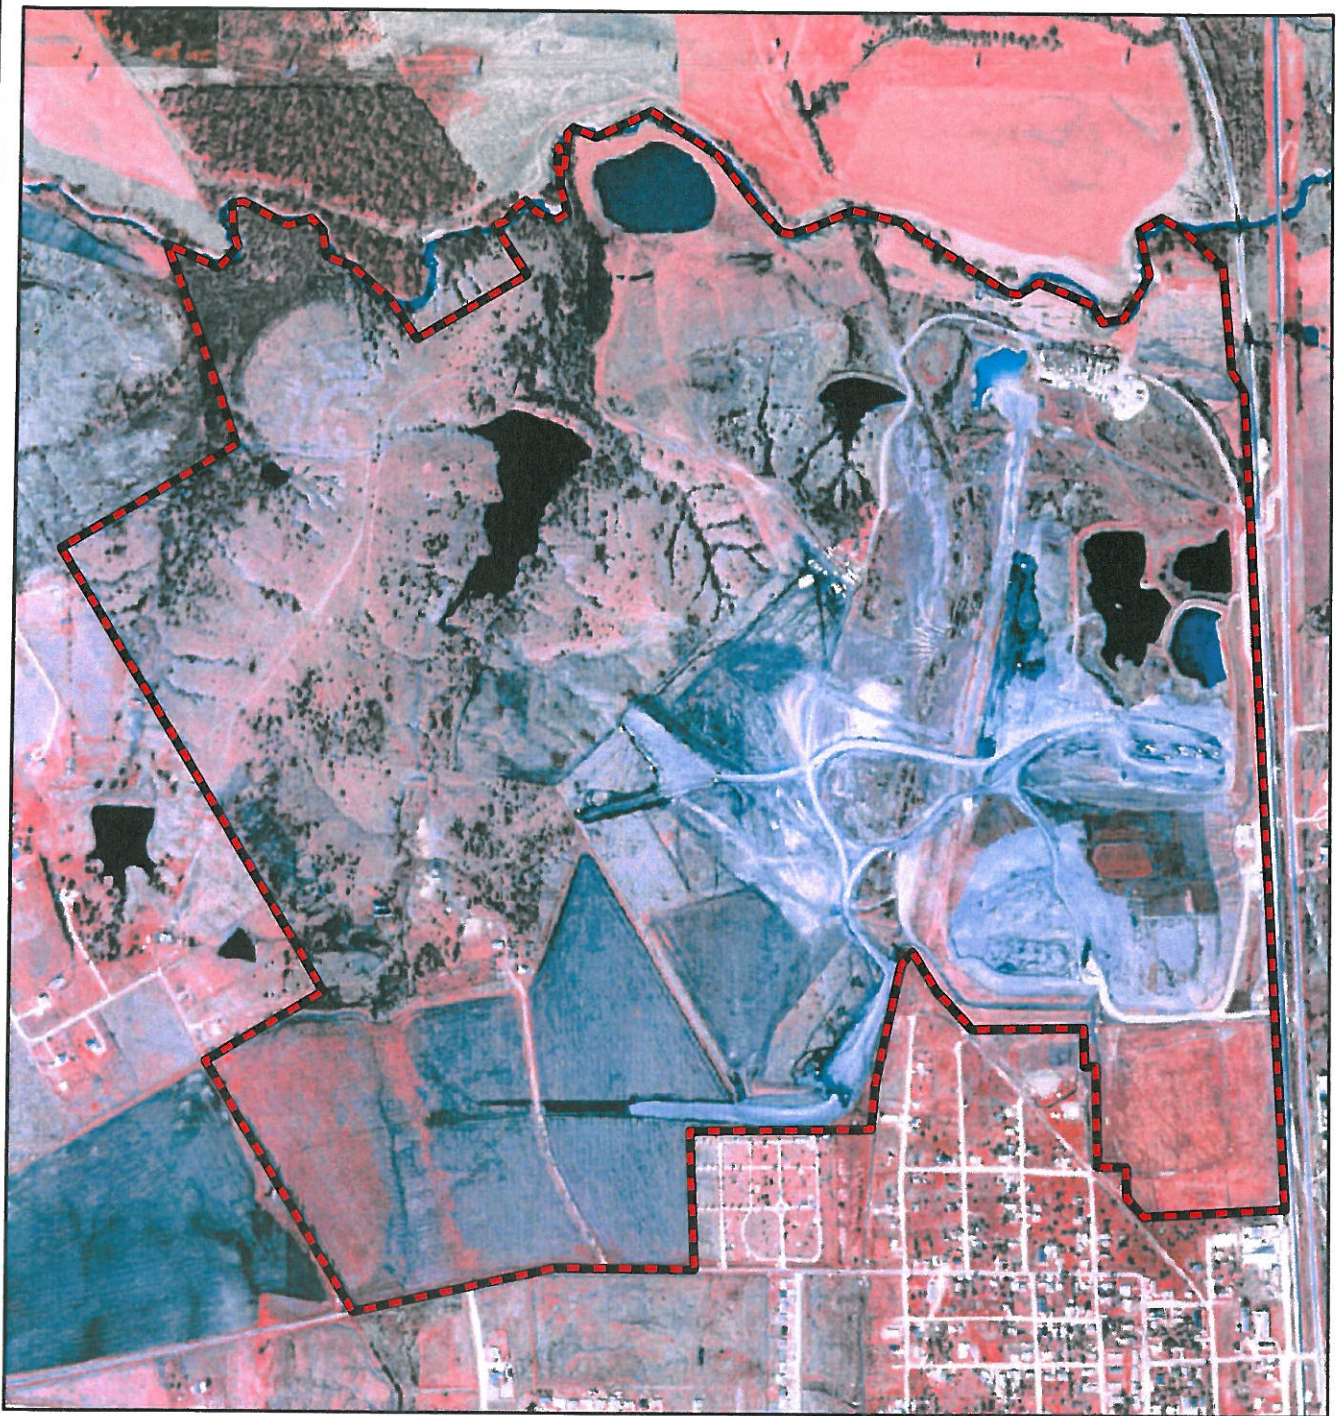
FIGURE 4

As mentioned above, the study area has been utilized as a landfill since 1976. The USGS topographic map (**Figure 4**) shows the eastern portion of the study area as a clay pit. Black and white aerial photography from the NRCS Soil Surveys of Dallas and Ellis County date to 1962 and 1975, respectively, and show the study area as undeveloped.

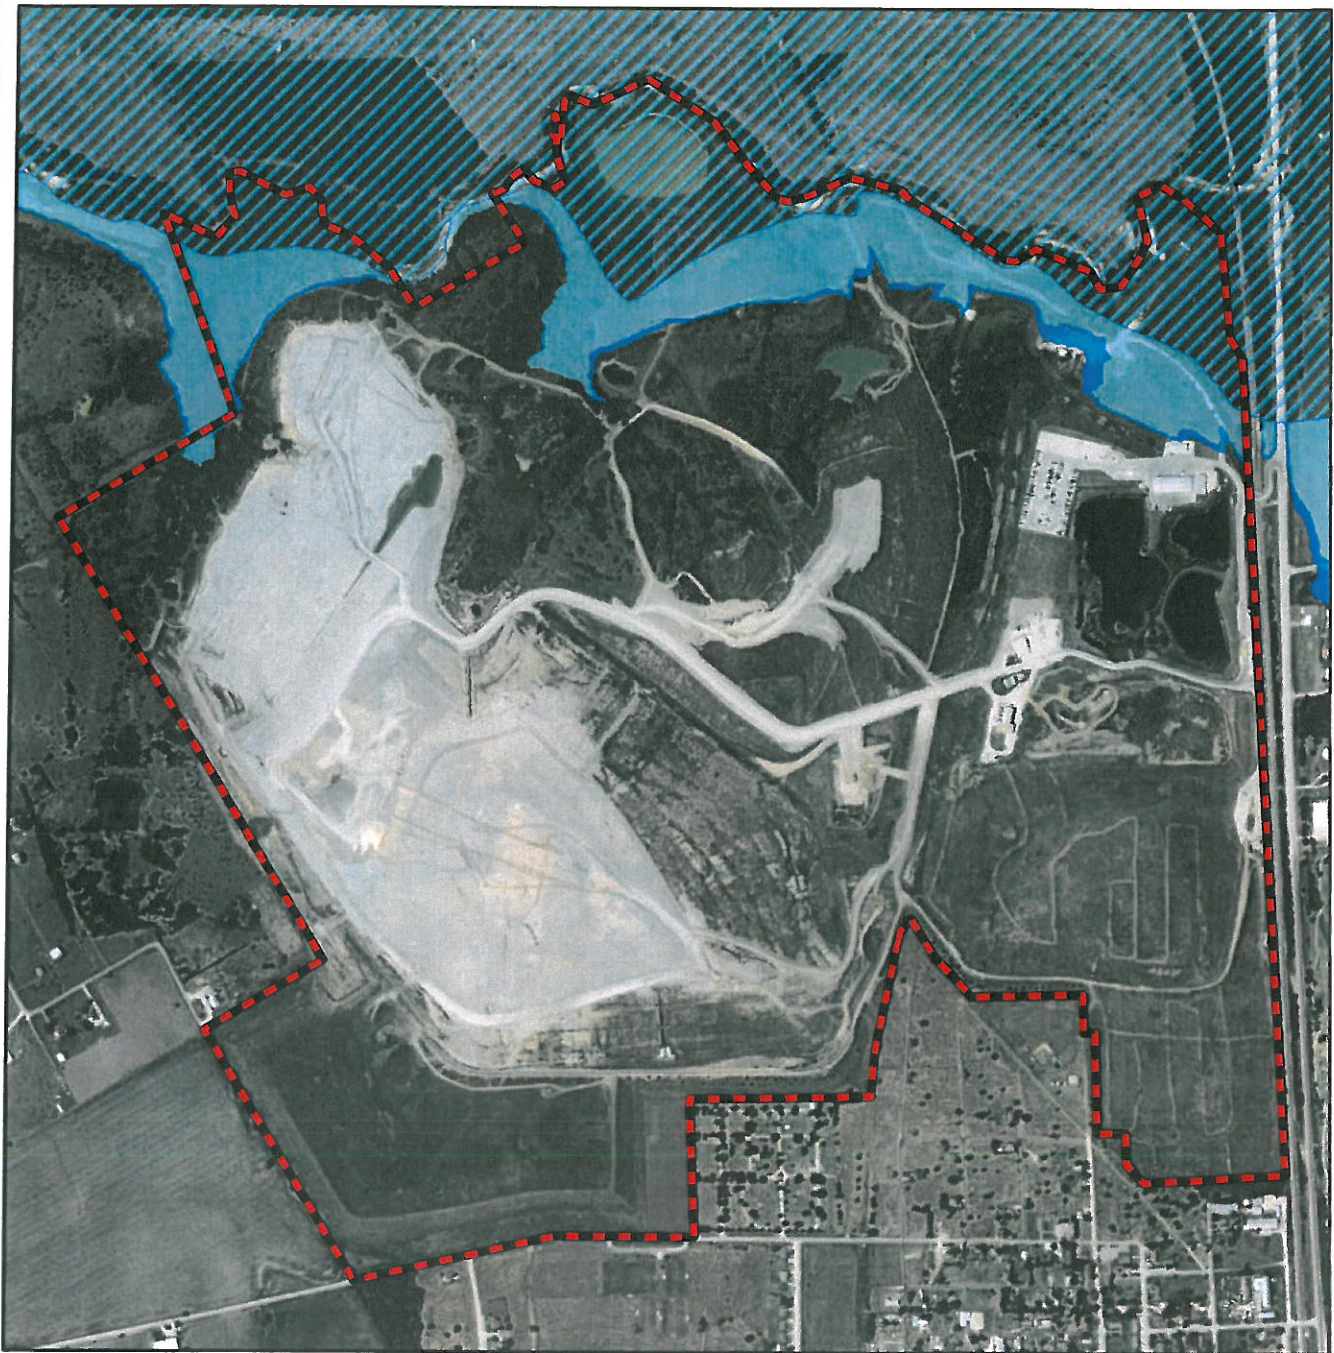
FIGURE 7

Zone AE - 1% Annual Chance Flood Hazard, base elevations determined, floodway
-

Zone AE - 1% Annual Chance Flood Hazard, base elevations not determined
-

Zone X - 0.2% Annual Chance Flood Hazard

According to the Flood Insurance Rate Map (FIRM) published by the National Flood Insurance Program, the portion of the study area along Ten Mile Creek is mapped as floodway. A narrow band parallel to the floodway is mapped as having 1% chance annual flood hazard, and is bordered to the south by a very narrow band mapped as a 0.2% annual chance flood hazard. The remainder of the study area is out of the floodplain in Zone X (areas determined to be outside of the 0.2% annual chance flood) (**Figure 7**).
