**Richmond Sanitary Landfill Site
OS-08-570-13-OS
Monitoring Report No. 24
Part of Lots 1, 2, and 3, Concession IV
Township of Richmond
County of Lennox and Addington**

Project No. 081-12459-00

Re: Richmond Landfill Site
Annual Monitoring Report #24

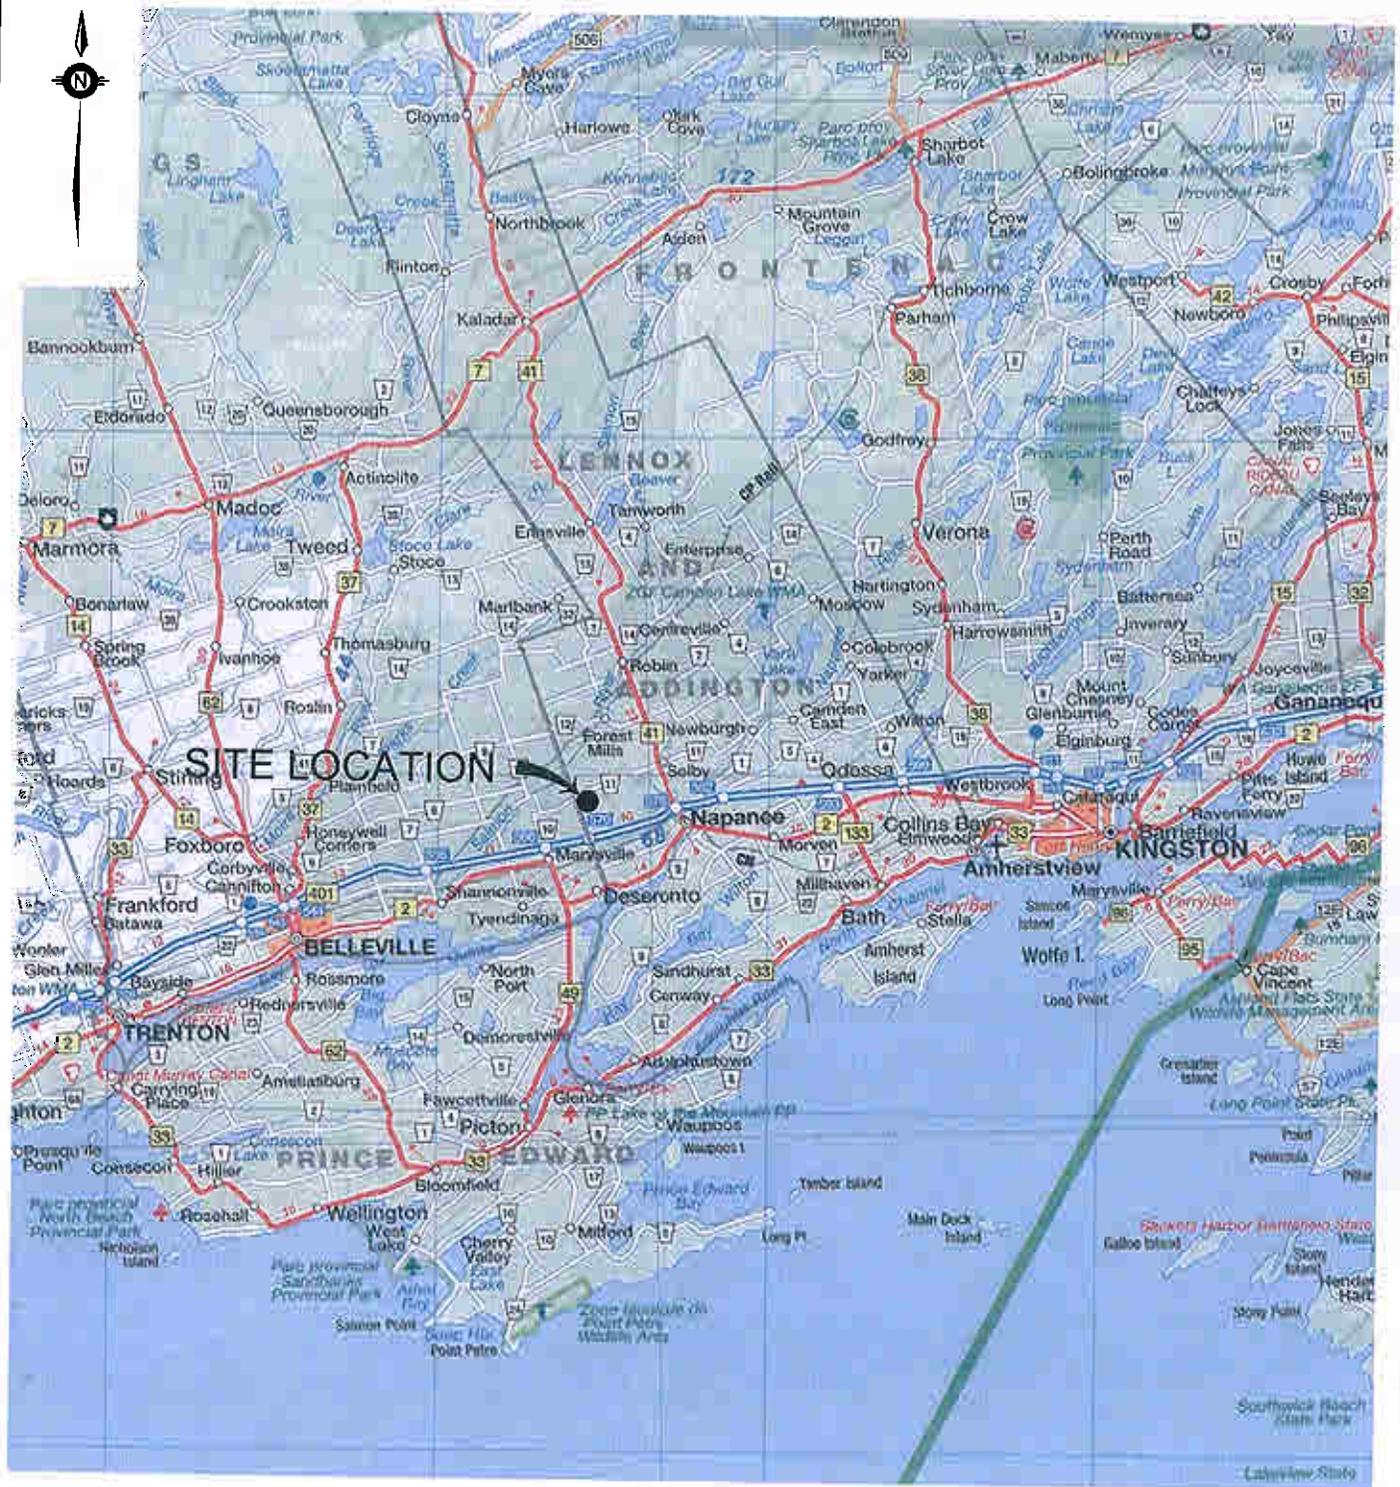
Figure 1.1 Site Location

The site location can be seen in the following **Figure 1.1**.

SHEET 1.1	DWN BY: TCG CHK BY: JCA	DATE: MAR 2004 SCALE: SEE BAK SCALE
	WASTE MANAGEMENT OF CANADA CORP.	
	DRAWING NO. 0857013 - F1.1
