**HAWTHORN PARK LANDFILL  
APPENDIX III-4F  
HISTORICAL GROUNDWATER ANALYTICAL DATA**

**HAWTHORN PARK LANDFILL  
APPENDIX III-4G  
MCBRIDE-RATCLIFF ASSOCIATES, INC. – GEOLOGIC FAULT  
ASSESSMENT**

**HAWTHORN PARK LANDFILL  
APPENDIX III-4H  
PREVIOUS PERMIT DATA**

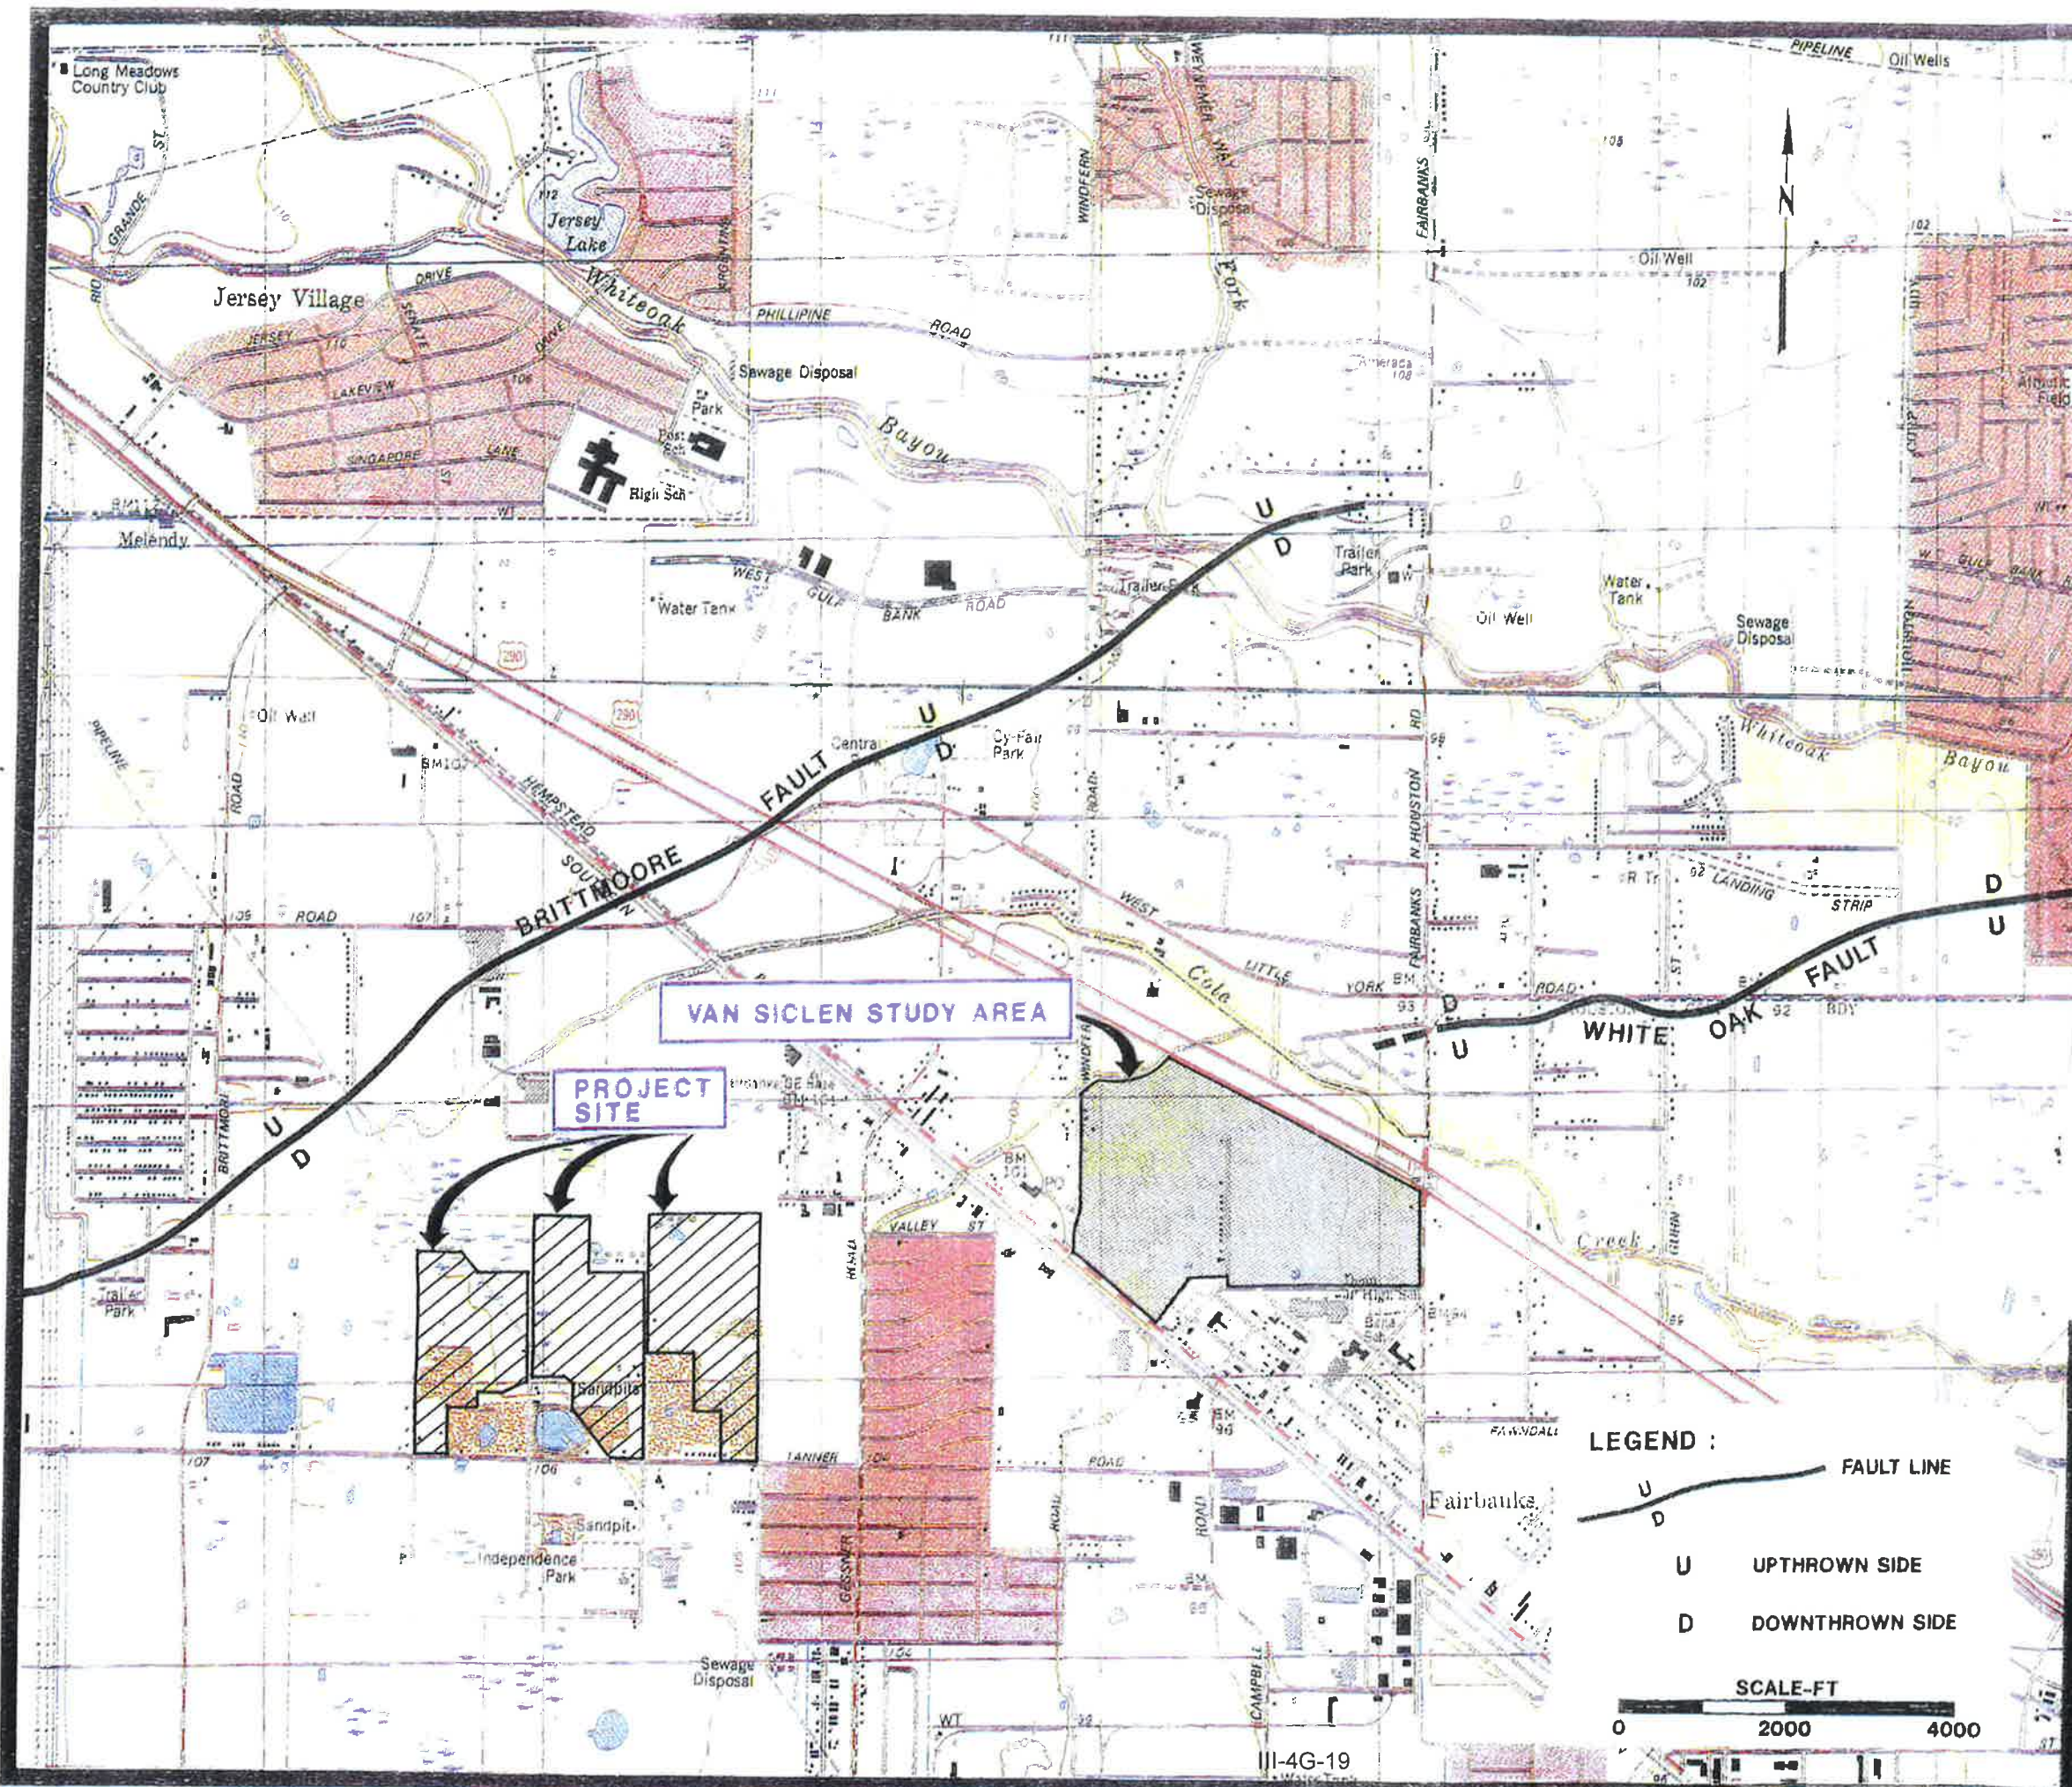
PROJECT NO: 90-0638  
FIGURE D-2

### HEUER FAULT LOCATION MAP 1979

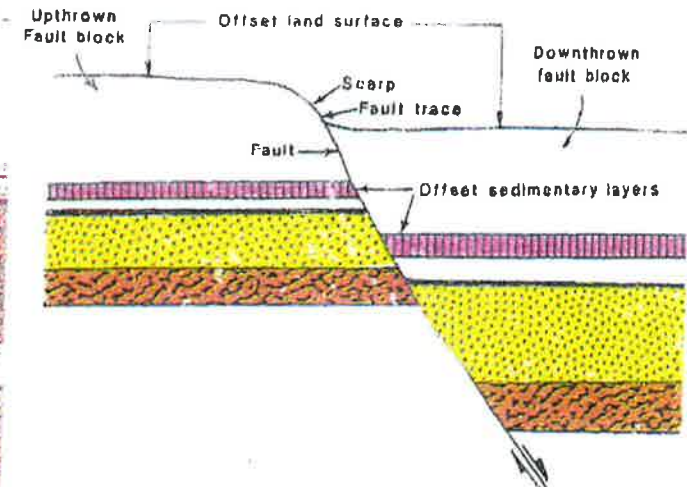
Vertical section through a hypothetical fault in the Houston area. Land surface was originally level, but has since been displaced by movement along the fault. Note thickening of sedimentary layers on the downthrown side. This indicates that faulting occurred repeatedly over a long period of time, while the sediments were being deposited. Such faults are common in the Texas Gulf Coast.

According to E.R. Verbeek, K.W. Ratzlaff and U.S. Clanton, rigid structures such as highways, runways, and building foundations, where built astride active faults, commonly display the consequences of differential vertical movement and horizontal extension. Breakage occurs as the sinking ground surface on the downthrown side no longer supports the structural load. Maximum damage normally occurs on and immediately adjacent to the fault scarp, within a zone that is typically 2-3 m wide, but which may vary in width from less than 1 m to more than 10 m. To either side of this zone, some limited fault-related failure may be seen in brittle material, but the most visible effect of fault movement here is tilting. The amount of tilt progressively decreases away from the fault scarp and is, for most faults, minor at distances of 20-30 m from the scarp. Surveying data, however, suggest that detectable amounts of tilt may be found as much as 70 m away from some faults.

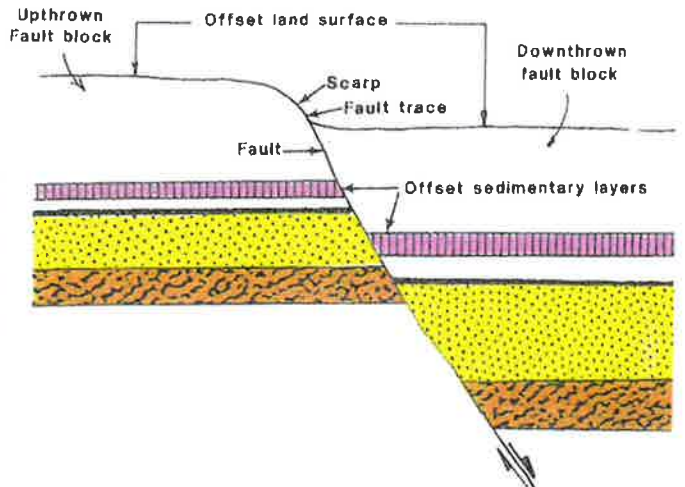
Vertical section through a hypothetical fault in the Houston area. Land surface was originally level, but has since been displaced by movement along the fault. Note thickening of sedimentary layers on the downthrown side. This indicates that faulting occurred repeatedly over a long period of time, while the sediments were being deposited. Such faults are common in the Texas Gulf Coast.

According to E.R. Verbeek, K.W. Ratzlaff and U.S. Clanton, rigid structures such as highways, runways, and building foundations, where built astride active faults, commonly display the consequences of differential vertical movement and horizontal extension. Breakage occurs as the sinking ground surface on the downthrown side no longer supports the structural load. Maximum damage normally occurs on and immediately adjacent to the fault scarp, within a zone that is typically 2-3 m wide, but which may vary in width from less than 1 m to more than 10 m. To either side of this zone, some limited fault-related failure may be seen in brittle material, but the most visible effect of fault movement here is tilting. The amount of tilt progressively decreases away from the fault scarp and is, for most faults, minor at distances of 20-30 m from the scarp. Surveying data, however, suggest that detectable amounts of tilt may be found as much as 70 m away from some faults.

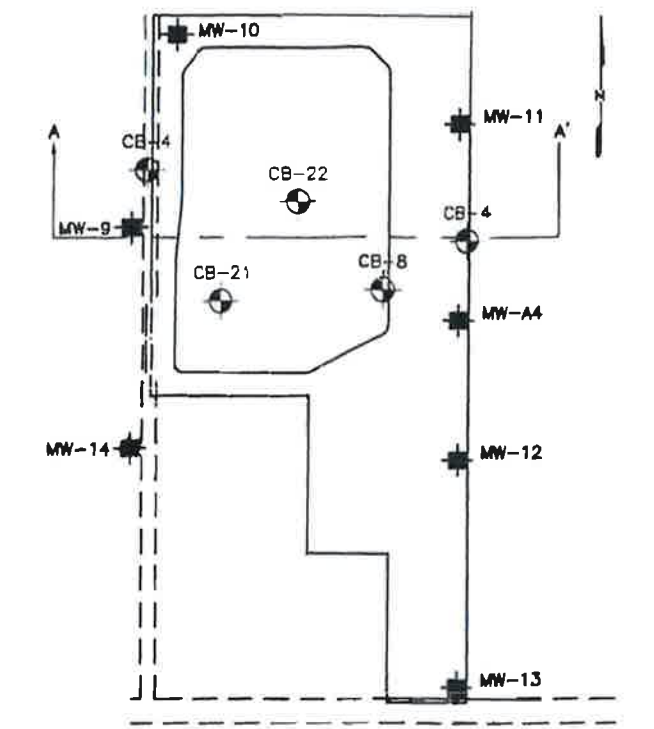
# CROSS-SECTION A-A'

1. SOIL BORINGS ARE PROJECTED TO CROSS-SECTION. ACTUAL BORING LOCATIONS ARE SHOWN ON INSET MAP AND ATTACHMENT 11-A. ACTUAL BORING LOGS ARE ALSO IN ATTACHMENT 11.
2. SUBSOIL PROFILE INTERPOLATED BETWEEN BORINGS. ACTUAL CONDITIONS MAY VARY FROM THOSE ILLUSTRATED.
3. VERTICAL EXAGGERATION FACTOR = 10
4. NOT FOR CONSTRUCTION. FOR PERMITTING USE ONLY.
5. CROSS-SECTION LOCATION ALSO SHOWN ON ATTACHMENT 6-A1.
6. MONITORING WELL DETAILS ARE SHOWN ON ATTACHMENT 7-C1 AND 7-C2.
7. METHANE PROBES AND VENTS ARE SHOWN ON ATTACHMENT 9-A1, 9-B, AND 9-C.

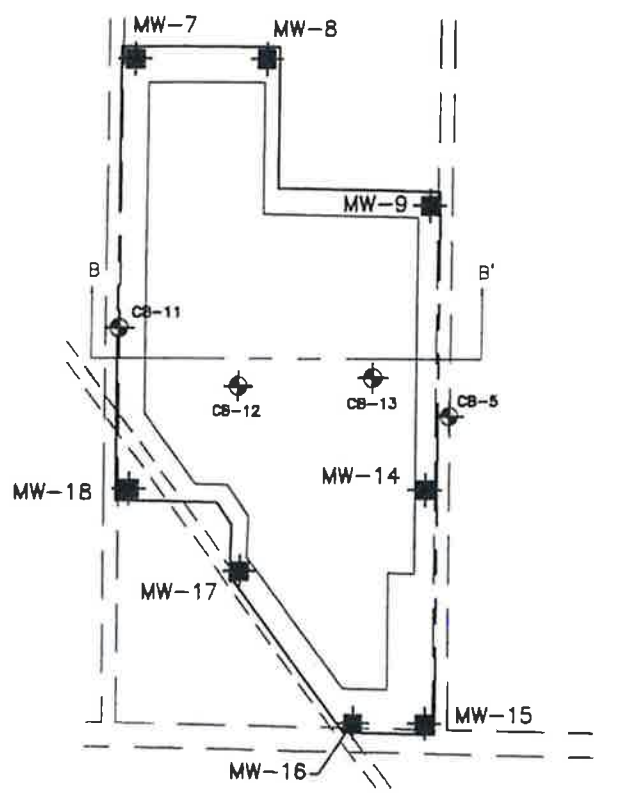
# CROSS-SECTION B-B'

- NOTES:**
- SOIL BORINGS ARE PROJECTED TO CROSS-SECTION. ACTUAL BORING LOCATIONS ARE SHOWN ON INSERT MAP AND ATTACHMENT 11-A. ACTUAL BORING LOGS ARE ALSO LOCATED IN ATTACHMENT 11.
  - SUBSOIL PROFILE INTERPOLATED BETWEEN BORINGS. ACTUAL CONDITIONS MAY VARY FROM THOSE ILLUSTRATED.
  - VERTICAL EXAGGERATION = 10
  - NOT FOR CONSTRUCTION. FOR PERMITTING USE ONLY.
  - CROSS-SECTION LOCATION ALSO SHOWN ON ATTACHMENT 6-A2.
  - MONITORING WELL DETAILS ARE SHOWN ON ATTACHMENT 7-C1 AND 7-C2.
  - METHANE PROBES AND VENTS ARE SHOWN ON ATTACHMENT 9-A2, 9-B, AND 9-C.

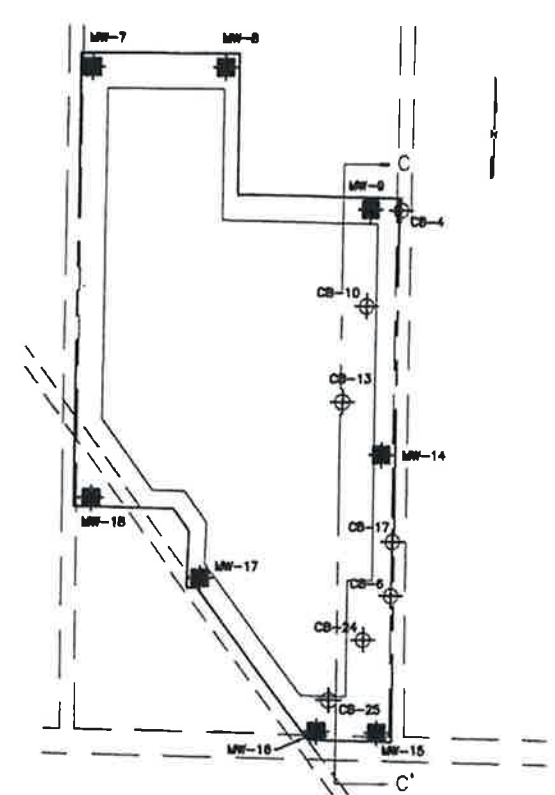
# CROSS-SECTION C-C'

1. SOIL BORINGS ARE PROJECTED TO CROSS-SECTION. ACTUAL BORING LOCATIONS ARE SHOWN ON ATTACHMENT 11-A.
2. SUBSOIL PROFILE INTERPOLATED BETWEEN BORINGS. ACTUAL CONDITIONS MAY VARY FROM THOSE ILLUSTRATED.
3. VERTICAL EXAGGERATION = 10
4. NOT FOR CONSTRUCTION. FOR PERMITTING USE ONLY.

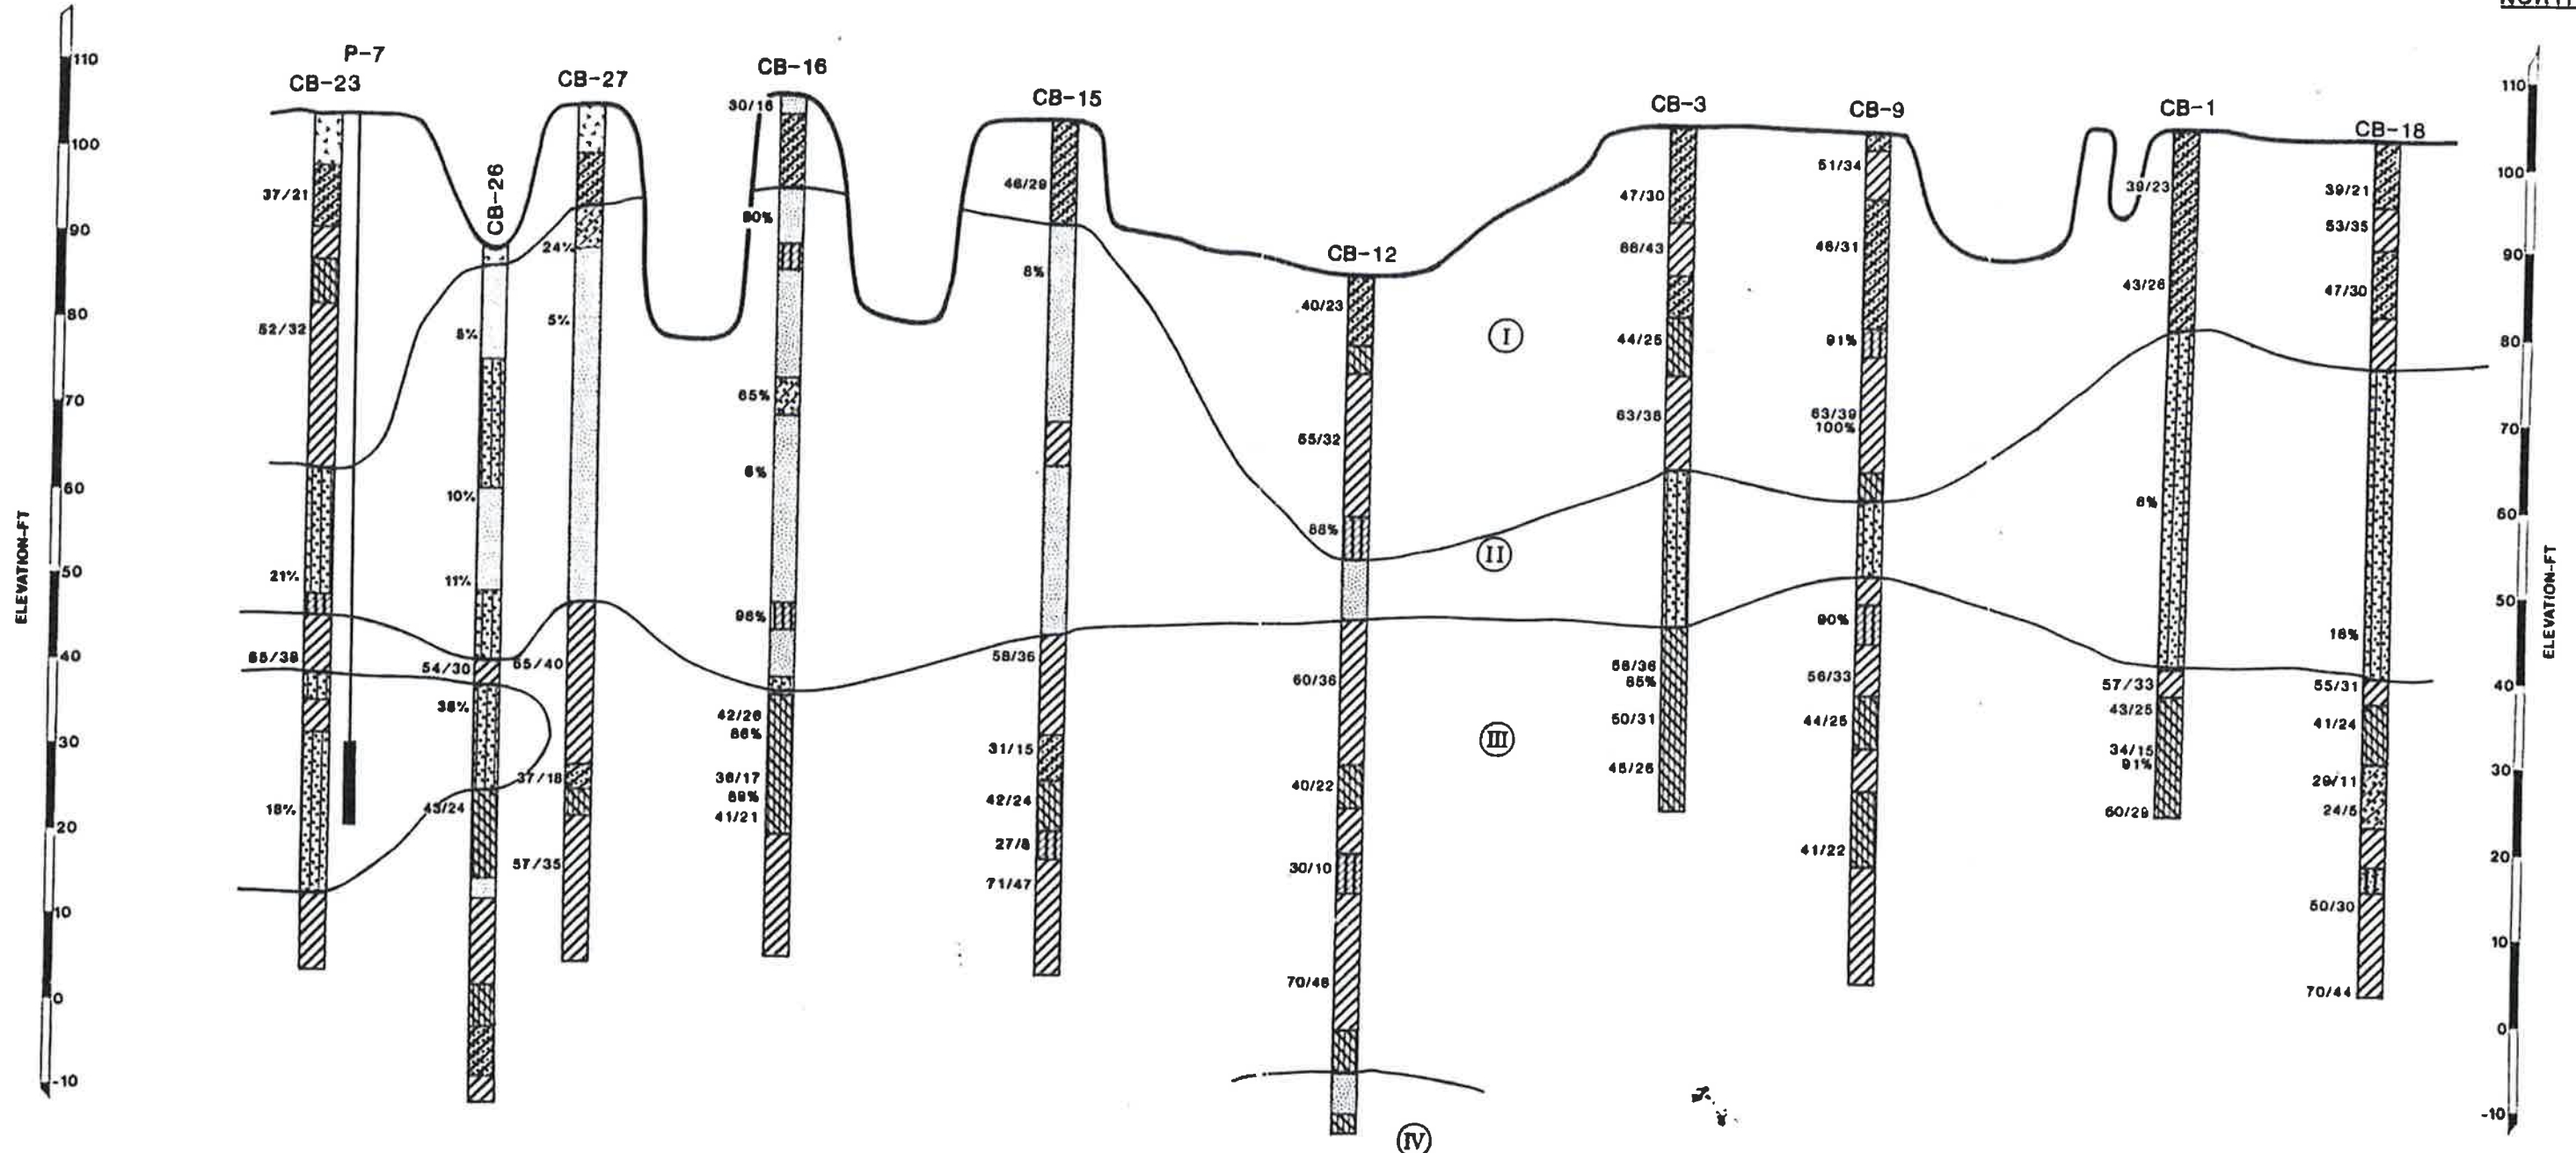
SCALE NOTED	PAGE CHECK	KD/LLD JRL	DATE 5-4-93	DATE 5-4-93	FILE NO 90-0638
SOIL PROFILE B-B'					PLUM 11-G

NOTE - SUBSOIL PROFILE INTERPOLATED BETWEEN BORINGS. ACTUAL CONDITIONS MAY VARY FROM THOSE ILLUSTRATED.

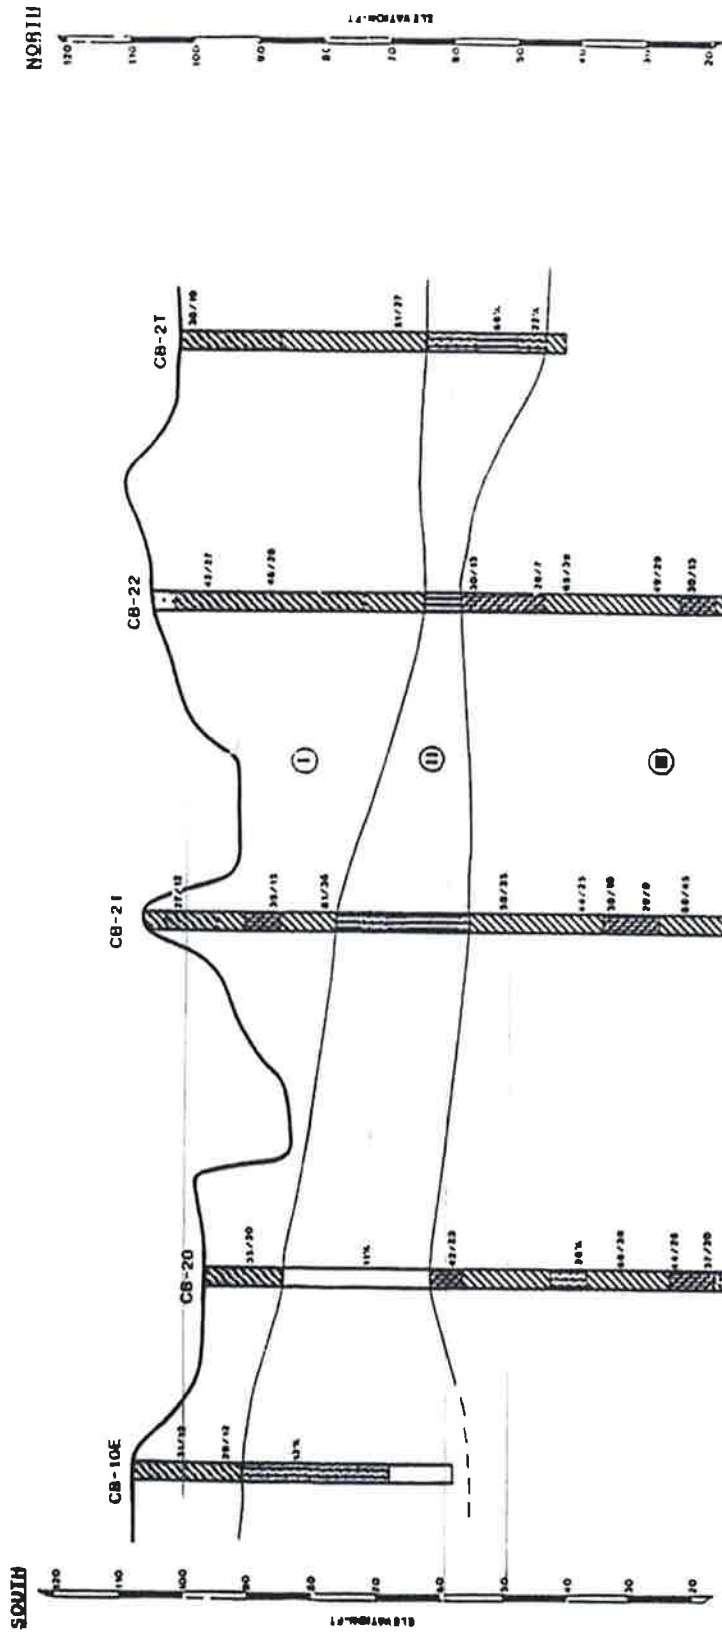
SECTION D-D

- I   Medium-Hard CLAY (CH) SANDY CLAY (CL) & SILTY CLAY (CL)
- II   Firm-Very Dense FINE SAND (SP), SILTY FINE SAND (SM), CLAYEY SAND (SC) SANDY SILT (ML) & CLAYEY SILT (ML)
- III   Stiff-Hard CLAY (CH) SANDY CLAY (CL) & SILTY CLAY (CL)
- IV   FINE SAND (SP) & SILTY FINE SAND (SM)
-   PROPOSED WASTE AREAS

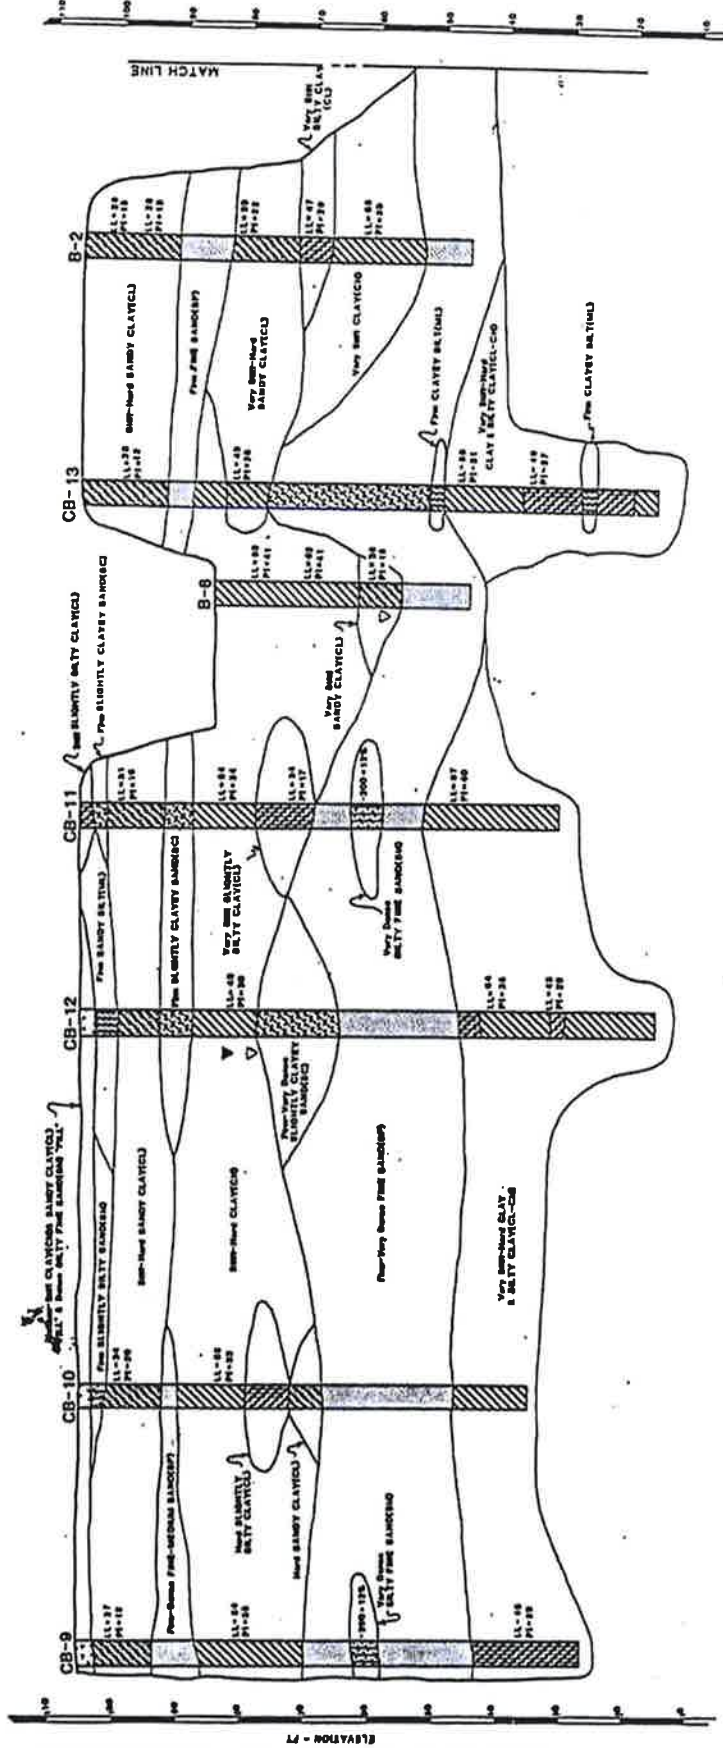
SECTION A-A

NOTE - BORING PROFILE INTERPOLATED BETWEEN BORINGS. ACTUAL CONDITIONS MAY VARY FROM THOSE ILLUSTRATED.

- ▽ OBSERVED STATIC GROUNDWATER LEVEL
- △ FREE WATER ENCOUNTERED

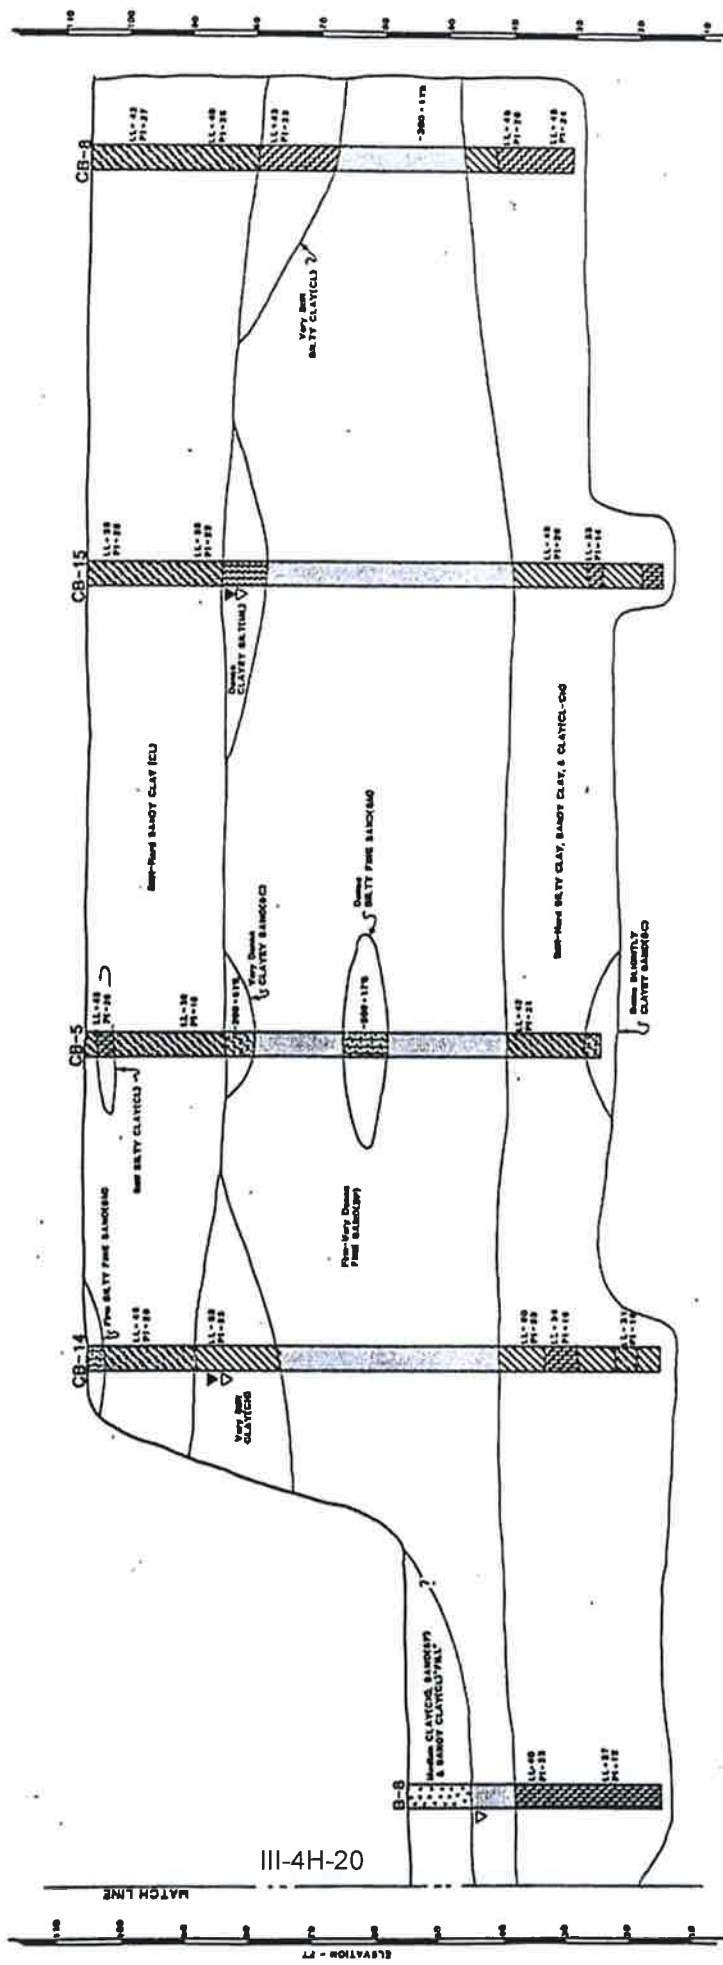
SECTION A-A

NOTE - SUBSOIL PROFILE INTERPOLATED BETWEEN BORINGS - ACTUAL CONDITIONS MAY VARY FROM THOSE ILLUSTRATED.

▽ OBSERVED STATIC GROUNDWATER LEVEL  
▽ FREE WATER ENCOUNTERED

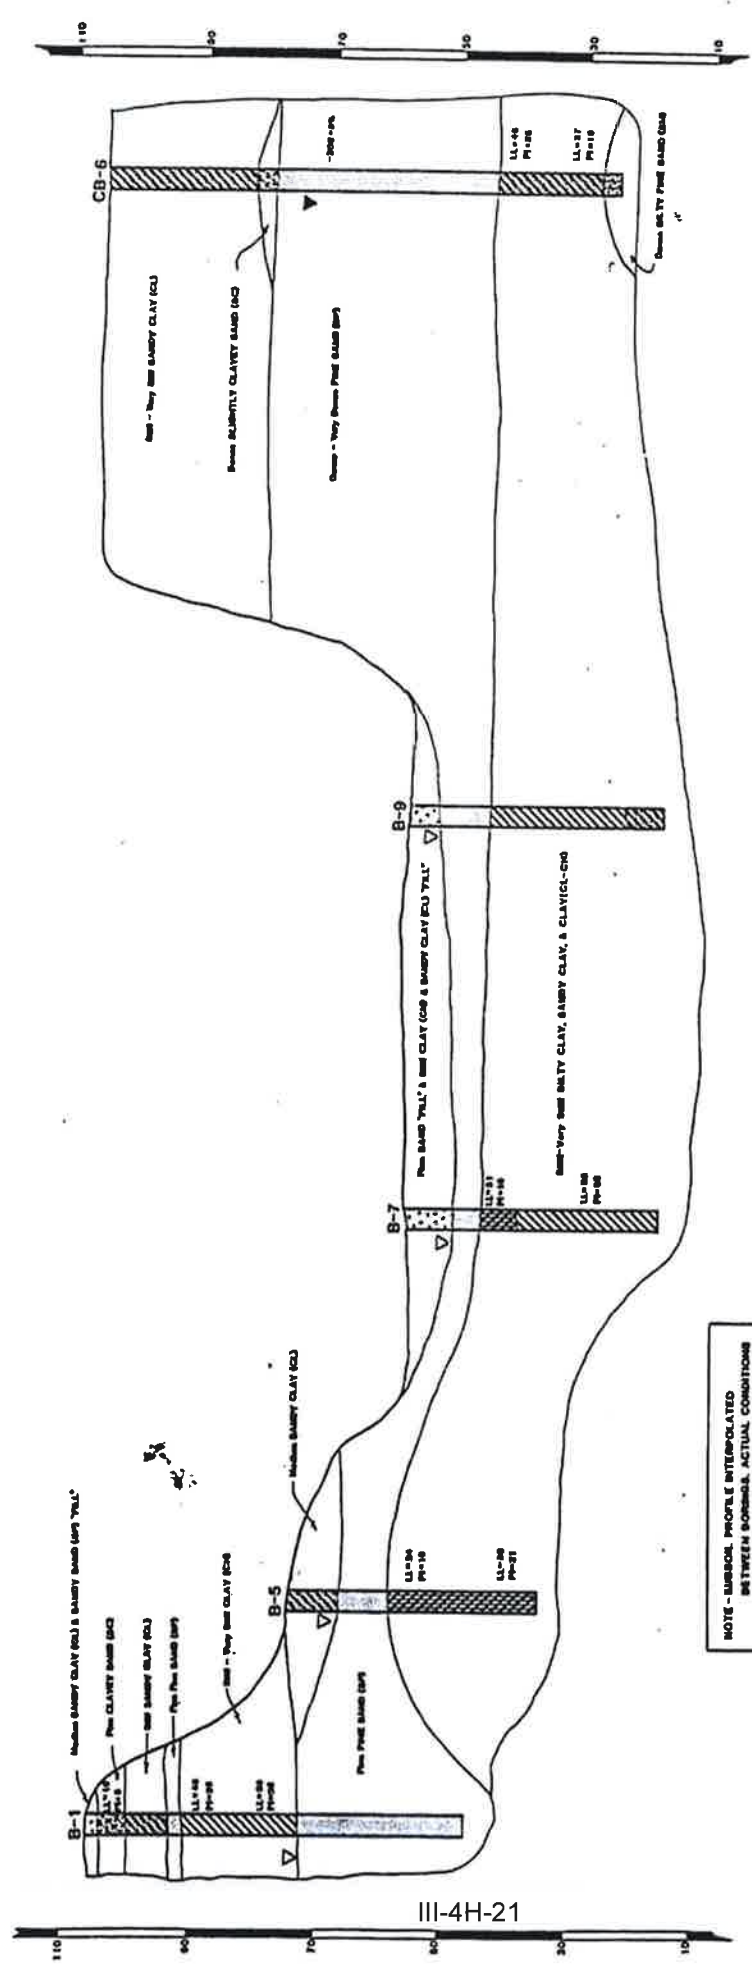
III-4H-21

NOTE - BORING PROFILE INTERPOLATED  
BETWEEN BORINGS. ACTUAL CONDITIONS  
MAY VARY FROM THOSE ILLUSTRATED.

▽ OBSERVED STATIC GROUNDWATER LEVEL  
△ FREE WATER ENCOUNTERED

DATE NOTED DATE OF FIELD WORK DATE OF REPORT	DRAWN BY CHECKED BY DATE	PROJECT NO. SHEET NO.
CRAWFORD STREET TYPE IV LANDFILL HARRIS COUNTY, TEXAS		WESTERN CONTRACTORS SERVICES, INC. HOUSTON, TEXAS		SOIL PROFILE 3

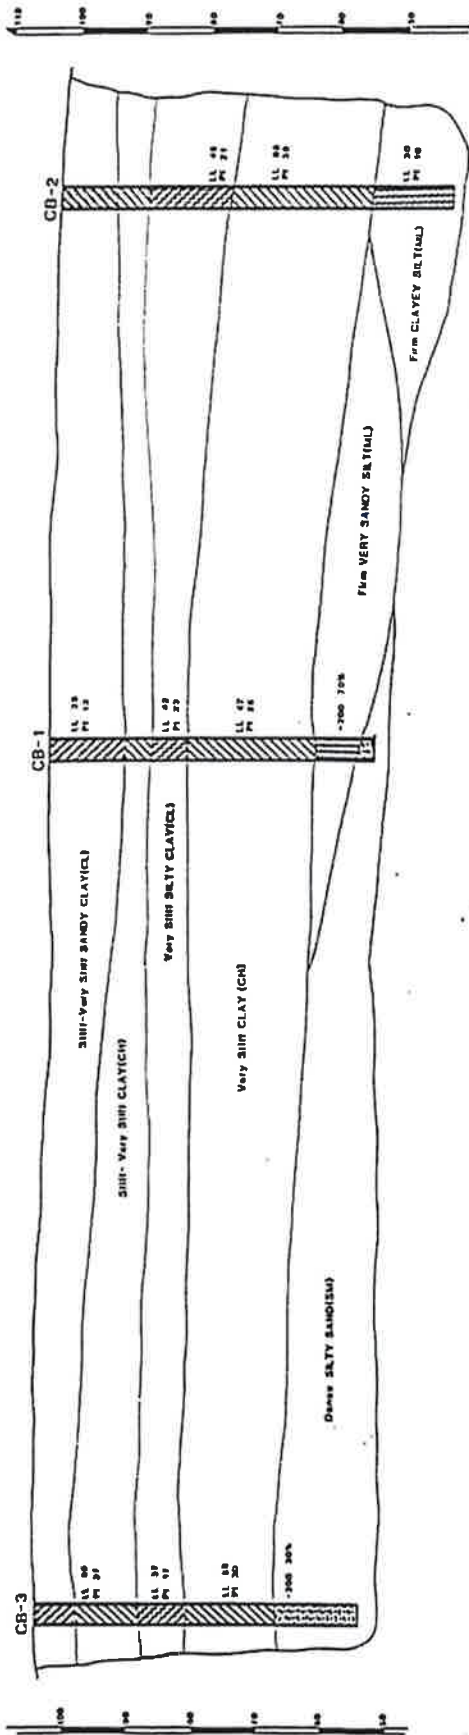
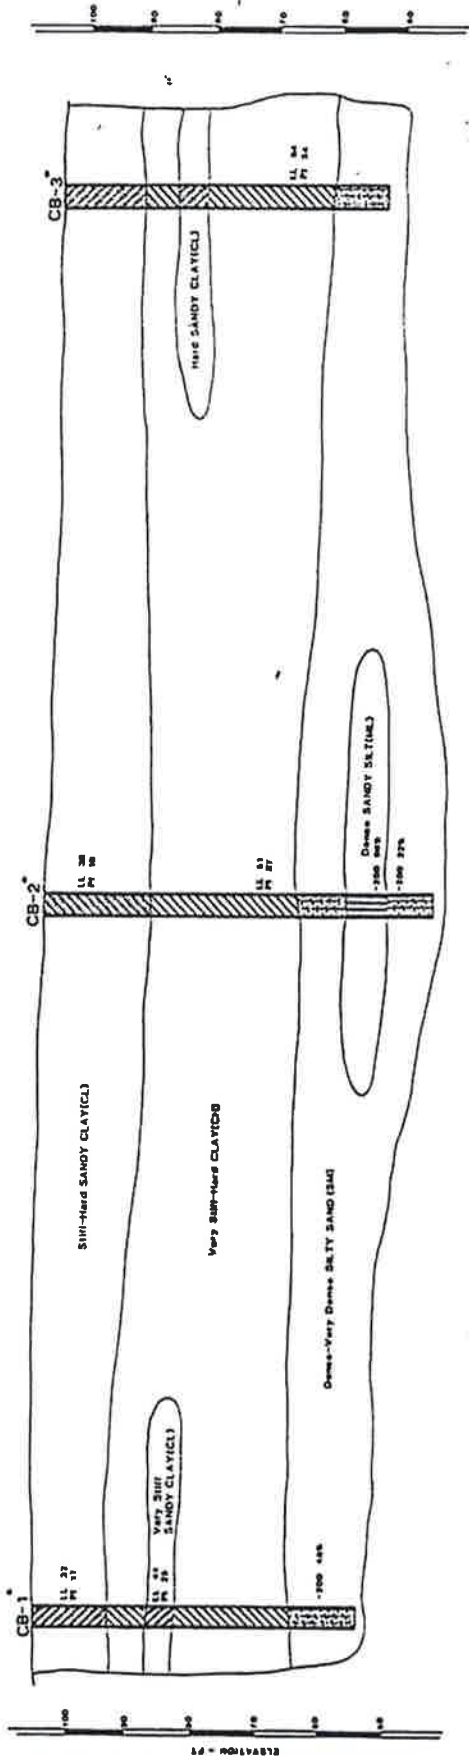
BORINGS DRILLED FOR ORIGINAL SOILS REPORT FOR PERMIT APPLICATION NO. 144B

McBride Ratcliff and Associates, Inc.  
 Geotechnical Engineers  
 14000 Katy Road  
 Houston, Texas 77060  
 SOIL STRATIGRAPHY -  
 NORTHERN EXTENSION  
 DATE: 3-17-82  
 DRAWN BY: J. B. BROWN  
 CHECKED BY: J. B. BROWN  
 SCALE: AS SHOWN  
 SHEET NO. 3

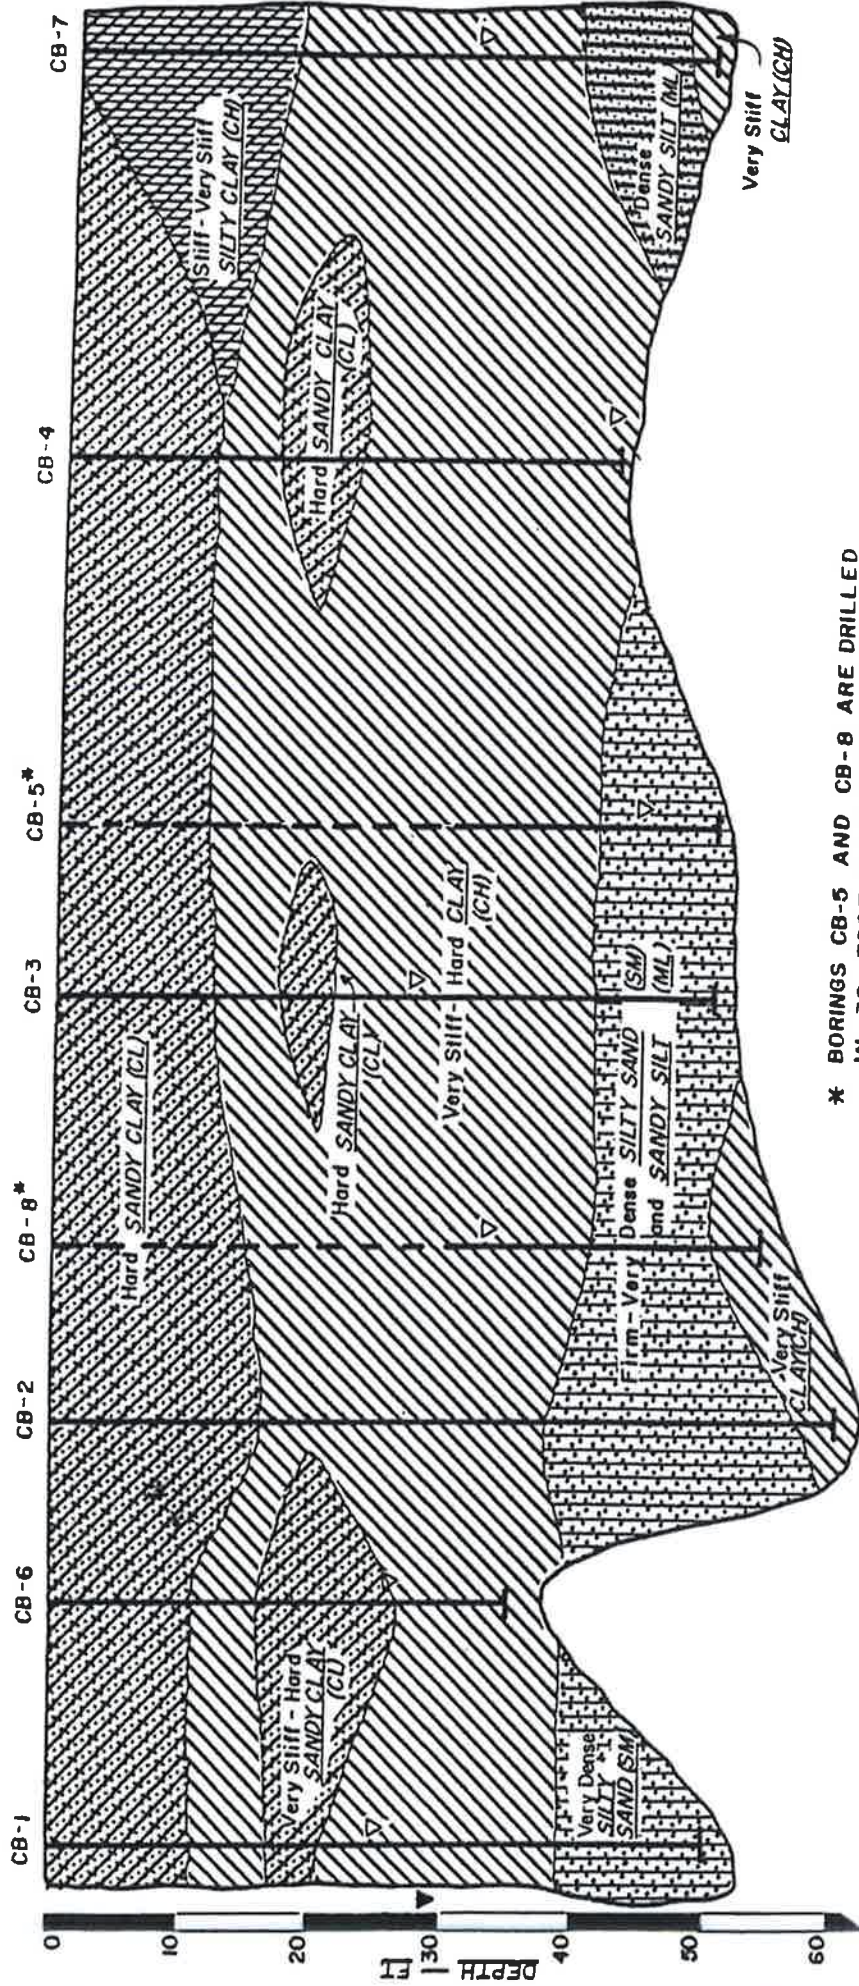
\* BORINGS CB-5 AND CB-8 ARE DRILLED IN 30-FOOT DEEP EXCAVATION.

▼ STATIC GROUNDWATER LEVEL

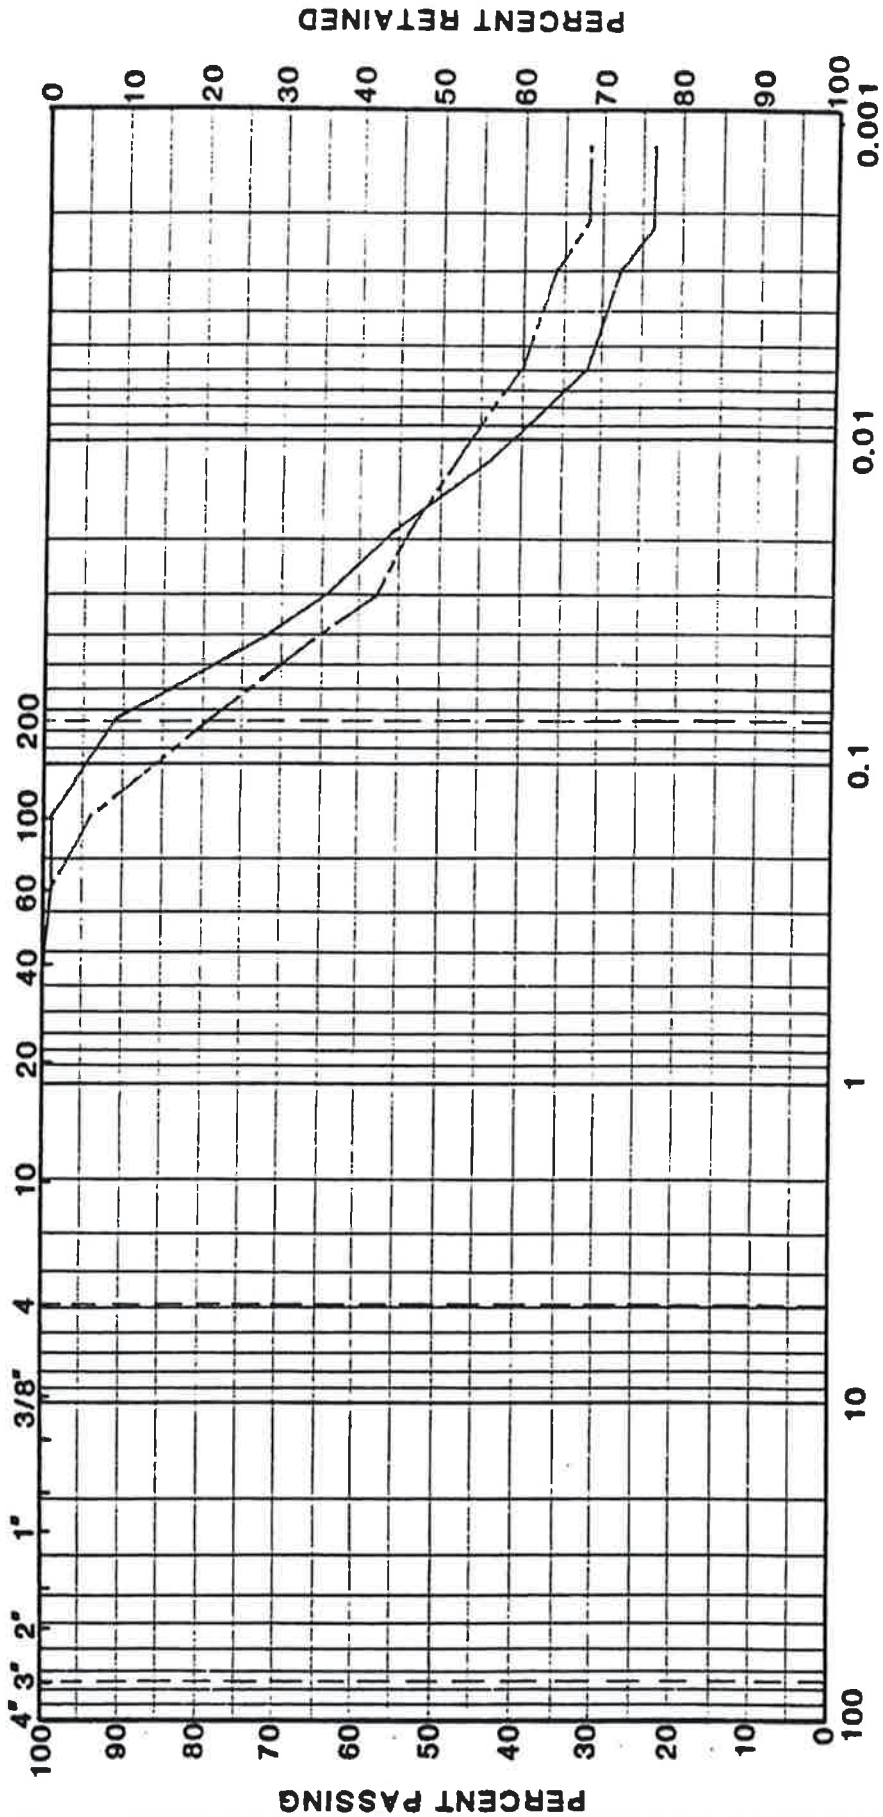
BORING NO.	DEPTH(FT)	CLASSIFICATION	SYMBOL
CB-1	73-75	CL	---
CB-2	2-4	CL	---

GRAIN SIZE DISTRIBUTION  
(UNIFIED SOIL CLASSIFICATION)

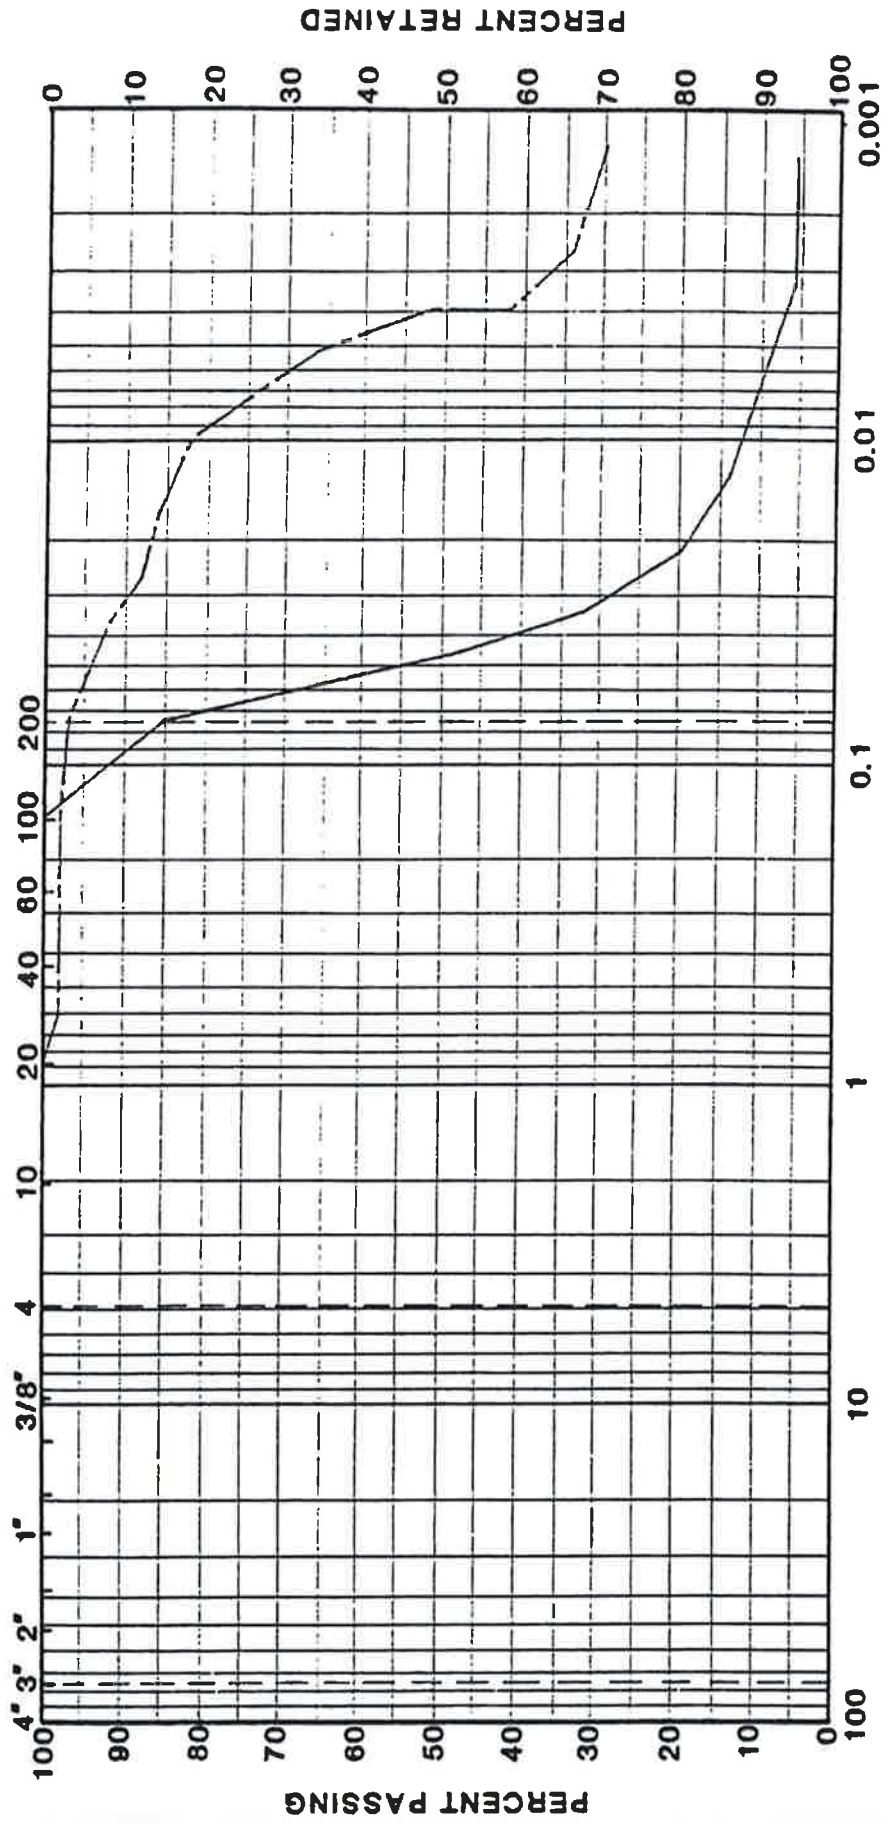
**GRAIN SIZE DISTRIBUTION**  
(UNIFIED SOIL CLASSIFICATION)

BORING NO.	DEPTH(FT)	CLASSIFICATION	SYMBOL
CB-3	63-65	CL	———
CB-4	38-40	CH	- - - -
