**HAWTHORN PARK LANDFILL  
APPENDIX III-4F  
HISTORICAL GROUNDWATER ANALYTICAL DATA**

**HAWTHORN PARK LANDFILL  
APPENDIX III-4G  
MCBRIDE-RATCLIFF ASSOCIATES, INC. – GEOLOGIC FAULT  
ASSESSMENT**

**HAWTHORN PARK LANDFILL  
APPENDIX III-4H  
PREVIOUS PERMIT DATA**

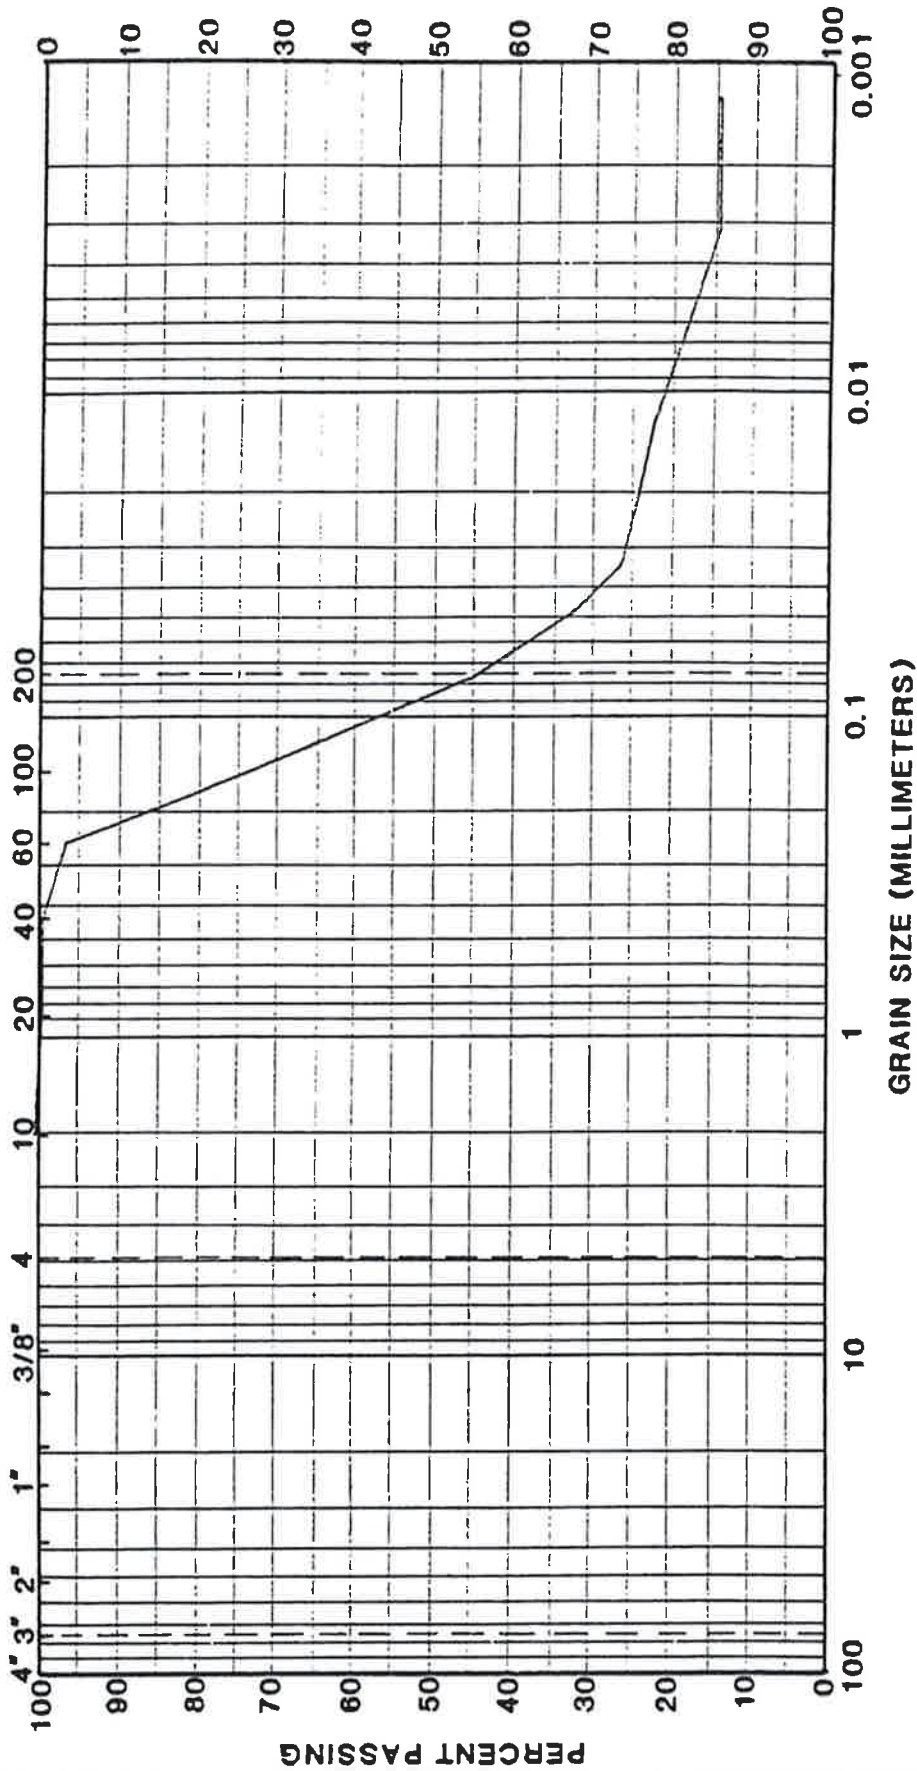
BORING NO.	DEPTH(FT)	CLASSIFICATION	SYMBOL
CB-5	6-8	SC	_____

**GRAIN SIZE DISTRIBUTION**  
(UNIFIED SOIL CLASSIFICATION)

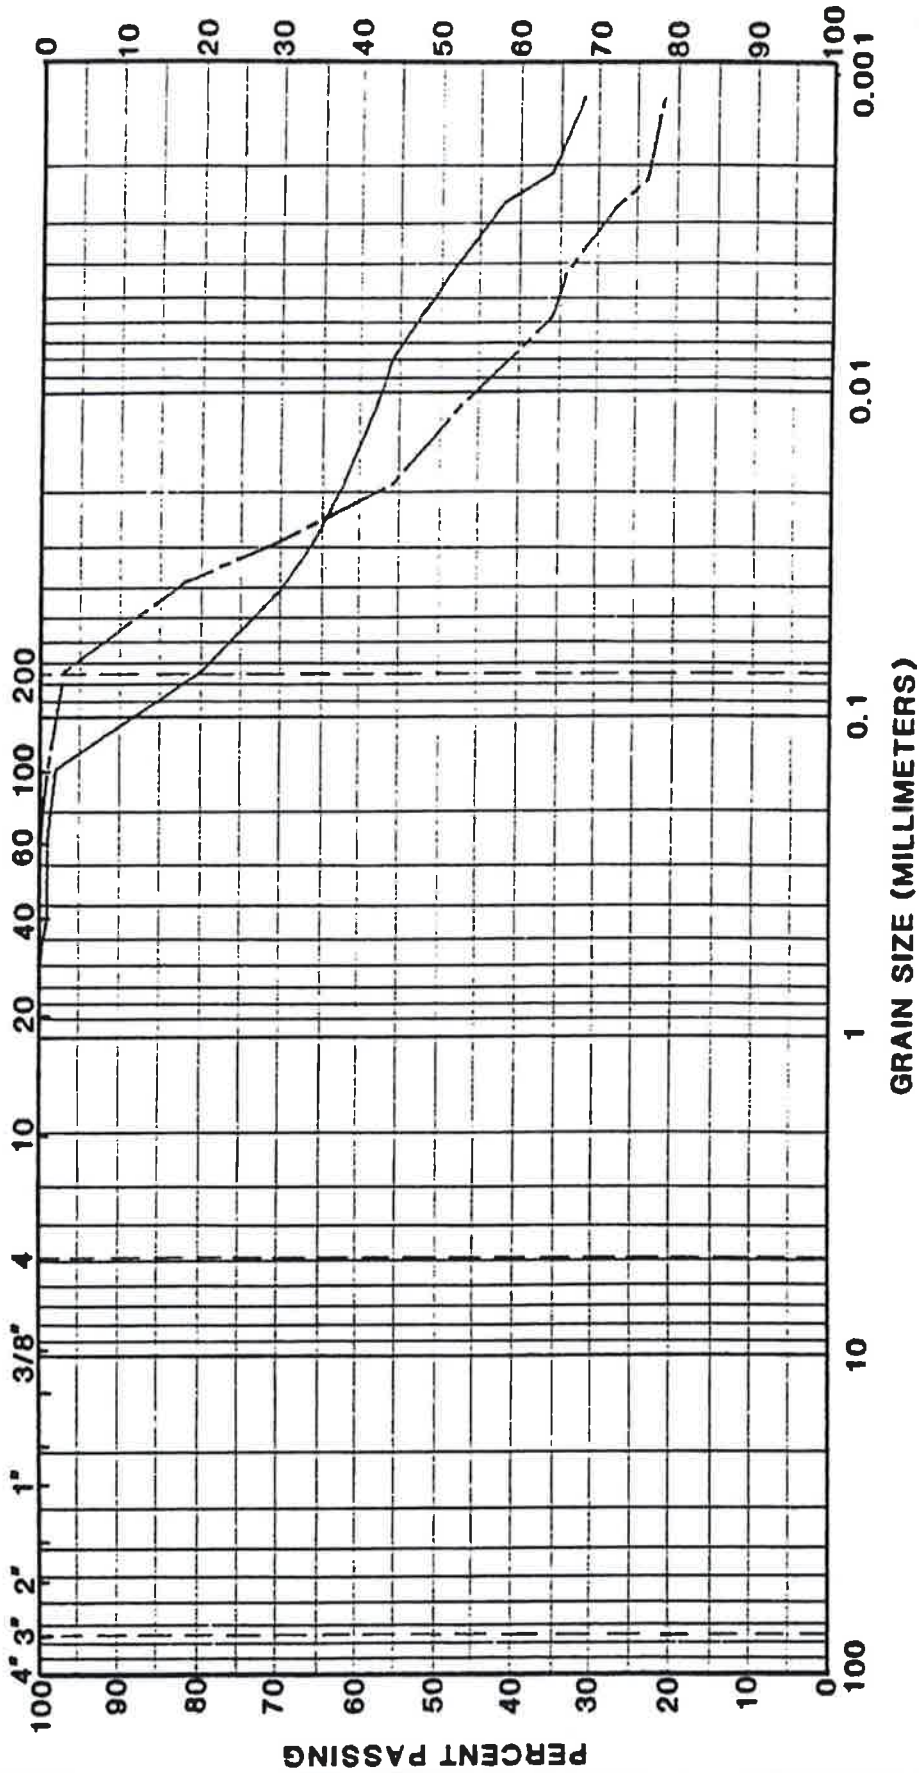
III-4H-33

**GRAIN SIZE DISTRIBUTION**  
(UNIFIED SOIL CLASSIFICATION)

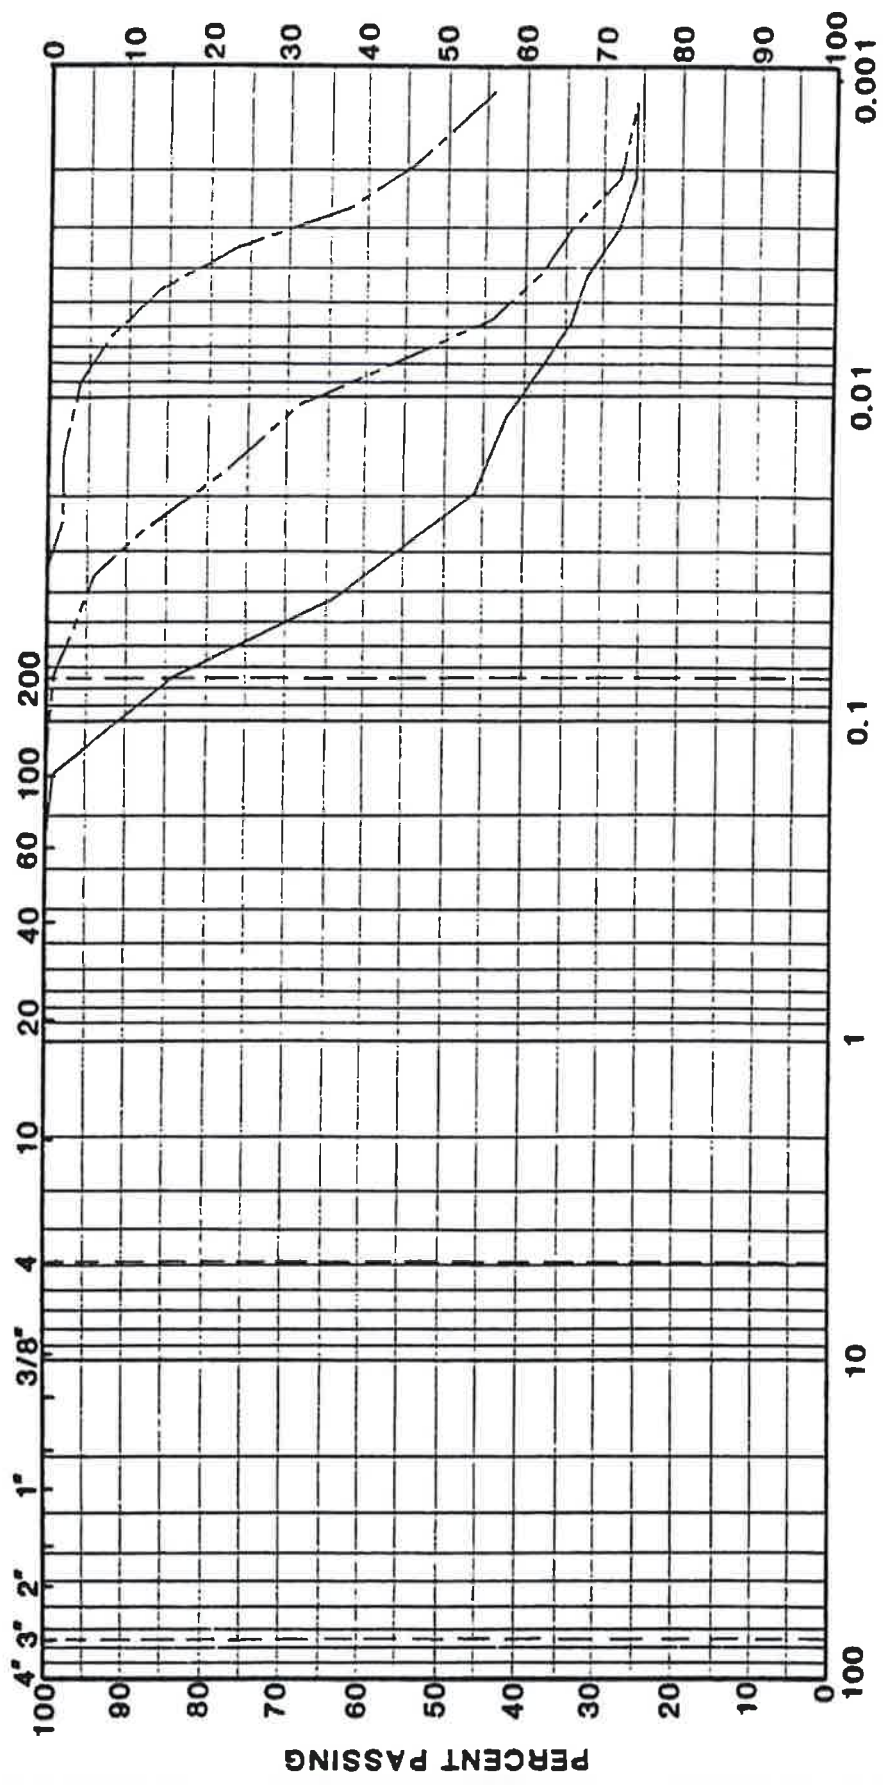
III-4H-34

BORING NO.	DEPTH(FT)	CLASSIFICATION	SYMBOL
CB-8	68-70	CL	—
CB-9	33-35	CH	---
CB-10	63-65	CH	---

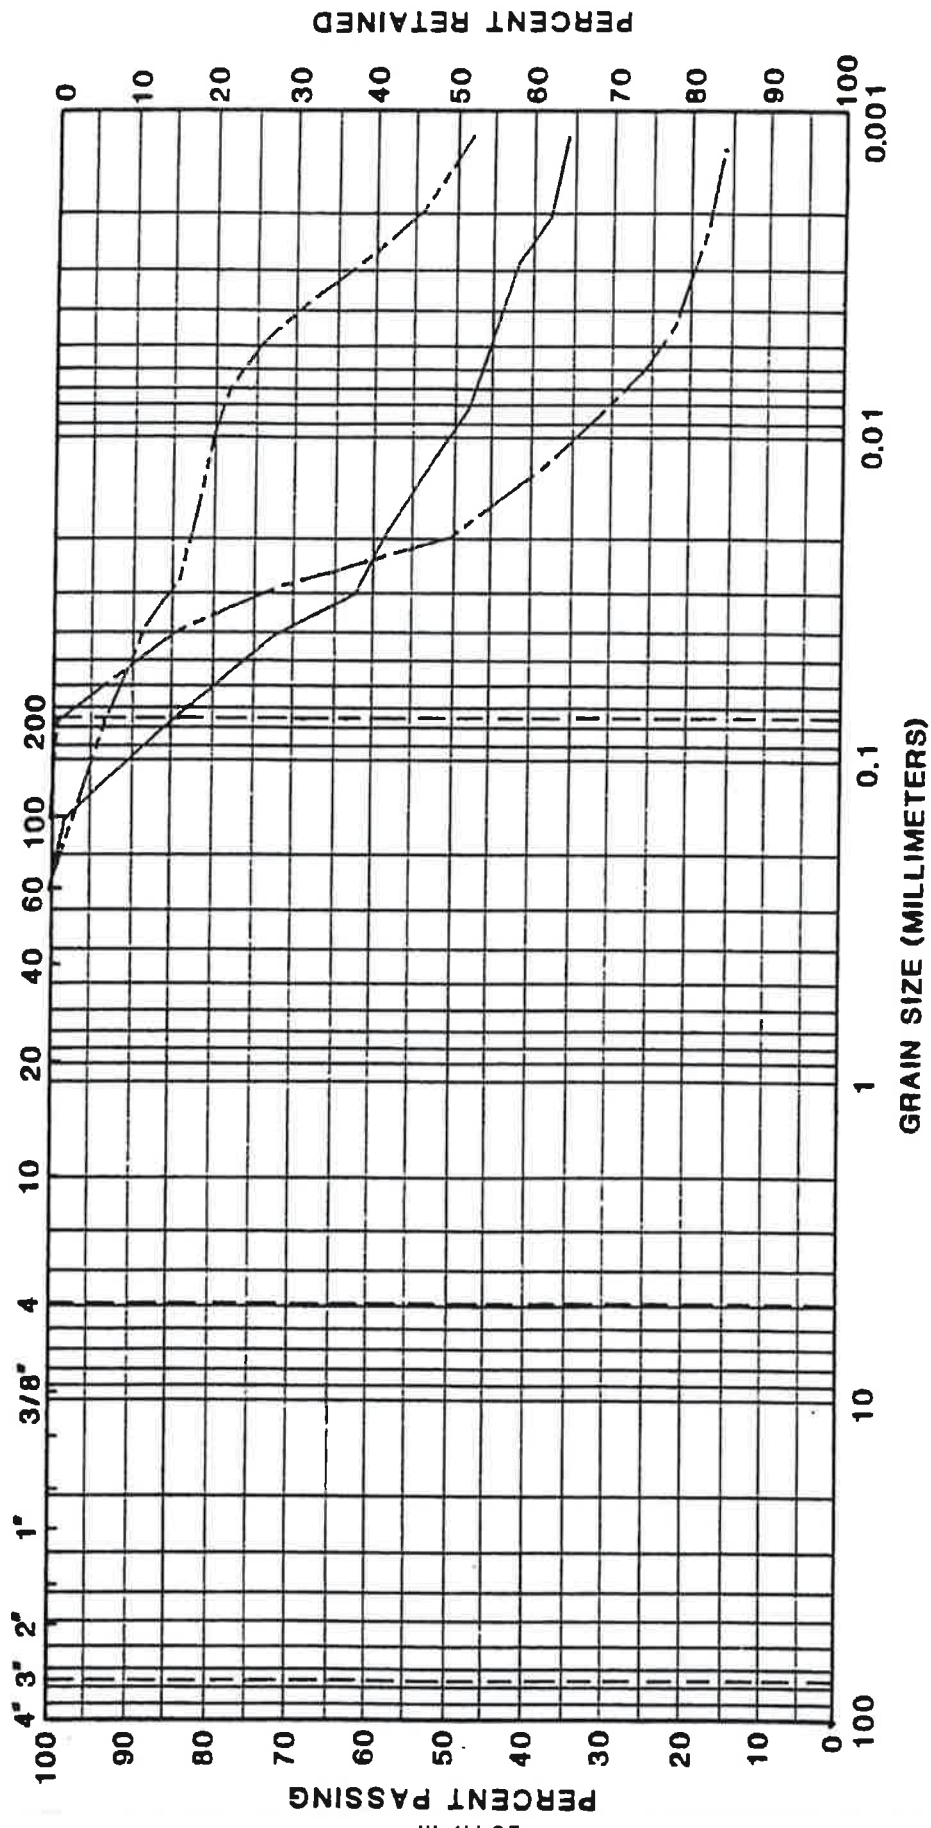
III-4H-35

BORING NO.	DEPTH (FT)	CLASSIFICATION	SYMBOL
CB-11	68-70	CL	—
CB-11	78-80	ML	---
CB-13	23-25	CH	---

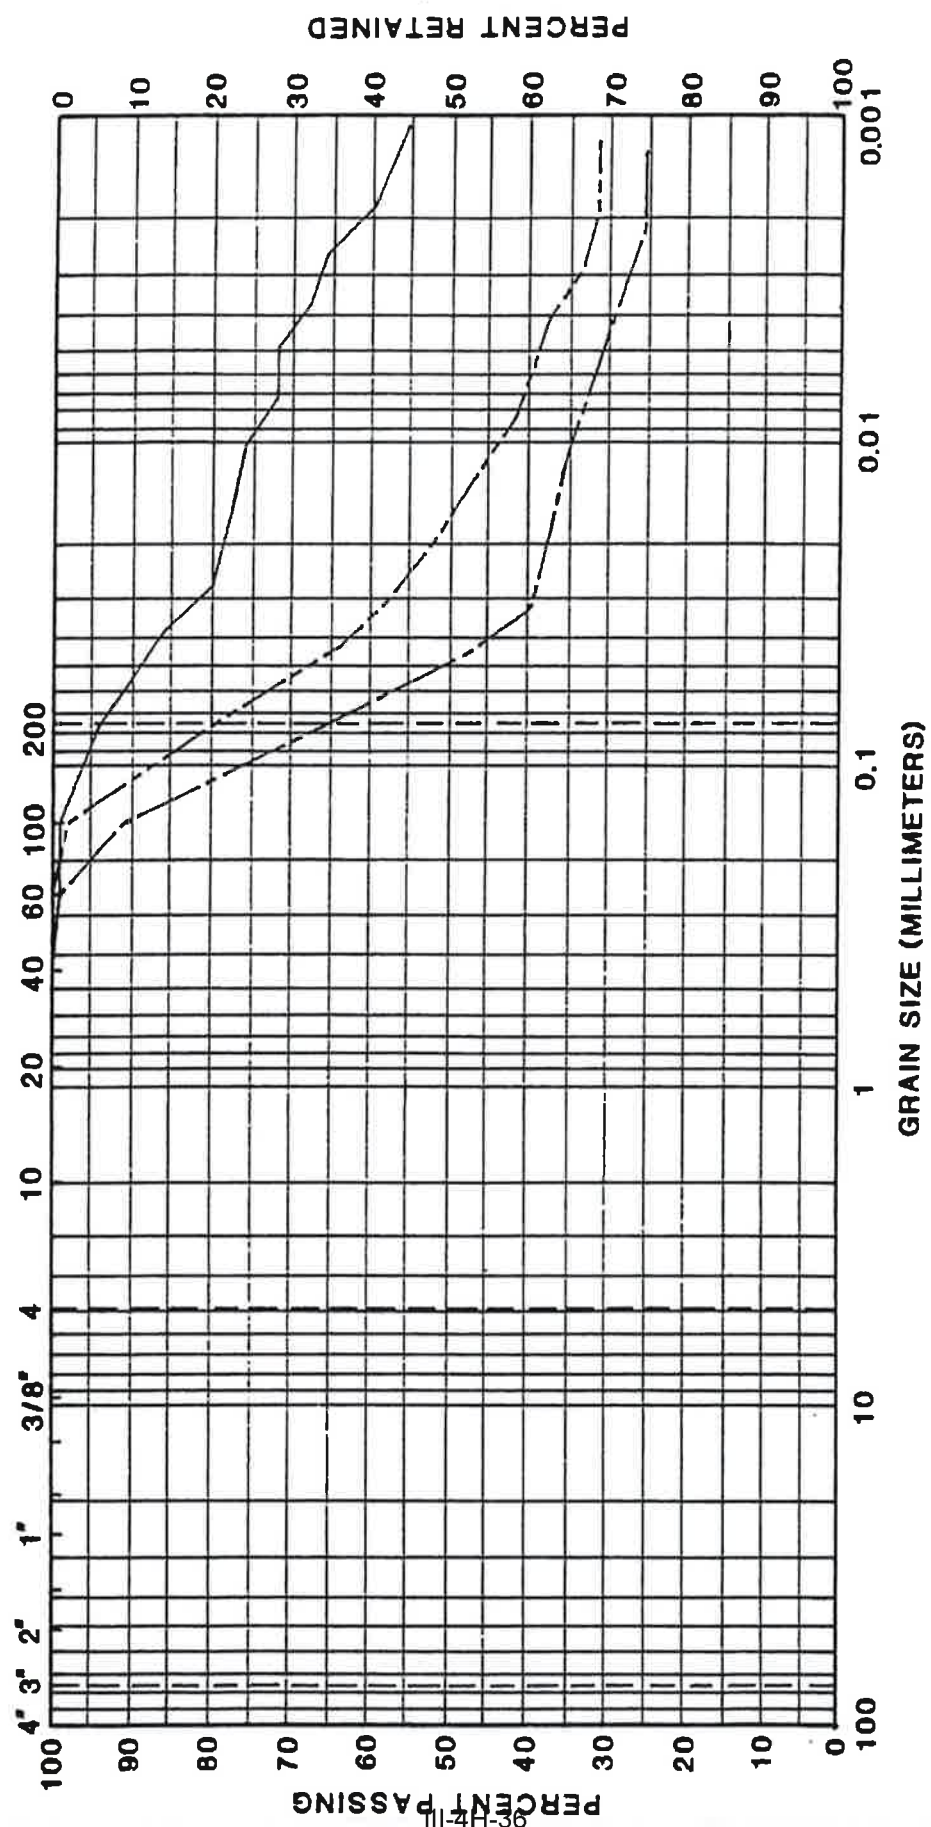
BORING NO.	DEPTH (FT)	CLASSIFICATION	SYMBOL
CB-14	68-70	CH	—
CB-15	8-10	CL	---
CB-16	18-20	ML	- - -

GRAIN SIZE DISTRIBUTION (UNIFIED SOIL CLASSIFICATION)

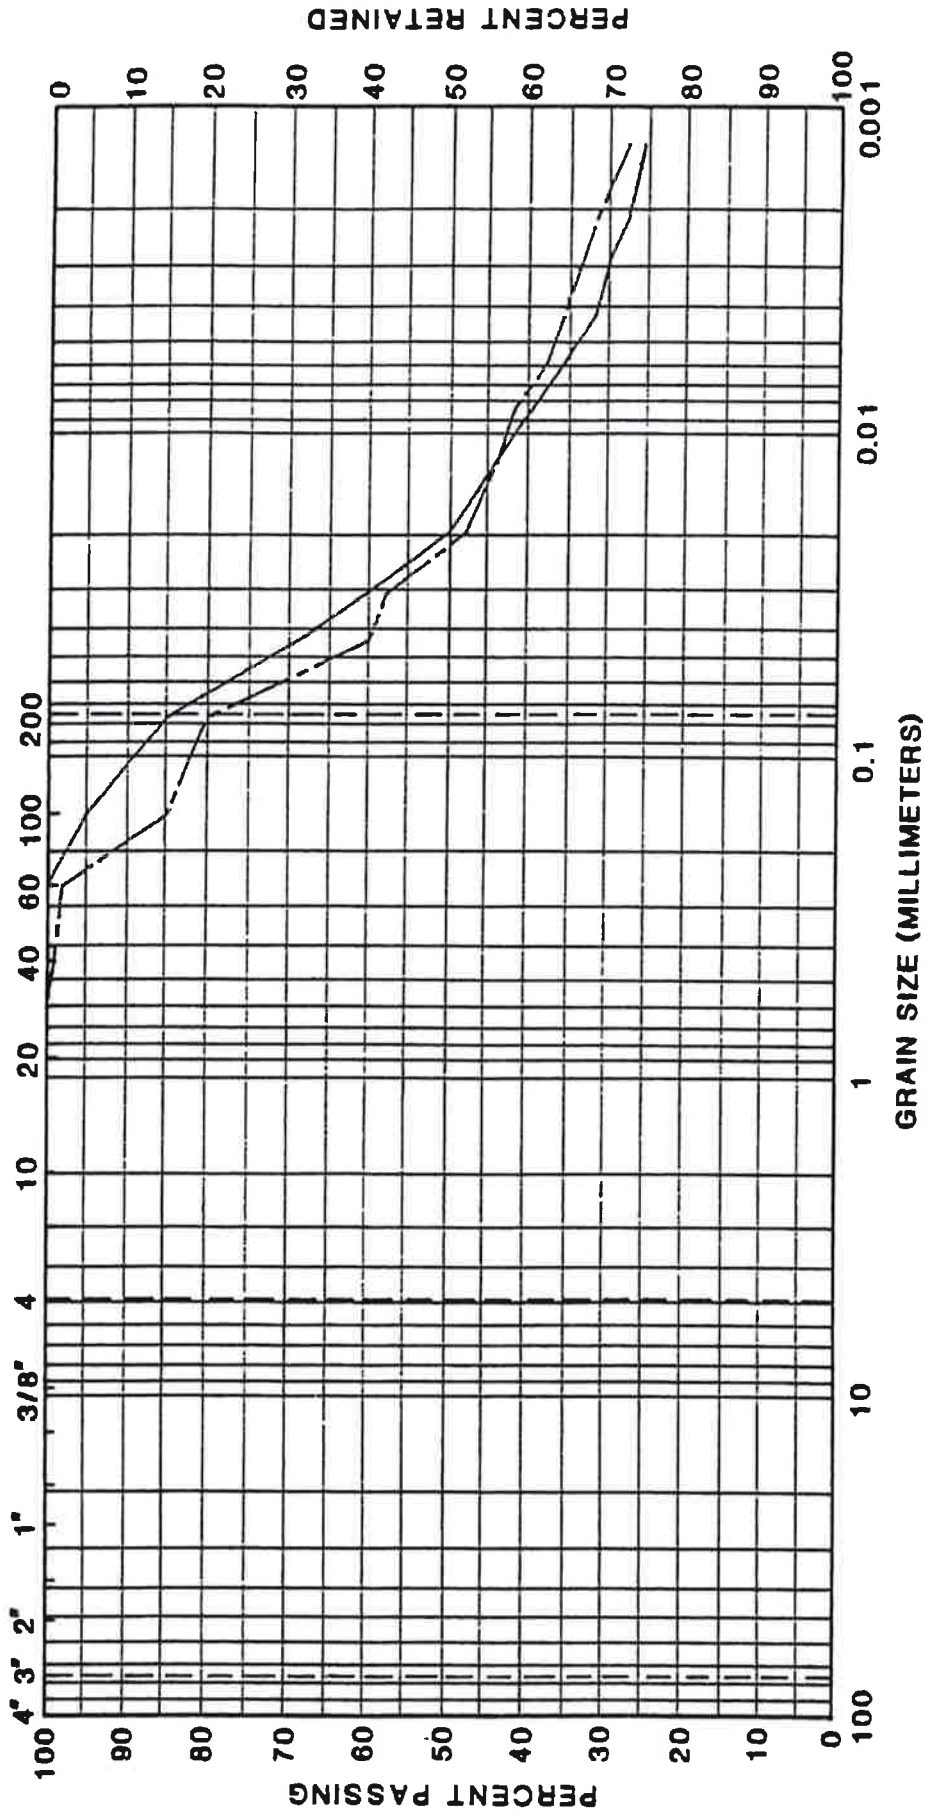
FILE NO. : 87-028  
 FIGURE NO. C-9  
 DATE :

GRAIN SIZE DISTRIBUTION (UNIFIED SOIL CLASSIFICATION)

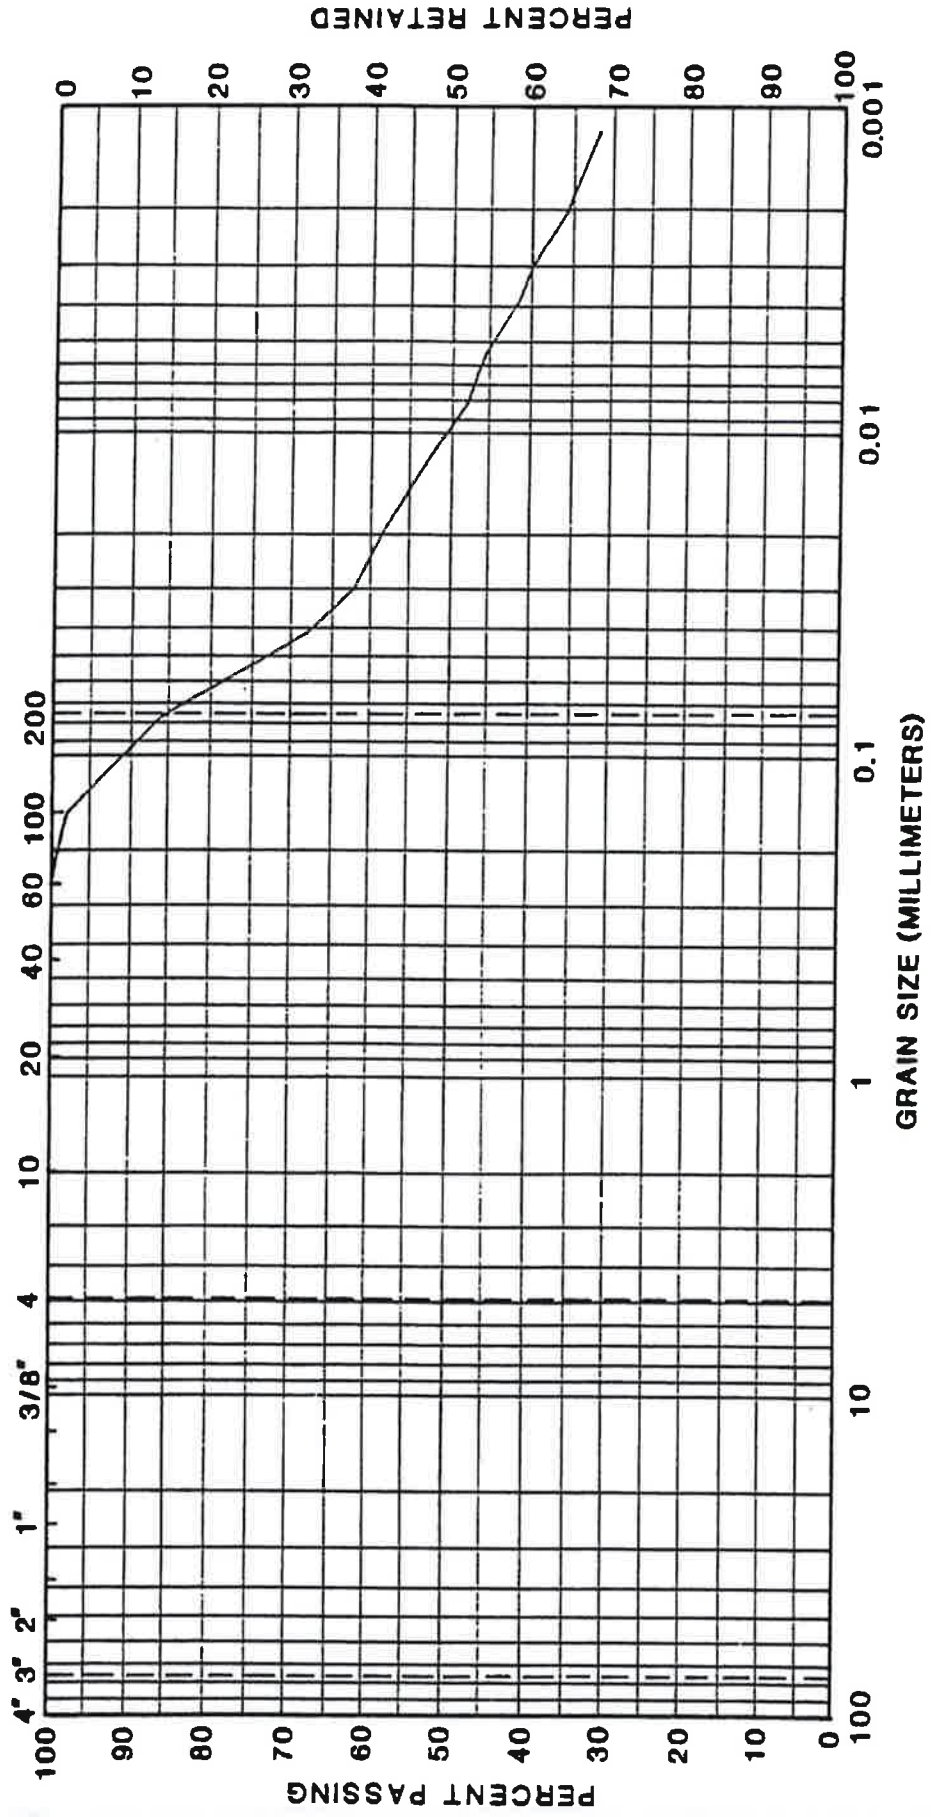
BORING NO.	DEPTH (FT)	CLASSIFICATION	SYMBOL
CB-16	73-75	CL	—

**GRAIN SIZE DISTRIBUTION**  
(UNIFIED SOIL CLASSIFICATION)

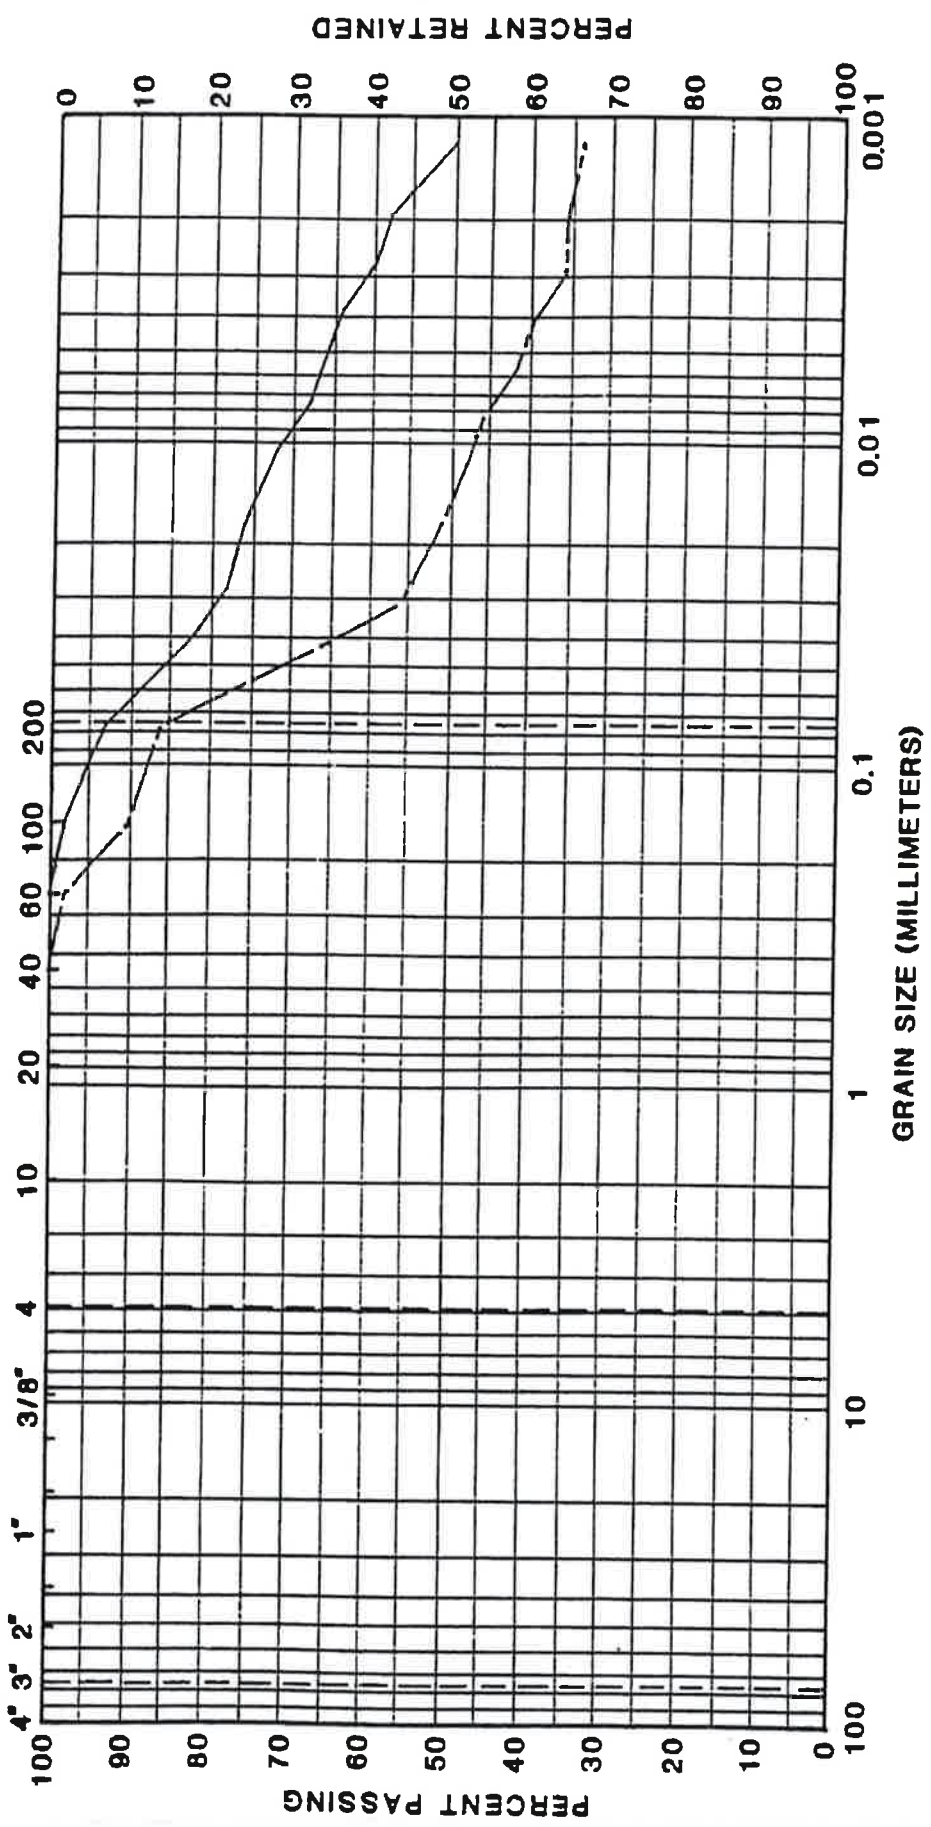
III-4H-39

BORING NO.	DEPTH(FT)	CLASSIFICATION	SYMBOL
P-4P	58-70	CL	—
P-5PA	72-74	CL	---
